**Report: TAB Report**  
**Function: Test, Adjust, & Balance**  
**Date: 08/06/2025**  
**Completed By: National TAB**

**07-28-25 CHIPOTLE #5670 BRIGHTON, MA**

470 WASHINGTON ST

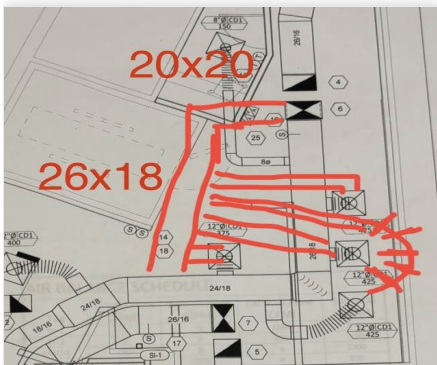
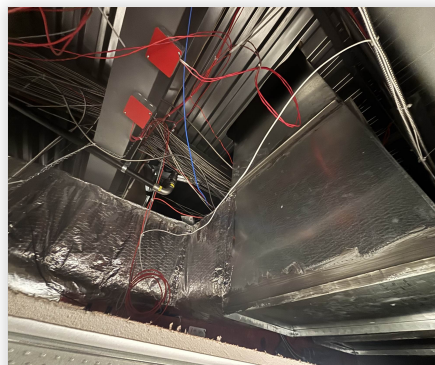
**Issue Name :** RTU1: Departure from Design Restricting Flow  
**Description :** Airflow restricted by departure from design. Main trunk line does not have long straightaway after main drop. Instead, there is a short undersized piece of duct that immediately elbows. Air supply to space barely within acceptable bounds, unable to adjust diffusers due to risk of decreasing airflow.

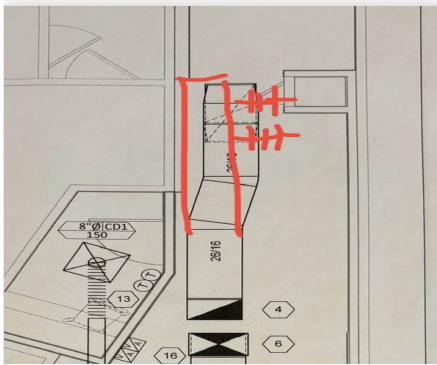
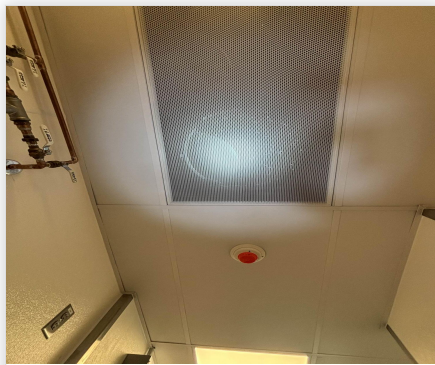
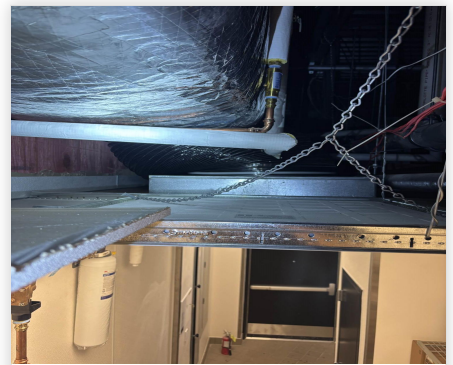
**Issue Name :** RTU1: Return Restricted by Misaligned Grille and Ductwork  
**Description :** Misaligned grill and ductwork are greatly increasing resistance to return flow. Increasing pressure in fan suction and decreasing supply.  
**Created By :** National TAB                      **Assigned To :** National TAB - Dan Hertenstein  
**Status :** Open  
**Priority :** Low                                      **Asset Tag :**  
**Originated Date :** 08/01/2025 - Ryan Smith - National TAB

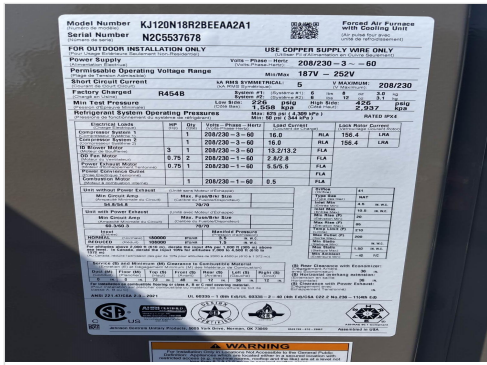
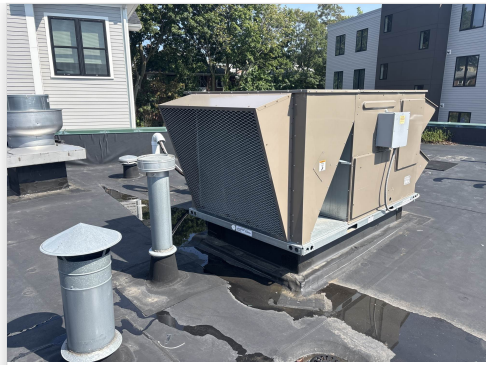
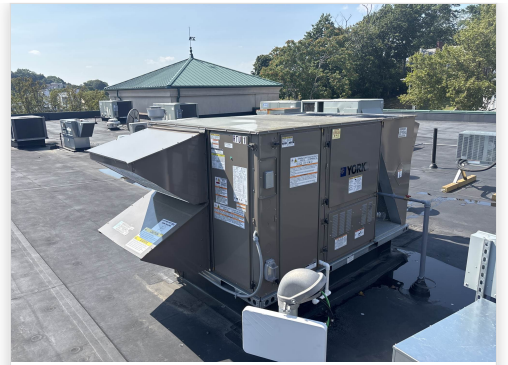
# Unit Data - PHOTO LOG

Notes:  
All diffusers left fully open and unadjusted due to risk of decreasing airflow below acceptable limit.

Unable to fully reduce motor pulley without over amping motor.

Supply airflow is restricted by immediate elbow in supply trunkline and misaligned return grille.

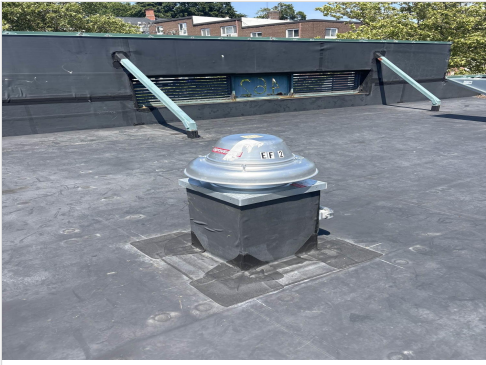
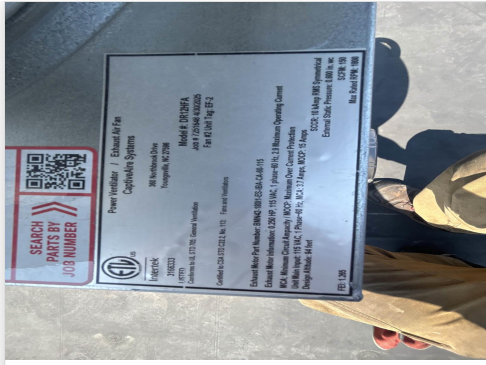
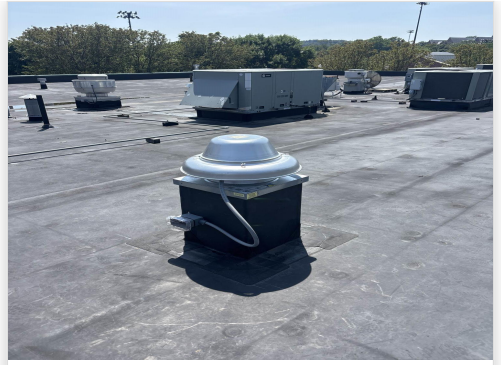
# Unit Data - PHOTO LOG

Motor set to 48%

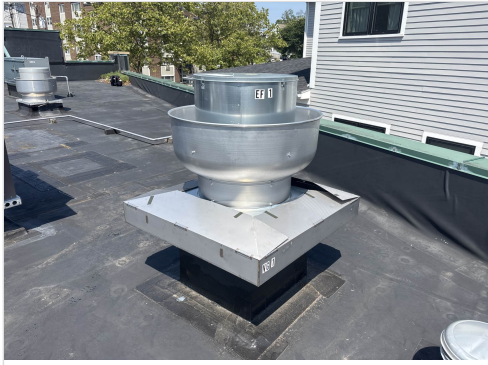
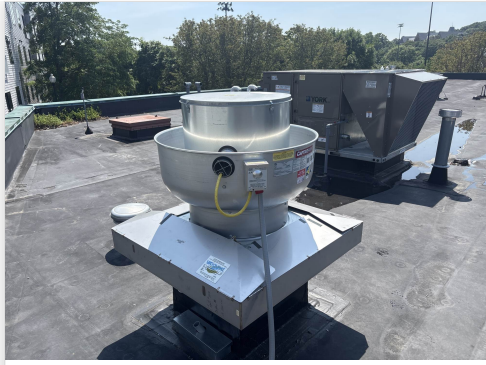
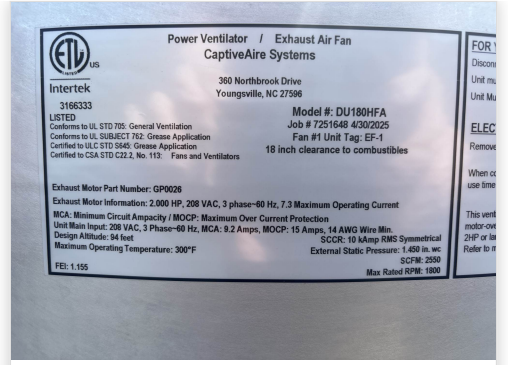
# Unit Data - PHOTO LOG

Motor set to 59.7 Hz

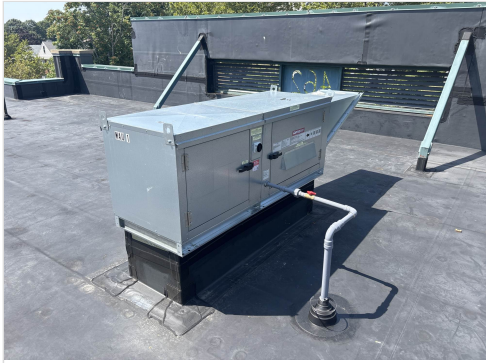
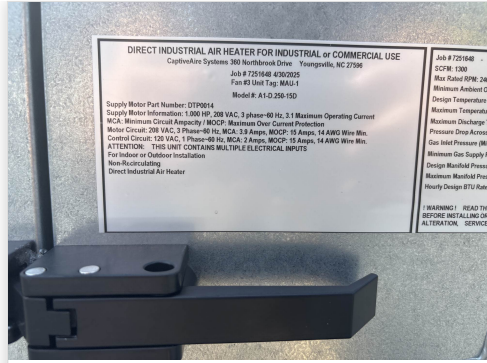
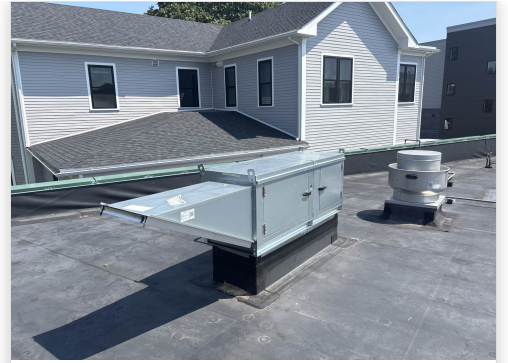
# Unit Data - PHOTO LOG

**DIRECT INDUSTRIAL AIR HEATER FOR INDUSTRIAL or COMMERCIAL USE**  
 CaptiveAire Systems 360 Northbrook Drive Youngsville, NC 27596  
 Job # 7251648 - F  
 SCFM: 1300  
 Max Rated RPM: 2400  
 Minimum Ambient Dry  
 Design Temperature 0  
 Maximum Temperature  
 Maximum Discharge Td  
 Pressure Drop Across F  
 Gas Inlet Pressure (Min)  
 Minimum Gas Supply Pn  
 Design Manifold Pressure  
 Maximum Manifold Press  
 Hourly Design BTU Rate 0

Supply Motor Part Number: DDP0614  
 Supply Motor Information: 1300 RPM, 208 VAC, 3 phase-60 Hz, 3.1 Maximum Operating Current  
 MCA: Minimum Circuit Ampacity / MOCP: Maximum Over Current Protection  
 Motor Circuit: 208 VAC, 3 Phase-60 Hz, MCA: 3.8 Amps, MOCP: 15 Amps, 14 AWG Wire Min.  
 Control Circuit: 120 VAC, 1 Phase-60 Hz, MCA: 2 Amps, MOCP: 15 Amps, 14 AWG Wire Min.  
**ATTENTION: THIS UNIT CONTAINS MULTIPLE ELECTRICAL INPUTS**  
 For Indoor or Outdoor Installation  
 Non-Recirculating  
 Direct Industrial Air Heater

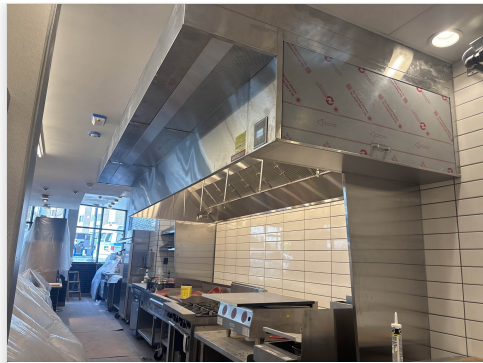
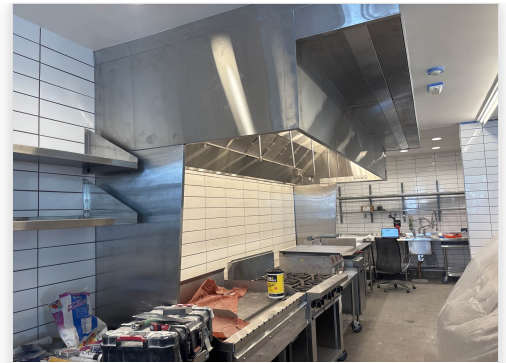
# Unit Data - PHOTO LOG

**Caplivoire Systems** Job # 7251648  
 360 Northbrook Drive Hood # 1  
 Youngsville, NC 27596 Length: 12' 9"

Model #: 5424 ND-2  
 Exhaust Hood without exhaust damper  
 Patent(s) (US) 7962653, (CA) 2530303, 2520669, 2520435
