Report: TAB Report
Function: Test, Adjust, & Balance
Date: 11/25/2025
Completed By: National TAB

PROJECT
11-17-25 CHILIS GREENSBURG, PA

400 Greengate Centre Cir

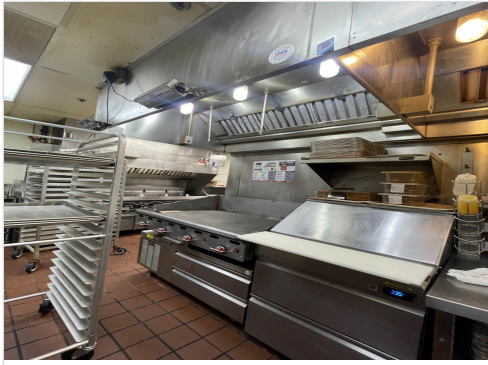
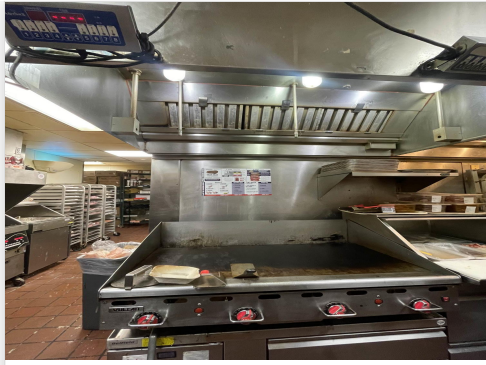
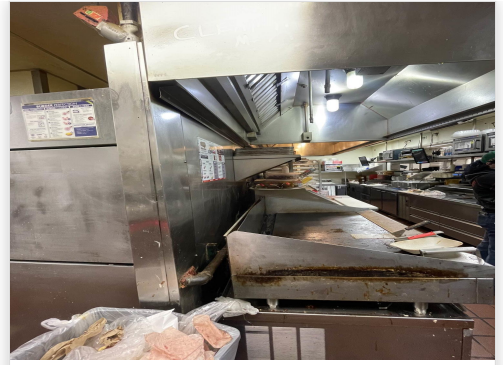
Unit Data - PHOTO LOG

Asset: HD2

Test Data Exhaust		
	Design	Actual
Filter Type	-	BAFFLE
Filter Size 1	-	12"X20"
Filter Qty 1	-	3
Filter AK factor size 1	-	1.54
Filter1 FPM	-	
Filter2 FPM	-	
Filter3 FPM	-	
Filter Ave FPM(corr)	-	
CFM	1350

Hood-1:100% Hood-2: 50% Hood-3:100% Hood-4: 100% Hood-5: N/A

Hood Left (griddle) requires a full length end panel to capture
 Recommended design: 180 CFM/LFT

Recommend floor length end panel for Hood 2 to improve smoke capture.

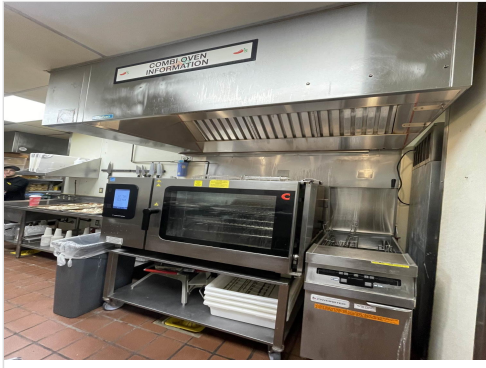
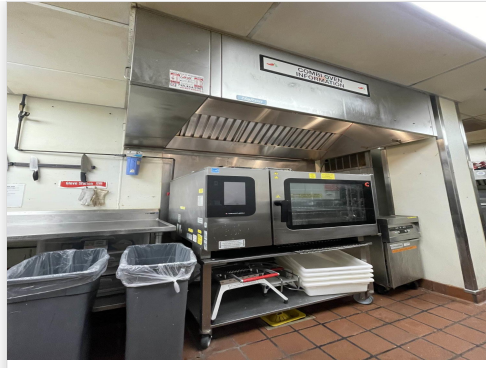
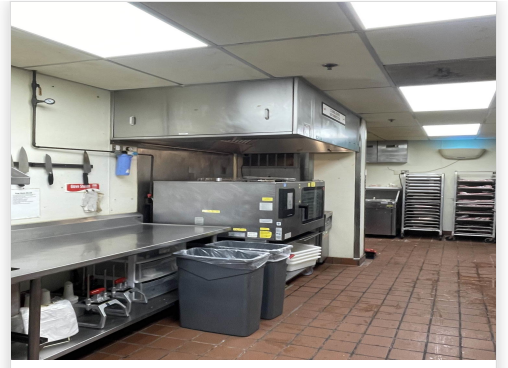
Unit Data - PHOTO LOG

Asset: HD4

Test Data Exhaust		
	Design	Actual
Filter Type	-	BAFFLE
Filter Size 1	-	16"X20"
Filter Qty 1	-	3
Filter AK factor size 1	-	2
Filter1 FPM	-	208
Filter2 FPM	-	217
Filter3 FPM	-	209
Filter Ave FPM(corr)	-	211.3
CFM	500	1268

Recommended design: 180 CFM/LFT and place an extended splash guard on the fryer right end, extend up 18"
