Report: TAB Report
Function: Test, Adjust, & Balance
Date: 11/25/2025
Completed By: National TAB

PROJECT
11-17-25 CHILIS GREENSBURG, PA

400 Greengate Centre Cir

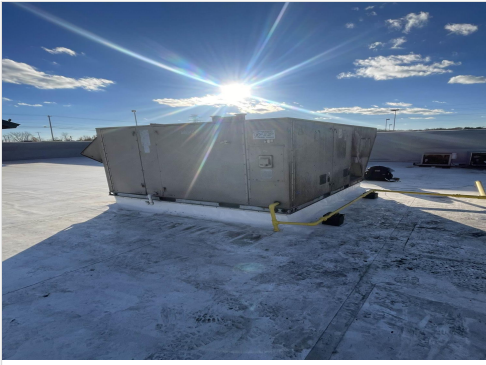
Asset: RTU-1

Supply total 375 CFM per ton (15-ton unit)

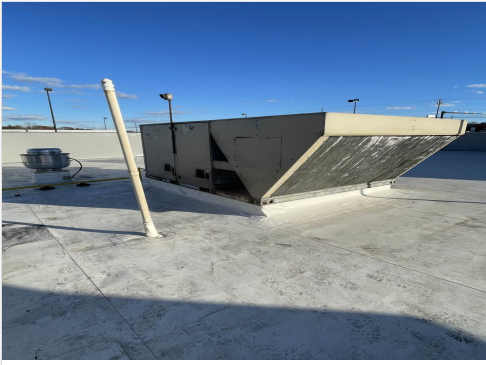
Asset: RTU-2

Notes:
Supply total 375 CFM per ton (15-ton unit)

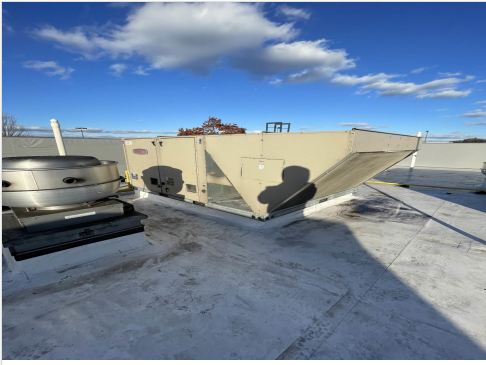
Asset: RTU-3

Notes:
Supply total 375 CFM per ton (15-ton unit)

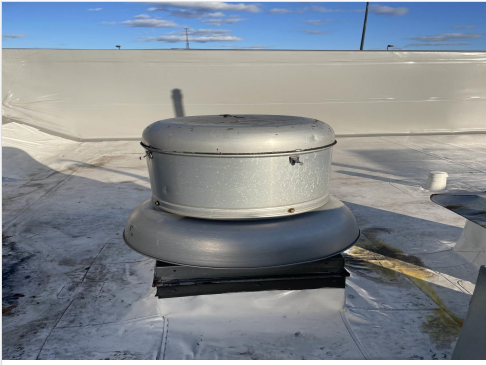
Unit Data - PHOTO LOG

Motor Data		
	Design	Actual
Horsepower	-	0.25
Motor Rpm	-	1300
Phase	-	1
Voltage (rated)	-	115
Amperage (rated)	-	3.2

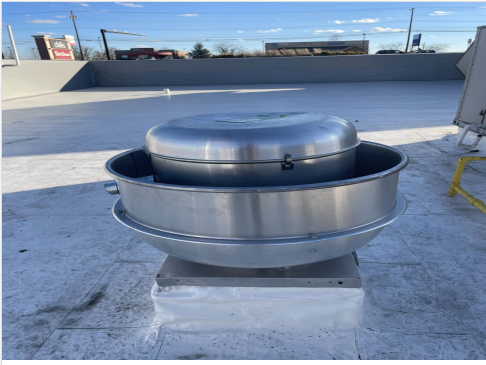
Unit Data - PHOTO LOG

Motor Data		
	Design	Actual
Horsepower	-	0.25
Motor Rpm	-	1550
Phase	-	1
Voltage (rated)	-	115
Amperage (rated)	-	3.2

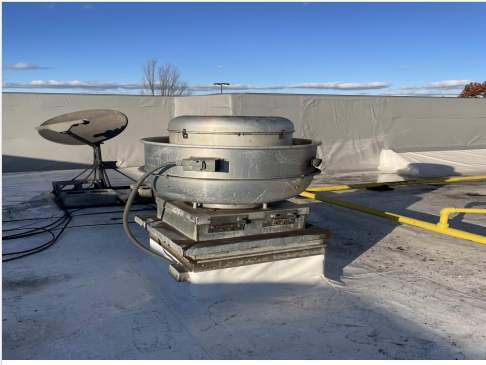
Unit Data - PHOTO LOG

Motor Data		
	Design	Actual
Horsepower	-	0.75
Motor Rpm	-	1750
Phase	-	3
Voltage (rated)	-	208
Amperage (rated)	-	2.48

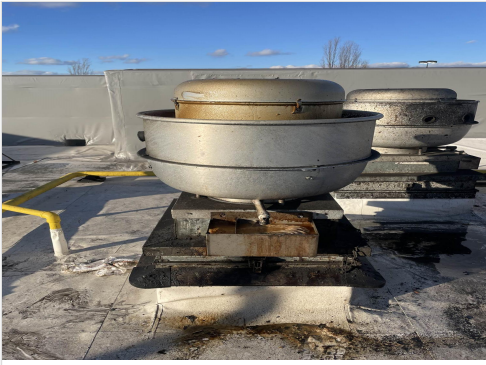
Asset: EF-2

Issue Name : Hood 2 / EF-2
Description : Hood 2 and its associated exhaust fan are both extremely greasy. Grease can be seen dripping from above cooking area and fan on roof is completely covered. Hood is below design.
Created By : National TAB **Assigned To :** National TAB - Dan Hertenstein
Status : Open
Priority : High **Asset Tag :**
Originated Date : 11/18/2025 - Jordan Best - National TAB

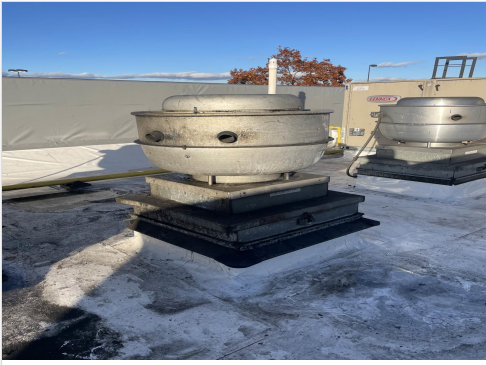
Unit Data - PHOTO LOG

Motor Data		
	Design	Actual
Horsepower	-	1
Motor Rpm	-	1725
Phase	-	3
Voltage (rated)	-	208
Amperage (rated)	-	3.2

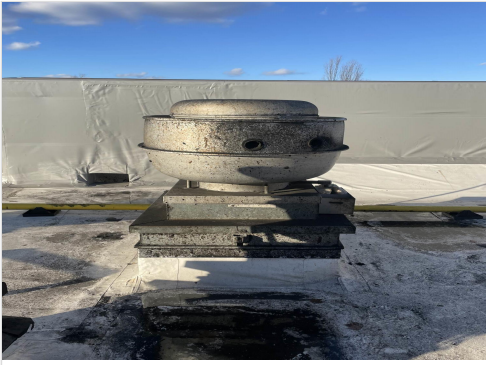
Unit Data - PHOTO LOG

Motor Data		
	Design	Actual
Horsepower	-	0.5
Motor Rpm	-	1725
Phase	-	3
Voltage (rated)	-	208
Amperage (rated)	-	1.8

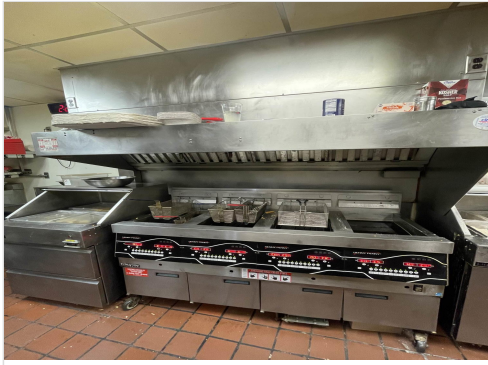
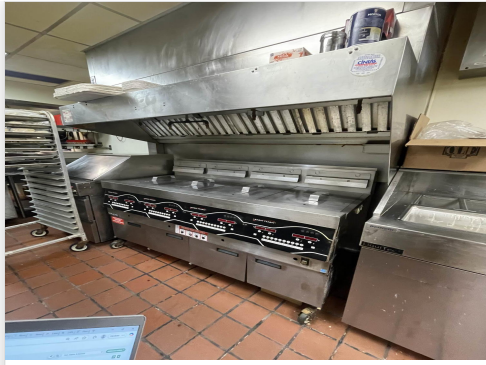
Asset: HD1

Test Data Exhaust		
	Design	Actual
Filter Type	-	BAFFLE
Filter Size 1	-	12"X20"
Filter Qty 1	-	4
Filter AK factor size 1	-	1.54
Filter1 FPM	-	353
Filter2 FPM	-	205
Filter3 FPM	-	183
Filter4 FPM	-	193
Filter Ave FPM(corr)	-	233.5
CFM	1330	1438

Recommended design: 180 CFM/LFT

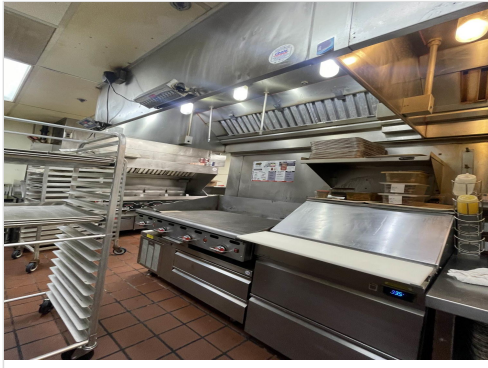
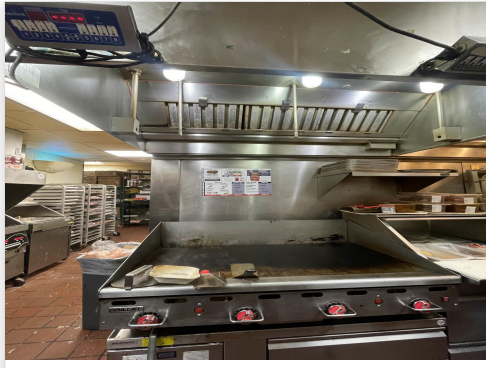
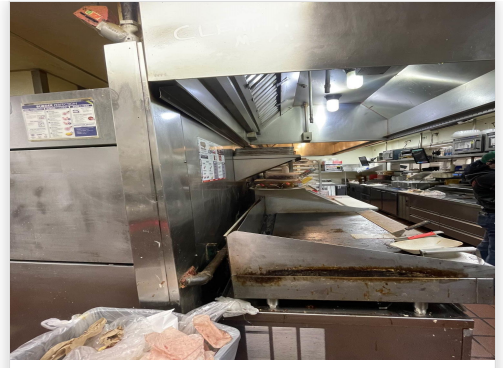
Asset: HD2

Hood Left (griddle) requires a full length end panel to capture
 Recommended design: 180 CFM/LFT

Hood-1:100% Hood-2: 50% Hood-3:100% Hood-4: 100% Hood-5: N/A

Unit	Issue Name	Priority	Description
Hood 2 (Flat Top Grill)	Needs left hood end panel / airflow	High	Left hood end panel needed to ensure 100% smoke capture. Once that is installed airflow could be reduced to help with building pressurization. Airflow is currently 1835 CFM out of 1300 CFM target.
Hood 3 (Oven)	Airflow is excessive	High	Hood airflow is 1835 CFM and only needs to be around 750 CFM. There is only a pastry oven and no other equipment. Blank off filters except those by the pastry oven and then re-evaluate and possibly reduce airflow at the fan.
Overall Building	Negative pressure / DOAS	High	Building pressure is extremely negative (-2103 CFM). Even best case after making changes above, the building will still be -1000 CFM. Recommend removing the RTU in the kitchen and replacing with a 3500 to 4000 CFM 100% OA DOAS to
EF / Hood Not in use	EF / Hood Not in use	Medium	There is a hood and exhaust fan that is no longer in use. Items are being stored under hood and fan is off at the disconnect on the roof. Recommend covering duct opening to ensure it doesn't cause a draft.

Recommend floor length end panel for Hood 2 to improve smoke capture.

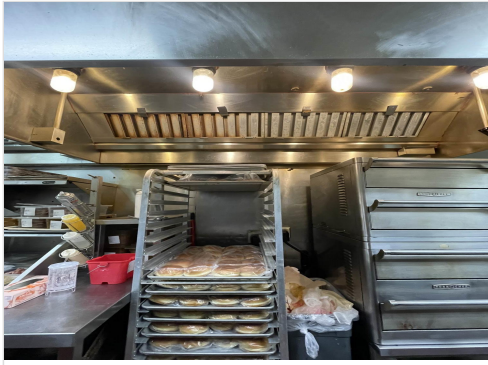
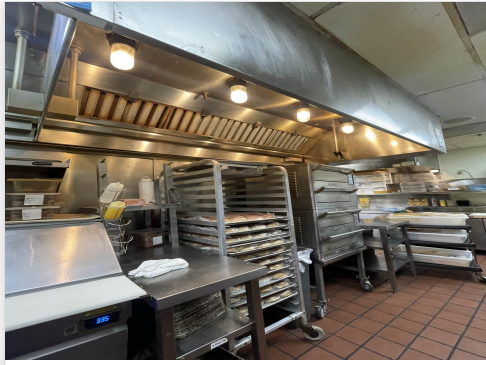
Asset: HD3

Test Data Exhaust		
	Design	Actual
Filter Type	-	BAFFLE
Filter Size 1	-	12"X20"
Filter Qty 1	-	4
Filter AK factor size 1	-	1.54
Filter1 FPM	-	281
Filter2 FPM	-	324
Filter3 FPM	-	363
Filter4 FPM	-	224
Filter Ave FPM(corr)	-	298
CFM	1327	1835

Notes:
Hood Right (pastry oven) no other equipment under it:
Recommended design: 100 CFM/LFT and block off a few filters that are not immediately around the oven.

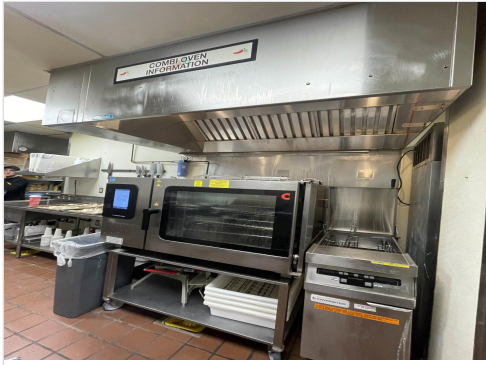
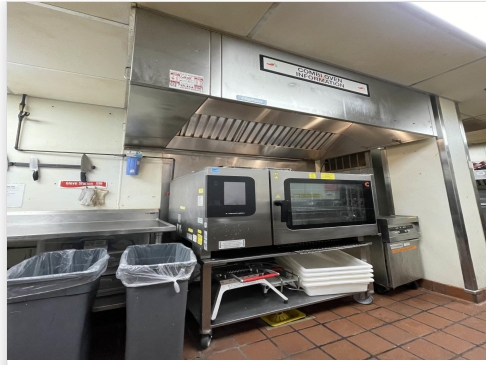
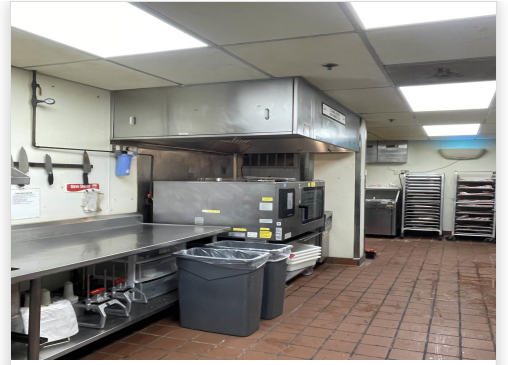
Asset: HD4

Test Data Exhaust		
	Design	Actual
Filter Type	-	BAFFLE
Filter Size 1	-	16"X20"
Filter Qty 1	-	3
Filter AK factor size 1	-	2
Filter1 FPM	-	208
Filter2 FPM	-	217
Filter3 FPM	-	209
Filter Ave FPM(corr)	-	211.3
CFM	500	1268

Recommended design: 180 CFM/LFT and place an extended splash guard on the fryer right end, extend up 18"

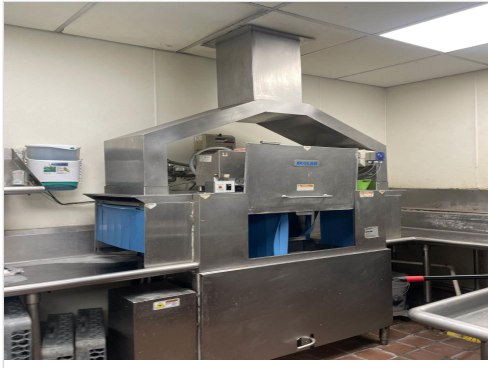
Asset: HD5

Issue Name : EF / Hood Not in use
Description : There is a hood and exhaust fan that is no longer in use. Items are being stored under hood and fan is off at the disconnect on the roof. Recommend covering duct opening to ensure it doesn't cause a draft.
Created By : National TAB **Assigned To :** National TAB - Dan Hertenstein
Status : Open
Priority : Low **Asset Tag :**
Originated Date : 11/18/2025 - Jordan Best - National TAB
