Report: TAB

Function: Test, Adjust, & Balance

**10-28-24 KROGER #024-721 - LEXINGTON,
KY (WIW)**

Project: 10-28-24 KROGER #024-721 - LEXINGTON, KY (WIW)

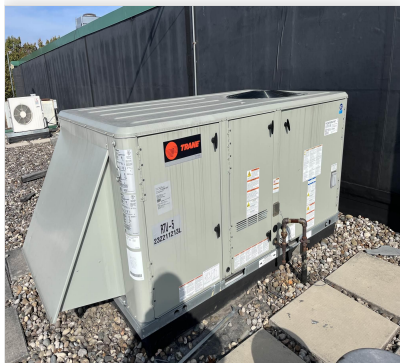
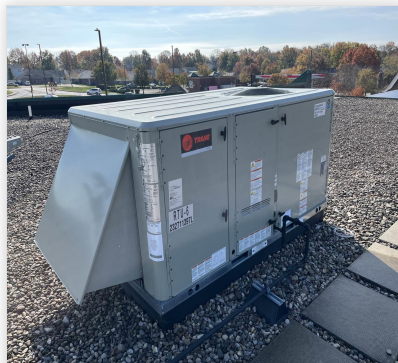
Rtu 5 duct leakage at drop down. Rtu 5 economizer controller potentiometers do not actuate economizer but economizer closes when fan off. Rtu-6 oa high above design even when economizer is fully closed.

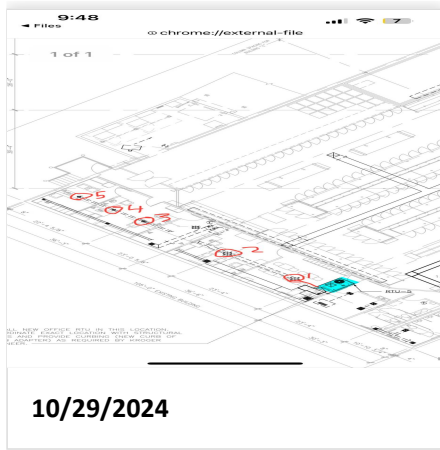
Project Issue File Details

Issue Name : RTU-5 GRD
Description : RTU-5 GRD
Created By : National TAB **Assigned To :** National TAB - Will Turnbough
Status : Open
Priority : InfoOnly **Asset Tag :** RTU5
Originated Date : 10/29/2024 - Cody Collett - National TAB
