**Report: TAB REPORT
Function: Test, Adjust, & Balance
Date: 12/15/2022**

12-12 WENDY'S #00355 - GREENSBORO, NC

WENDYS INTERNATIONAL LLC OPERATING UNIT

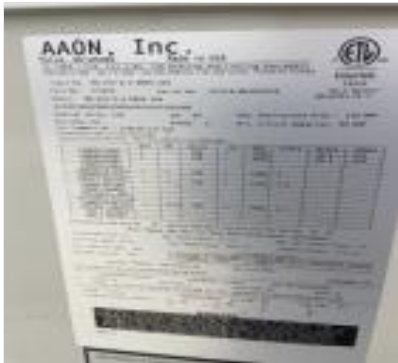
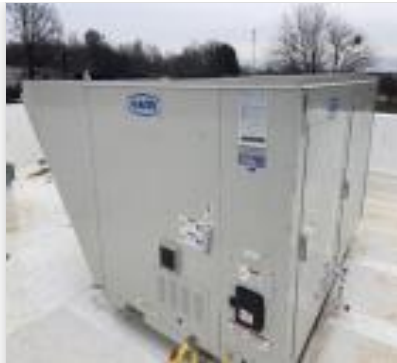
OAU-1

Unit Data		
	Design	Actual
MFG	AAON	AAON
Serial Num	-	2022C8-BNGP02019
Model Num	RN-020	RN-020-8-0-EB09-349
Type	OAU	OAU
Configuration	VERTICAL	VERTICAL
Num OA Filters 1	-	3
OA Filter Size 1	-	28.25X18.25X1
Num Final Filter 1	-	6
Final Filter Size 1	-	20X25X4

Test Data		
	Design	Actual
SF CFM	3300	3695
SF RPM	-	DD
RA CFM	0	0
OA CFM	3300	3695
RL Voltage	-	211/212/210
RL Amperage	-	5.8/6.5/6.8
SF Rotation	-	CCW
RA Damper Position	-	NA
Min OA Damper Position	-	100%
Min OA Damper Type	-	ODB

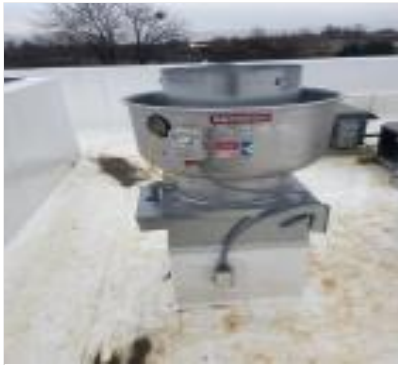
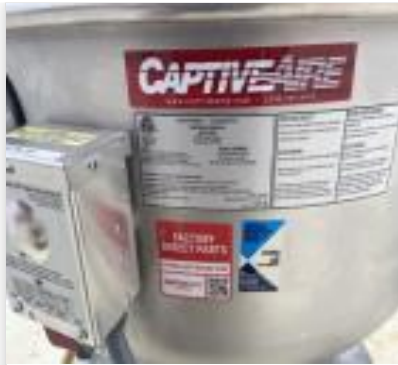
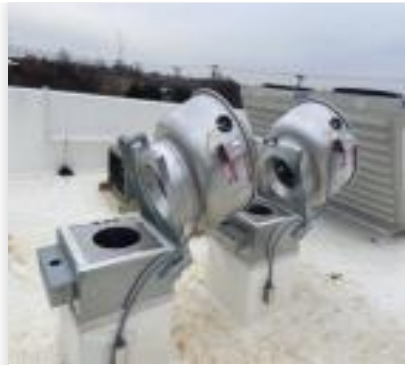
EF-2

Test Data		
	Design	Actual
CFM	1200	1208
Fan RPM	1254	1016
Fan Rotation	-	CCW
Motor RPM	-	1016
System SetPt	-	56"
RL Voltage	-	211
RL Amperage	-	2.8
Total ESP	1.250"	0.69"
Fan Inlet SP	-	-0.69"
Fan Discharge SP	-	ATM

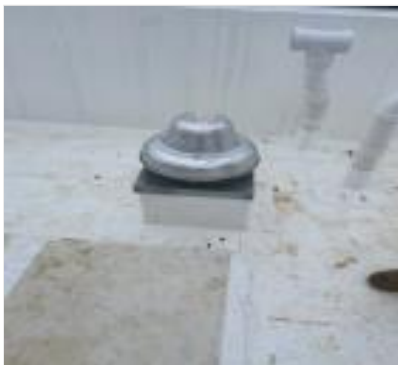
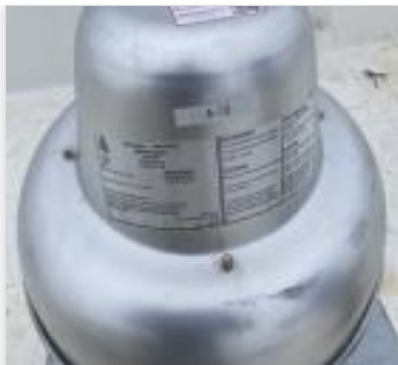
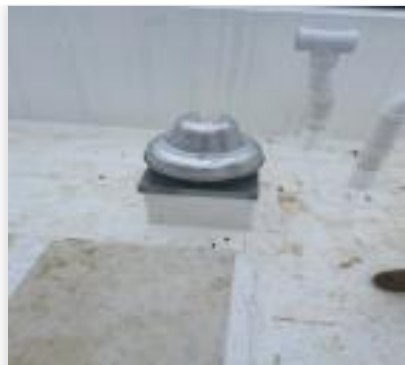
EF-3

RR EX FAN TIED TO LIGHT IN RR. REAR DOOR BUILD PRESSURE DID NOT CHANGE MUCH WHEN RR EX FAN TURNS ON BUT FRONT INTERANCE DID. WHEN RR FAN COMES ON FRONT DOOR BP DROPS FROM 0.008 TO 0.002 BUT IS STILL POSITIVE.

Test Data		
	Design	Actual
CFM	300	296
Fan RPM	1500	1045
Fan Rotation	-	CCW
Motor RPM	-	1045
System SetPt	-	60P
RL Voltage	-	115
RL Amperage	-	1.8
Total ESP	0.34"	0.48"
Fan Inlet SP	-	-0.48"
Fan Discharge SP	-	ATM
