**Report: TAB Report**  
**Function: Test, Adjust, & Balance**  
**Date: 11/13/2022**

## 11-07 WALGREENS #3848 - DEER PARK, TX

Project: 11-07 WALGREENS #3848 - DEER PARK, TX

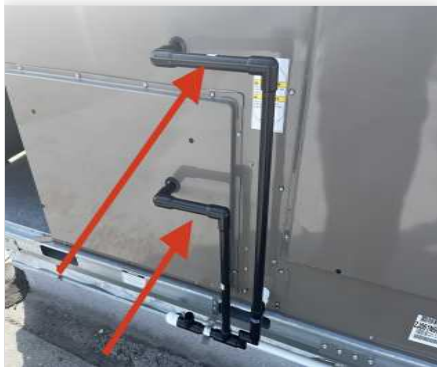
IMG\_0123.jpeg

**Description :** COSTGARD CONDENSATE DRAINS ARE NOT PROPERLY SUPPORTED. COSTGARD RECOMMENDS SUPPORTS WHERE SHOWN ON PICTURE.

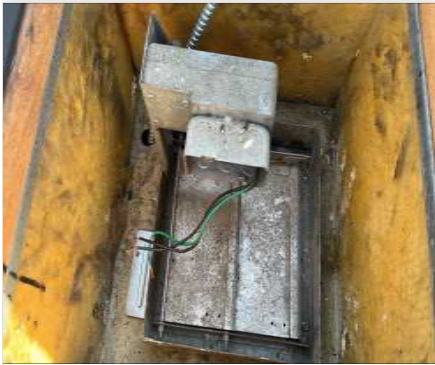
Image\_2022\_11\_13T1324...

**Description :** EF-4 WOULD NOT POWER ON. UNIT HAS ACTUATED BACK DRAFT DAMPER THAT IS UNPOWERED.

Fan rotation is correct	Pass
Pulleys are aligned and belts are tensioned properly	ALL EFS ARE DIRECT DRIVE.
Speed controller installed and functional (direct drive)	EF 1-3 ARE SINGLE SPEED. EF-4 HAS SPEED CONTROLLER INSTALLED BUT FAN DID NOT POWER ON.
Fan is secured to the curb	Pass
Back draft damper is installed and functional	Fail
No exterior damage to the fan	Pass
No unusual noise or vibration	Pass
Controls are functional	Fail
Additional Comments:	EF-4 SERVING THE OFFICE AND PHOTO LAB WILL NOT POWER ON. UNIT HAS MOTORIZED BACKDRAFT DAMPER BUT IS NOT POWERED.

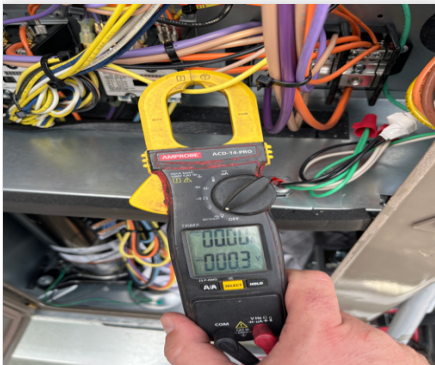
FuselTea6177916a62495...

**Description :** RTU-2 FAN MOTOR IS ONLY MEASURING CURRENT ON 2 OF 3 PHASES. MEASURED CURRENT ON BOTH PHASES ARE 7.7/4.1 FLA AT 60 Hz.

TAB WAS UNABLE TO BE COMPLETED DUE TO THE FOLLOWING: 1) RTU-2 FUSE SERVING SUPPLY FAN MOTOR HAD BLOWN. MOTOR WAS RUNNING ON 2 OF 3 PHASES. OTHER 2 PHASES WERE DRAWING 7.7 AMPS OUT OF 4.1 FLA. UNIT TURNED OFF TO AVOID DAMAGING MOTOR. 2) RTU-3 NEEDS PULLEY CHANGE. FAN SPEED IS MINIMIZED BUT UNIT IS OPERATING AT 159% OF DESIGN AIR FLOW. 3) EF-4 WOULD NOT OPERATE. UNABLE TO DETERMINE HOW FAN TURNS ON. FAN HAS MOTORIZED BACKDRAFT DAMPER, BUT DAMPER IS NOT HOOKED UP TO POWER.
