Report: TAB Report
Function: Test, Adjust, & Balance
Date: 08/27/2025
Completed By: National TAB

PROJECT
09-01-25 FREDDY'S HOLMDEL, NJ

Project: 09-01-25 FREDDY'S HOLMDEL, NJ

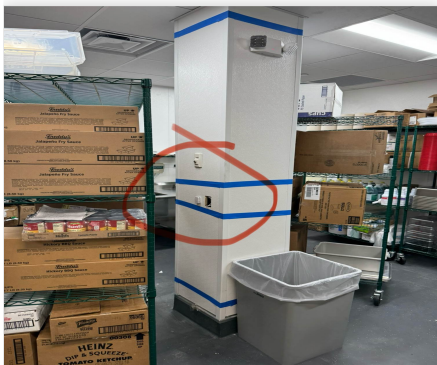
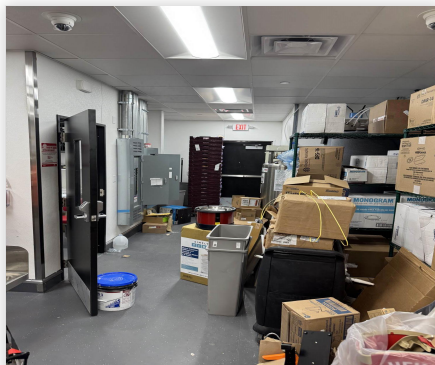
Issue Name : RTU 3 - Temperature Sensor Location
Description : Note: RTU 3 temperature sensor is installed per print but this is physically located in the zone of RTU 2. Found RTU 3 zone Getting cold, recommend relocating space sensor to RTU 3 zone.
Created By : National TAB **Assigned To :** National TAB - Dan Hertenstein
Status : Open
Priority : High **Asset Tag :**
Originated Date : 08/28/2025 - Ryan Ash - National TAB

Area served by RTU-3 is getting cold. found sensor is located in the area of RTU-2 (which is per print) recommend relocating RTU-3 sensor.

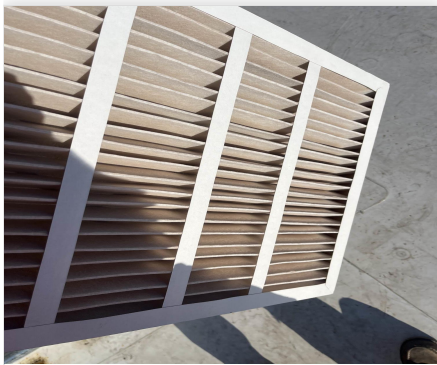
Issue Name : RTU- Filters
Description : RTU Filters are dusty but not clogged. Recommend replacement prior to store opening.
Created By : National TAB **Assigned To :** National TAB - Dan Hertenstein
Status : Open
Priority : Low **Asset Tag :**
Originated Date : 08/27/2025 - Tyler Youells - National TAB

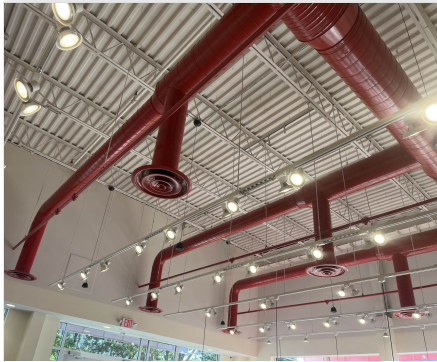
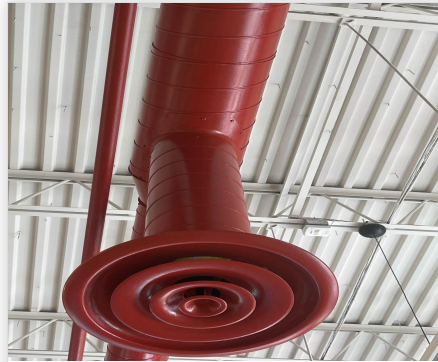
Issue Name : RTU-1 No Dampers
Description : RTU-1 Does not have balancing dampers installed. NTi is unable to proportionally balance dining room diffusers.
Created By : National TAB **Assigned To :** National TAB - Dan Hertenstein
Status : Open
Priority : Low **Asset Tag :**
Originated Date : 08/27/2025 - Tyler Youells - National TAB

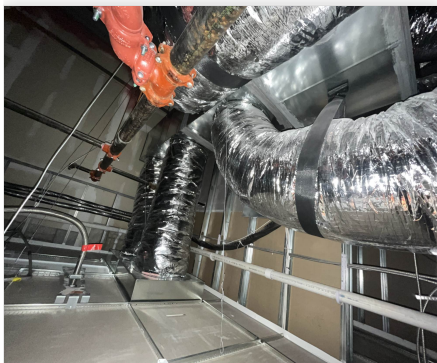
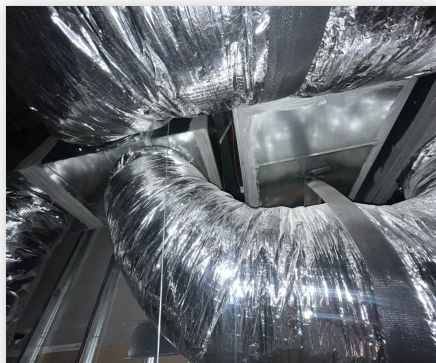
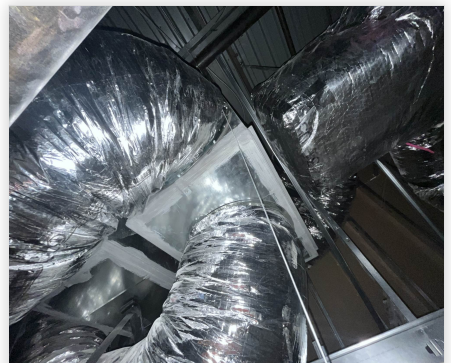
Issue Name : RTU-2 Duct drops/trunkline
Description : Note only: duct drops did not line up with supply and return routing. Found 2X flex ducts used to connected supply and return trunklines to each drop. Unit was balanced to design flow.
Created By : National TAB **Assigned To :** National TAB - Dan Hertenstein
Status : Open
Priority : InfoOnly **Asset Tag :**
Originated Date : 08/28/2025 - Tyler Youells - National TAB

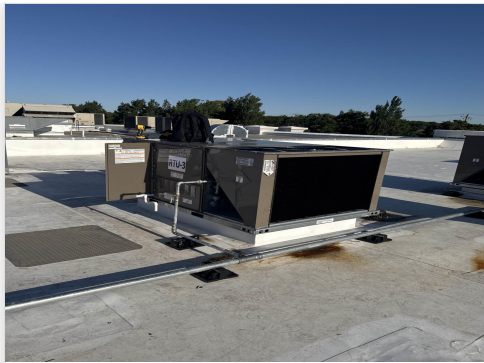
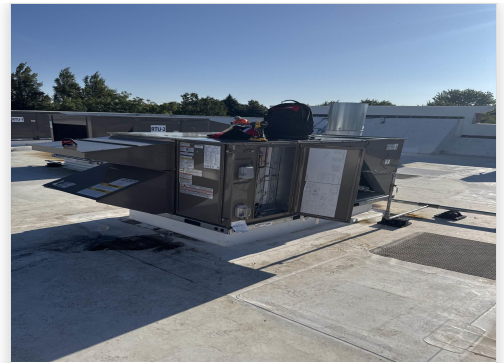
Asset: RTU3

Unit Data		
	Design	Actual
MFG	CARRIER	YORK
Serial Num	-	N2F5107423
Model Num	48HCEA06	KJ061N12B4DFEAL2A1
Type	RTU	RTU
Configuration	VERTICAL	VERTICAL
Num OA Filters 1	-	1
OA Filter Size 1	-	31x22
Num Final Filter 1	-	4
Final Filter Size 1	-	16x24x2

General	
	Actual
Fan Rotation Correct	YES
Unit Filters Clean	YES/SLIGHT LOADING
Condensate Drain Installed	YES

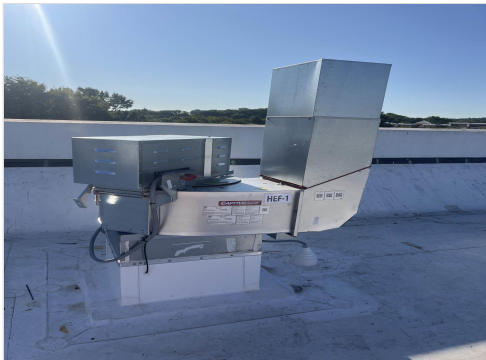
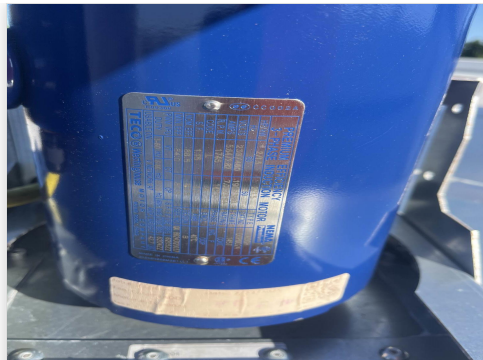
Asset: HEF1

Unit Data		
	Design	Actual
MFG	CAPTIVEAIRE	CAPTIVEAIRE
Model Num	CASRE18DD	CASRE18DD
Serial Num	-	7328629
Type	UTILITY	UTILITY
Configuration	VERTICAL	VERTICAL

Test Data		
	Design	Actual
CFM	1600	1627
Fan RPM	-	1111
Fan Rotation	-	CCW
Motor RPM	-	1111
System SetPt	-	38.2HZ
RL Voltage	-	235 VFD
RL Amperage	-	2.1 VFD
Total ESP	1.40"	NA
Fan Inlet SP	-	NA
Fan Discharge SP	-	NA

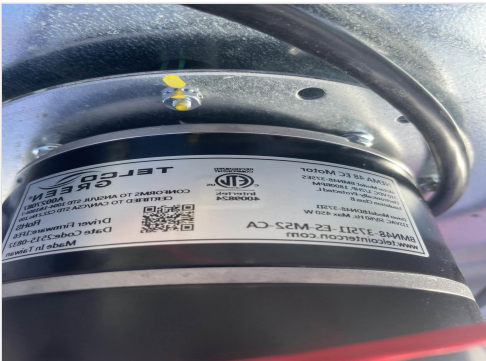
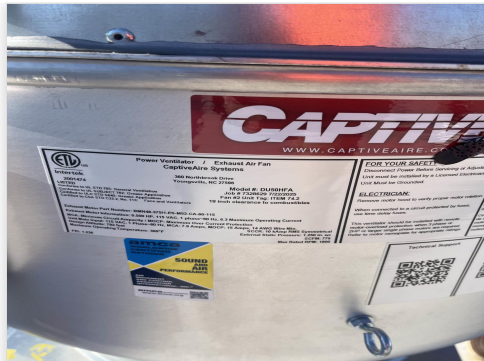
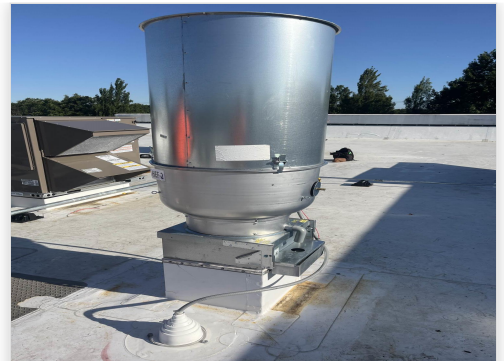
Asset: HEF2

Unit Data		
	Design	Actual
MFG	CAPTIVEAIRE	CAPTIVEAIRE
Model Num	DU50HFA	DU50HFA
Serial Num	-	7328629
Type	UPBLAST	UPBLAST
Configuration	VERTICAL	VERTICAL

Test Data		
	Design	Actual
CFM	775	787
Fan RPM	-	990
Fan Rotation	-	CCW
Motor RPM	-	990
System SetPt	-	55%
RL Voltage	-	118.6
RL Amperage	-	2.1
Total ESP	1.250"	0.62"
Fan Inlet SP	-	-0.62"
Fan Discharge SP	-	ATM

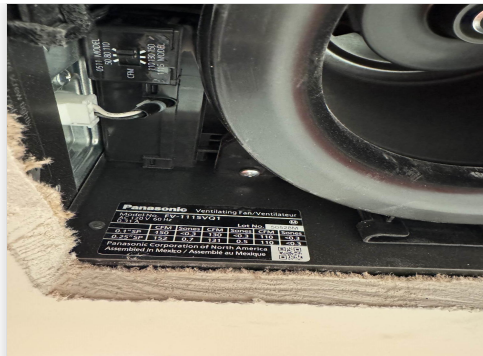
Asset: TEF3

Unit Data		
	Design	Actual
MFG	GREENHECK	PANASONIC
Model Num	SP-B110	FV-1115VQ1
Serial Num	-	50528M
Type	CEILING	CEILING

Test Data		
	Design	Actual
CFM	110	103
System SetPt	-	HIGH

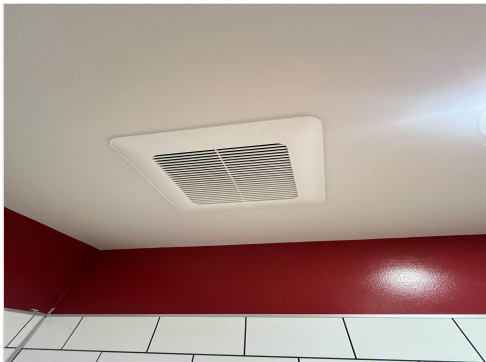
Asset: TEF4

Unit Data		
	Design	Actual
MFG	GREENHECK	PANASONIC
Model Num	SP-B110	FV-1115VQ1
Serial Num	-	50528M
Type	CEILING	CEILING

Test Data		
	Design	Actual
CFM	110	107
System SetPt	-	HIGH

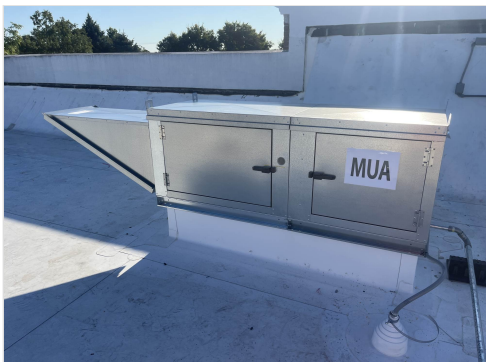
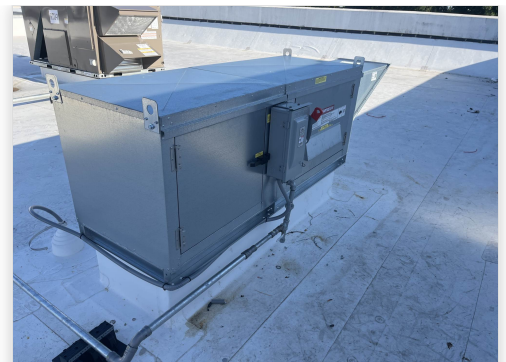
Asset: MUA1

Unit Data		
	Design	Actual
MFG	CAPTIVEAIRE	CAPTIVEAIRE
Model Num	A1-D.250-15D	A1-D.250-15D
Serial Num	-	7328629
Type	MUA	MUA
Configuration	VERTICAL	VERTICAL

Gas Heat		
	Design	Actual
Heater Operates (y/n)	-	YES
Flame Status (pass/fail)	-	PASS
Inlet Air Temp SetPt	55	55
Discharge Air Temp SetPt	60	60
Air Flow Switch SP Actual	-	0.34"
