**Report: TAB Report**  
**Function: Test, Adjust, & Balance**  
**Date: 06/11/2025**  
**Completed By: National TAB**

**PROJECT**  
**06-09-25 CAVA INDIANAPOLIS, IN (IUPUI)**

Project: 06-09-25 CAVA INDIANAPOLIS, IN (IUPUI)

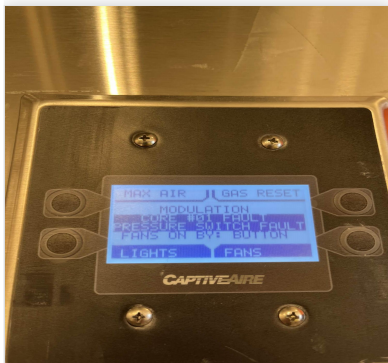
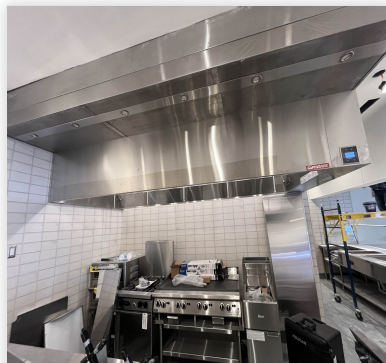
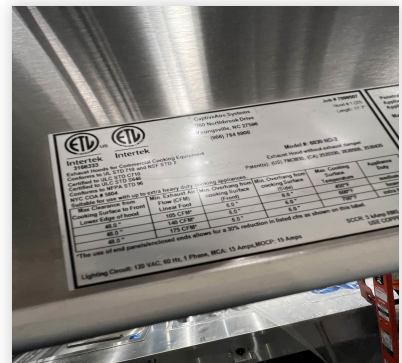
**Issue Name :** HOOD-1 Alarms  
**Description :** HOOD-1 alarms are showing “pressure switch fault” and “core #1 fault” this is usually due to the ansul system and fire suppression system not being completed. This should clear once fire suppression test is done.  
**Created By :** National TAB **Assigned To :** National TAB - Dylan Crisman  
**Status :** Open  
**Priority :** Low **Asset Tag :**  
**Originated Date :** 06/11/2025 - Dylan Crisman - National TAB

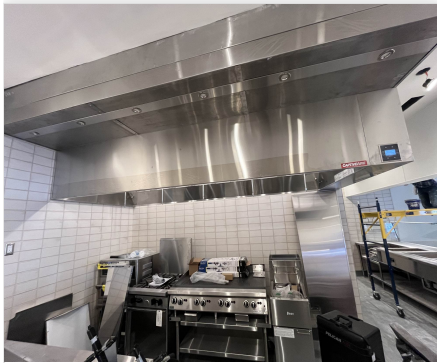
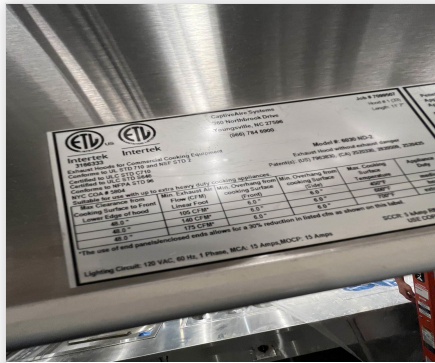
**Issue Name :** HOOD-1 HMI  
**Description :** HD-1 HMI does not allow me to change speed setpoints. When changed, it reverts back to 76%. No change in airflow. CAS service confirmed they will look into this when they arrive to do their startups. Unit is set at 95% of design at 2496/2606 CFM.  
**Created By :** National TAB      **Assigned To :** National TAB - Dylan Crisman  
**Status :** Open  
**Priority :** High      **Asset Tag :**  
**Originated Date :** 06/11/2025 - Dylan Crisman - National TAB

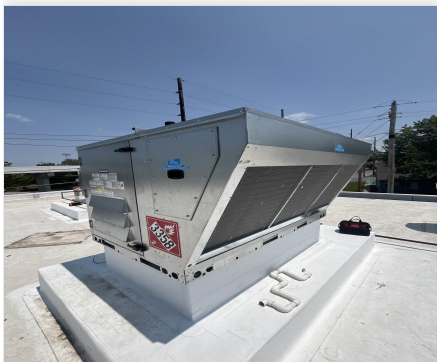
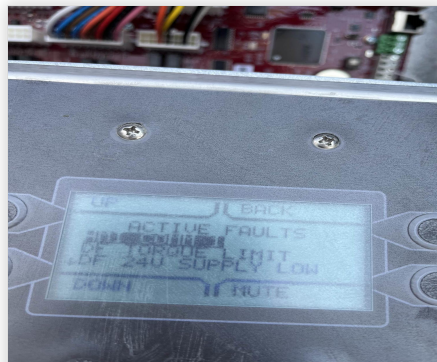
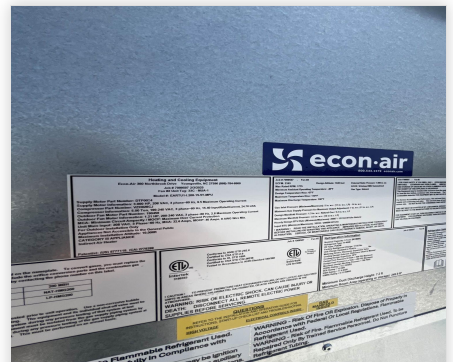
**Issue Name :** MUA-1 alarms  
**Description :** MUA has multiple alarms that keep going in and out, unable to get access to any of the menus to test heating and cooling stages, change setpoints per checklist specifications. CAS service is aware and is having the same issue remotely. Confirmed they will look into it when they arrive for start ups.  
**Created By :** National TAB                      **Assigned To :** National TAB - Dylan Crisman  
**Status :** Open  
**Priority :** High                                      **Asset Tag :**  
**Originated Date :** 06/11/2025 - Dylan Crisman - National TAB
