**Report: TAB Report**  
**Function: Test, Adjust, & Balance**  
**Date: 10/30/2025**  
**Completed By: National TAB**

**PROJECT**  
**10-27-25 QT #1422 MESA, AZ**

QUIKTRIP  
4705 SOUTH 129TH EAST AVENUE  
TULSA, OK 74134

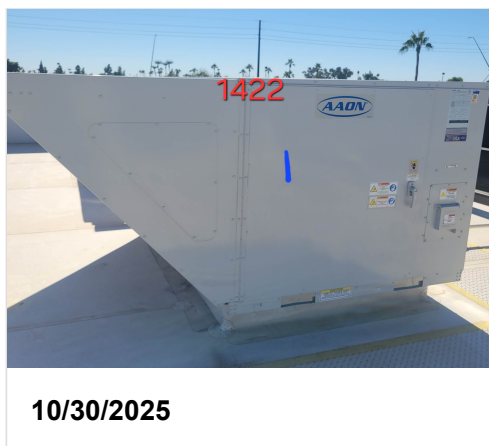
### Unit Data - PHOTO LOG

Unit Data		
	Design	Actual
MFG	NA	AAON
Serial Num	-	202010-ANEK21203
Model Num	NA	RN-013-5-0-EA0A-152
Num OA Filters 1	-	1
OA Filter Size 1	-	45X19
Num Final Filter 1	-	2
Final Filter Size 1	-	46X22.5X2

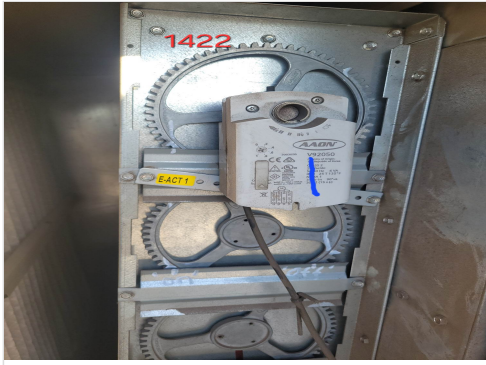
## Test Data - PHOTO LOG

Test Data		
	Design	Actual
SF CFM	4200	4494
SF RPM	-	47 HZ
OA CFM (Hoods On)	800	784
OA CFM (Hoods Off)	350	351
RL Voltage	-	170
RL Amperage	-	8.0
VFD Max SetPt	-	78.4
VFD Min SetPt	-	24
OA Damper Position (Hoods On)	-	46.0
OA Damper Position (Hoods Off)	-	0.0

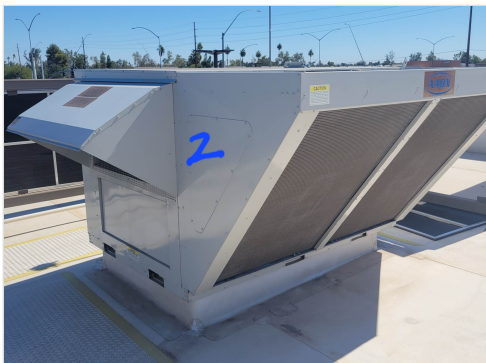
### Unit Data - PHOTO LOG

Unit Data		
	Design	Actual
MFG	NA	AAON
Serial Num	-	202010-ANEK21201
Model Num	NA	RN-013-8-0-EA0A-152
Num OA Filters 1	-	1
OA Filter Size 1	-	45X22
Num Final Filter 1	-	2
Final Filter Size 1	-	46X19.5X2

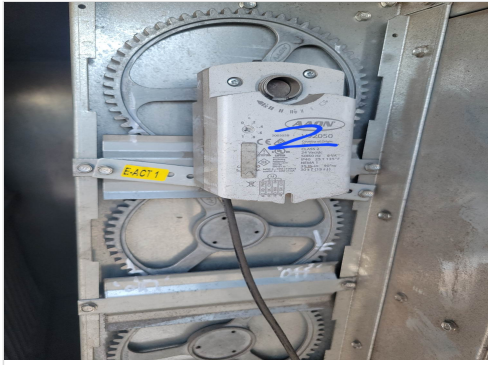
## Test Data - PHOTO LOG

Test Data		
	Design	Actual
SF CFM	4200	4049
SF RPM	-	47 HZ
OA CFM (Hoods On)	800	804
OA CFM (Hoods Off)	350	323
RL Voltage	-	165.5
RL Amperage	-	7.8
VFD Max SetPt	-	76.4
VFD Min SetPt	-	24.0
OA Damper Position (Hoods On)	-	46.0
OA Damper Position (Hoods Off)	-	0.0

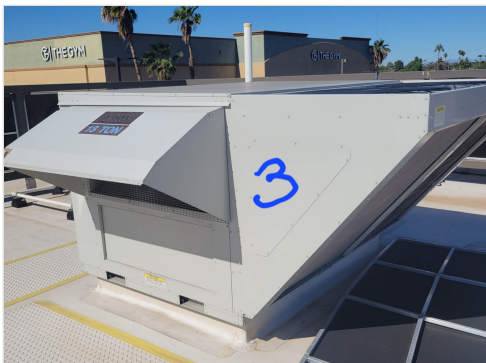
### Unit Data - PHOTO LOG

Unit Data		
	Design	Actual
MFG	NA	AAON
Serial Num	-	202010-ANEK21202
Model Num	NA	RN-013-8-0-EA0A-152
Num OA Filters 1	-	1
OA Filter Size 1	-	45X22
Num Final Filter 1	-	2
Final Filter Size 1	-	46X19.5X2

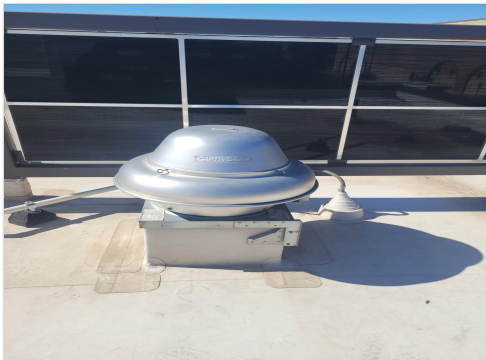
### Unit Data - PHOTO LOG

Unit Data		
	Design	Actual
MFG	NA	CAPTIVEAIRE
Model Num	NA	DR50HFA
Serial Num	-	4603528
Type	-	DOWNBLAST
Configuration	-	VERTICAL

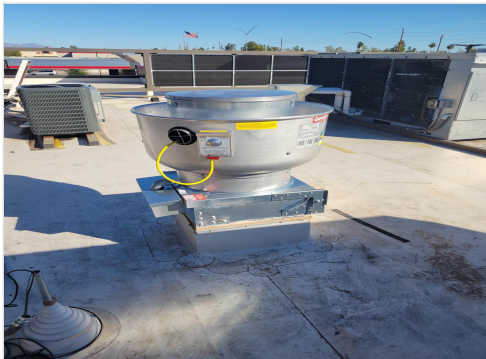
### Unit Data - PHOTO LOG

Unit Data		
	Design	Actual
MFG	NA	CAPTIVEAIRE
Model Num	NA	DU50HFA
Serial Num	-	7660155
Type	UPBLAST	UPBLAST
Configuration	VERTICAL	VERTICAL
