**Report: TAB Report**  
**Function: Test, Adjust, & Balance**  
**Date: 10/30/2025**  
**Completed By: National TAB**

**PROJECT**  
**10-27-25 QT #1422 MESA, AZ**

QUIKTRIP  
4705 SOUTH 129TH EAST AVENUE  
TULSA, OK 74134

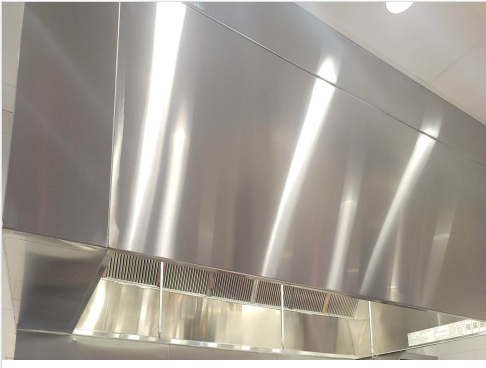
**Unit Data - PHOTO LOG**

Unit Data		
	Design	Actual
MFG	CAPTIVEAIRE	CAPTIVEAIRE
Model Num	6030ND-2-F	6030ND-2-F
Job / Serial Num	-	7660155
Type	-	TYPE I CANOPY
Hood length	-	108"
Hood Width	-	60"
