Report: TAB Report
Function: Test, Adjust, & Balance
Date: 10/30/2025
Completed By: National TAB

PROJECT
10-27-25 QT #1422 MESA, AZ

Project: 10-27-25 QT #1422 MESA, AZ

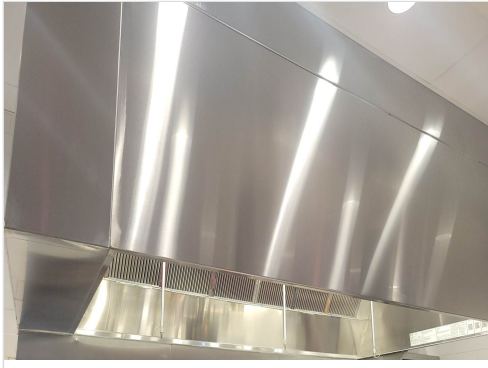
Unit Data - PHOTO LOG

Asset: HD1

Unit Data		
	Design	Actual
MFG	CAPTIVEAIRE	CAPTIVEAIRE
Model Num	6030ND-2-F	6030ND-2-F
Job / Serial Num	-	7660155
Type	-	TYPE I CANOPY
Hood length	-	108"
Hood Width	-	60"

Test Data Exhaust		
	Design	Actual
Filter Type	-	CAPTRATE SOLO
Filter Size 1	-	16X20
Filter Qty 1	-	6
Filter AK factor size 1	-	2.08
Filter Total AK Area	-	12.48
Filter1 FPM	-	112
Filter2 FPM	-	118
Filter3 FPM	-	120
Filter4 FPM	-	117
Filter5 FPM	-	116
Filter6 FPM	-	111
Filter Ave FPM(corr)	-	116
CFM	1350	1448
