Report: TAB Report
Function: Test, Adjust, & Balance
Date: 10/30/2025
Completed By: National TAB

PROJECT
10-27-25 QT #1422 MESA, AZ

Project: 10-27-25 QT #1422 MESA, AZ

Project Summary

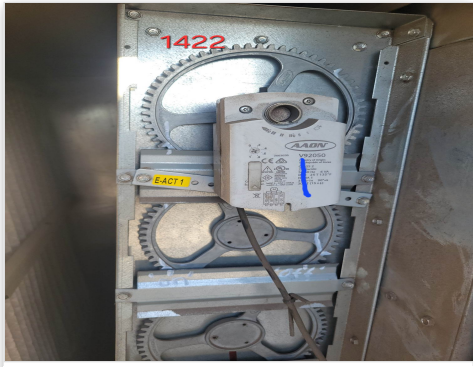
Test Data - PHOTO LOG

Test Data		
	Design	Actual
SF CFM	4200	4494
SF RPM	-	47 HZ
OA CFM (Hoods On)	800	784
OA CFM (Hoods Off)	350	351
RL Voltage	-	170
RL Amperage	-	8.0
VFD Max SetPt	-	78.4
VFD Min SetPt	-	24
OA Damper Position (Hoods On)	-	46.0
OA Damper Position (Hoods Off)	-	0.0

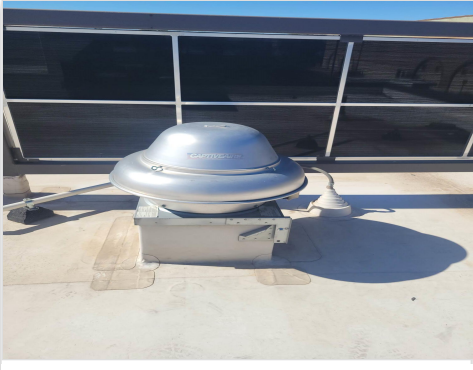
Unit Data - PHOTO LOG

Unit Data		
	Design	Actual
MFG	NA	CAPTIVEAIRE
Model Num	NA	DR50HFA
Serial Num	-	4603528
Type	-	DOWNBLAST
Configuration	-	VERTICAL

[1] FAN SPEED FULLY MINIMIZED. COMBO-OVEN GRILLE DAMPER INACCESSIBLE. ABOVE DESIGN, NOT ANTICIPATED TO CAUSE ANY ISSUE.
