Report: TAB Report
Function: Test, Adjust, & Balance
Date: 10/30/2025
Completed By: National TAB

PROJECT
10-27-25 QT #1422 MESA, AZ

Project: 10-27-25 QT #1422 MESA, AZ

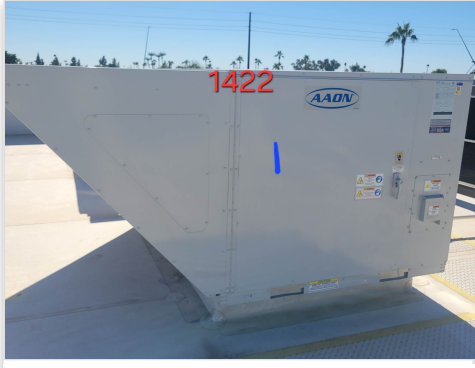
Unit Data - PHOTO LOG

Unit Data		
	Design	Actual
MFG	NA	AAON
Serial Num	-	202010-ANEK21203
Model Num	NA	RN-013-5-0-EA0A-152
Num OA Filters 1	-	1
OA Filter Size 1	-	45X19
Num Final Filter 1	-	2
Final Filter Size 1	-	46X22.5X2

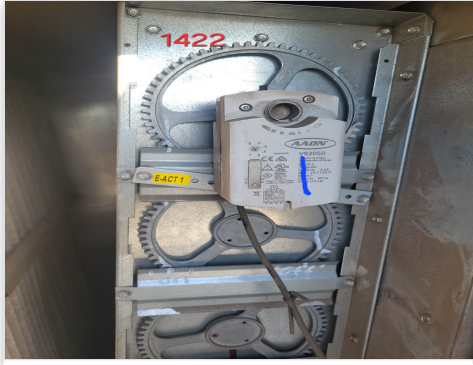
Test Data - PHOTO LOG

Test Data		
	Design	Actual
SF CFM	4200	4494
SF RPM	-	47 HZ
OA CFM (Hoods On)	800	784
OA CFM (Hoods Off)	350	351
RL Voltage	-	170
RL Amperage	-	8.0
VFD Max SetPt	-	78.4
VFD Min SetPt	-	24
OA Damper Position (Hoods On)	-	46.0
OA Damper Position (Hoods Off)	-	0.0

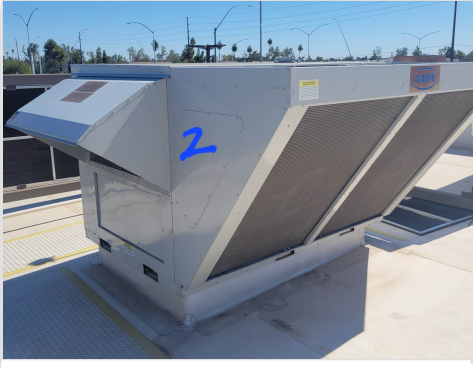
Unit Data - PHOTO LOG

Unit Data		
	Design	Actual
MFG	NA	AAON
Serial Num	-	202010-ANEK21201
Model Num	NA	RN-013-8-0-EA0A-152
Num OA Filters 1	-	1
OA Filter Size 1	-	45X22
Num Final Filter 1	-	2
Final Filter Size 1	-	46X19.5X2

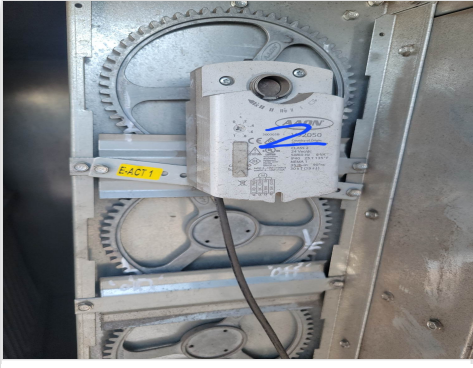
Test Data - PHOTO LOG

Test Data		
	Design	Actual
SF CFM	4200	4049
SF RPM	-	47 HZ
OA CFM (Hoods On)	800	804
OA CFM (Hoods Off)	350	323
RL Voltage	-	165.5
RL Amperage	-	7.8
VFD Max SetPt	-	76.4
VFD Min SetPt	-	24.0
OA Damper Position (Hoods On)	-	46.0
OA Damper Position (Hoods Off)	-	0.0

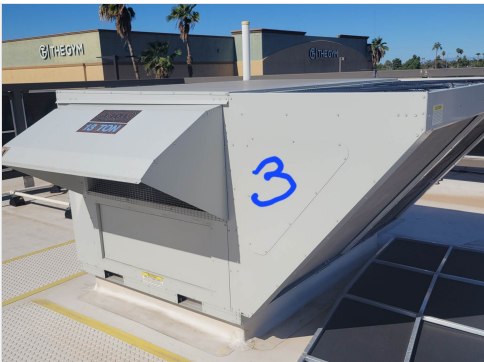
Unit Data - PHOTO LOG

Unit Data		
	Design	Actual
MFG	NA	AAON
Serial Num	-	202010-ANEK21202
Model Num	NA	RN-013-8-0-EA0A-152
Num OA Filters 1	-	1
OA Filter Size 1	-	45X22
Num Final Filter 1	-	2
Final Filter Size 1	-	46X19.5X2

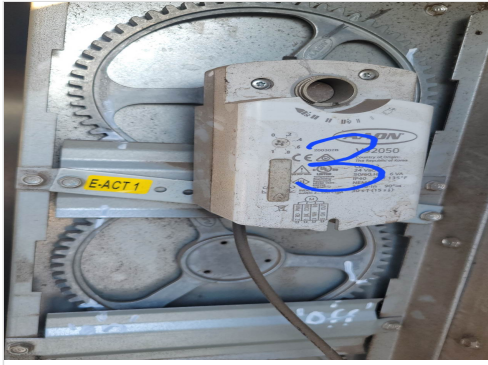
Test Data - PHOTO LOG

Test Data		
	Design	Actual
SF CFM	4200	4443
SF RPM	-	49.8 HZ
OA CFM (Hoods On)	800	880
OA CFM (Hoods Off)	350	344
RL Voltage	-	182.2
RL Amperage	-	9.0
VFD Max SetPt	-	83
VFD Min SetPt	-	24
OA Damper Position (Hoods On)	-	46.0
OA Damper Position (Hoods Off)	-	0.0

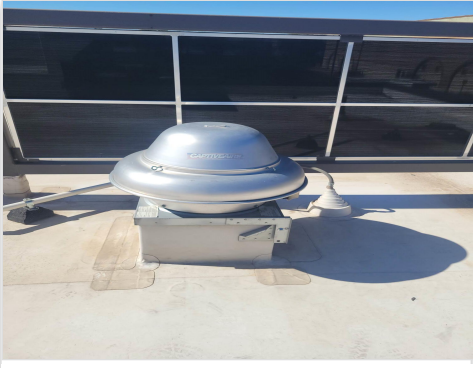
Unit Data - PHOTO LOG

Unit Data		
	Design	Actual
MFG	NA	CAPTIVEAIRE
Model Num	NA	DR50HFA
Serial Num	-	4603528
Type	-	DOWNBLAST
Configuration	-	VERTICAL

[1] FAN SPEED FULLY MINIMIZED. COMBO-OVEN GRILLE DAMPER INACCESSIBLE. ABOVE DESIGN, NOT ANTICIPATED TO CAUSE ANY ISSUE.

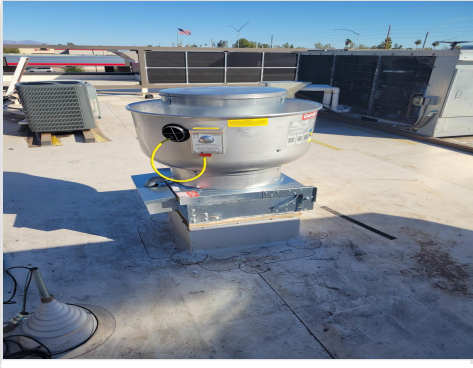
Unit Data - PHOTO LOG

Unit Data		
	Design	Actual
MFG	NA	CAPTIVEAIRE
Model Num	NA	DU50HFA
Serial Num	-	7660155
Type	UPBLAST	UPBLAST
Configuration	VERTICAL	VERTICAL

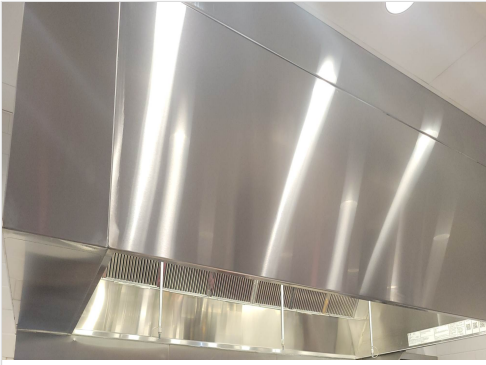
Unit Data - PHOTO LOG

Unit Data		
	Design	Actual
MFG	CAPTIVEAIRE	CAPTIVEAIRE
Model Num	6030ND-2-F	6030ND-2-F
Job / Serial Num	-	7660155
Type	-	TYPE I CANOPY
Hood length	-	108"
Hood Width	-	60"
