Report: TAB Report
Function: Test, Adjust, & Balance
Date: 02/05/2025
Completed By: National TAB

02-03-25 CHIPOTLE #5144 GRANVILLE, OH

Project: 02-03-25 CHIPOTLE #5144 GRANVILLE, OH

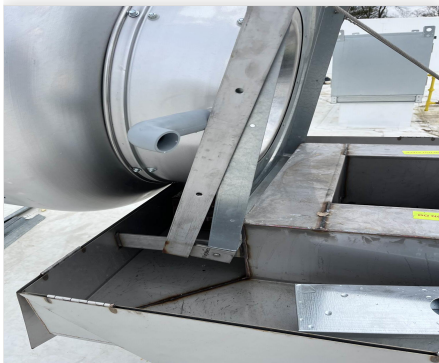
Issue Name : KEF hinge kit installed incorrectly.
Description : On arrival KEF hinge kit installed incorrectly. Hinge kit only installed with 2 screws affixing the fan to the hinge kit. Corrected by mechanical.
02/04/2025

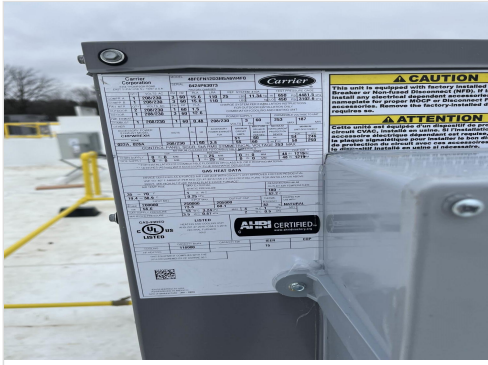
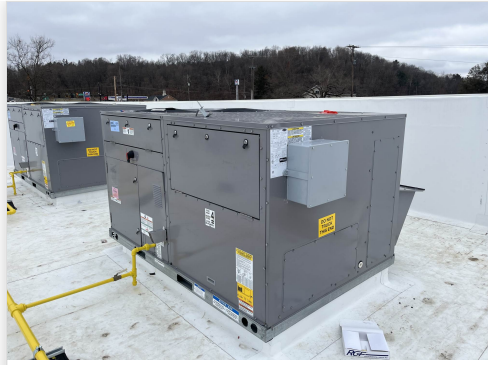
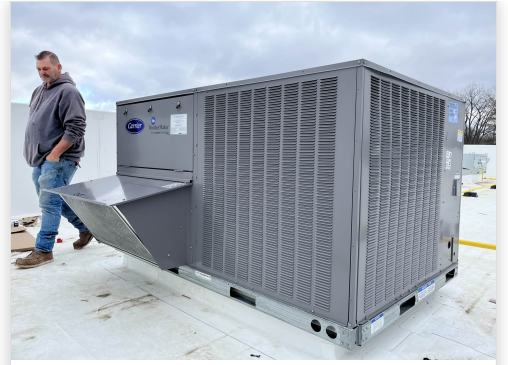
Unit Data - PHOTO LOG

Unit Data		
	Design	Actual
MFG	YORK	CARRIER
Serial Num	-	0424P63073
Model Num	ZJ120	48FCFN12D3M5A6W4F0
Type	RTU	RTU
Configuration	VERTICAL	VERTICAL
Num OA Filters 1	-	1
OA Filter Size 1	-	36x20"
Num Final Filter 1	-	4
Final Filter Size 1	-	20"x20"

Static pressures taken with OA closed as OA damper was not staying reliably open.

Unit schedule and diffuser total do not add up to the same total; set unit total based on diffuser total which is within 10% of unit schedule total.

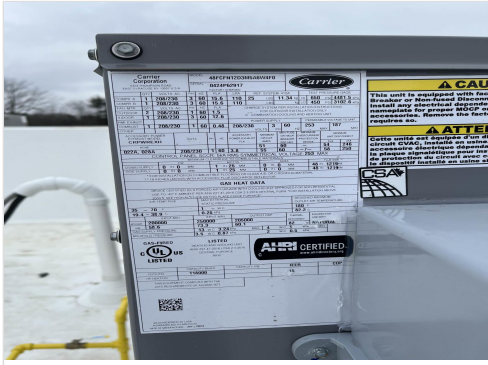
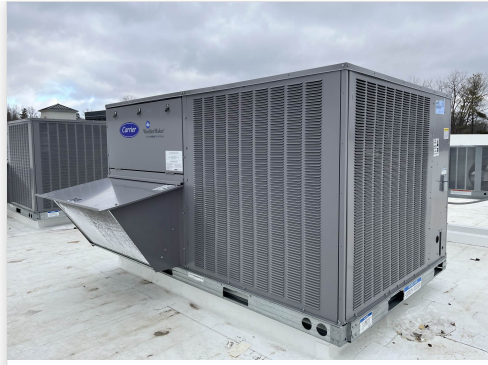
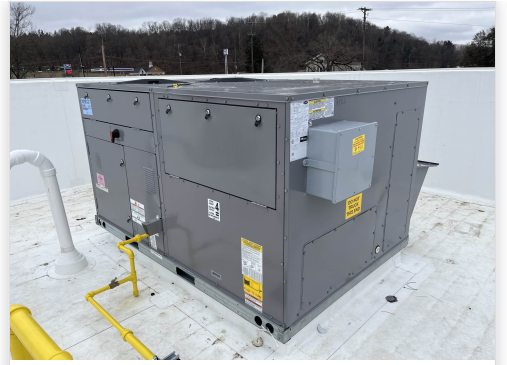
Unit Data - PHOTO LOG

Unit Data		
	Design	Actual
MFG	YORK	CARRIER
Serial Num	-	0424P62917
Model Num	ZJ120	48FCFN12D3M5A6W4F0
Type	RTU	RTU
Configuration	VERTICAL	VERTICAL
Num OA Filters 1	-	1
OA Filter Size 1	-	36X20
Num Final Filter 1	-	4
Final Filter Size 1	-	20X20

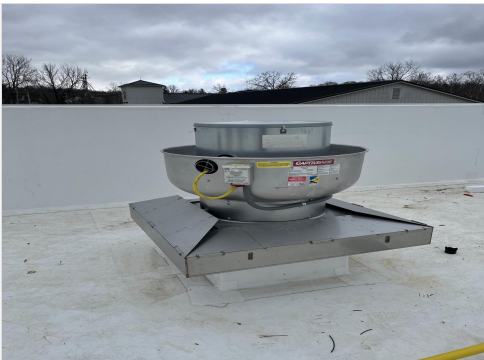
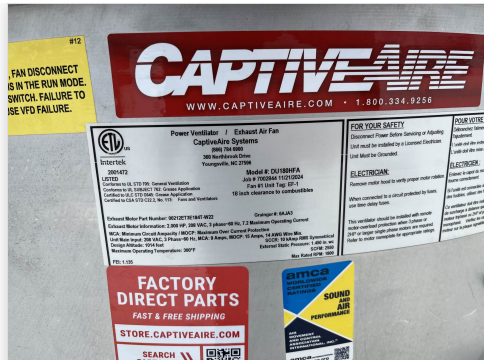
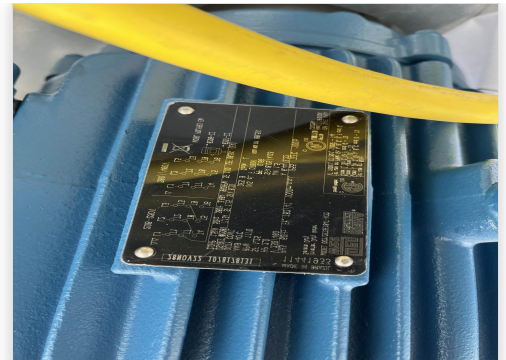
Unit Data - PHOTO LOG

Unit Data		
	Design	Actual
MFG	CAPTIVIE-AIRE	CAPTIVIE-AIRE
Model Num	DU180HFA	DU180HFA
Serial Num	-	7002844
Type	UPBLAST	UPBLAST
Configuration	VERTICAL	VERTICAL

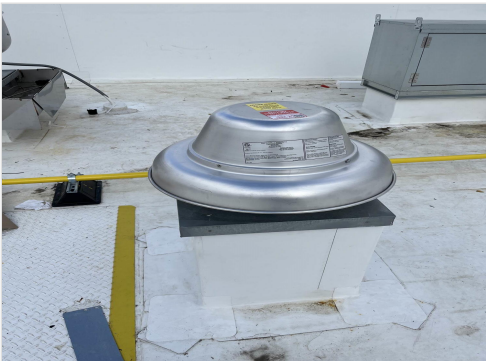
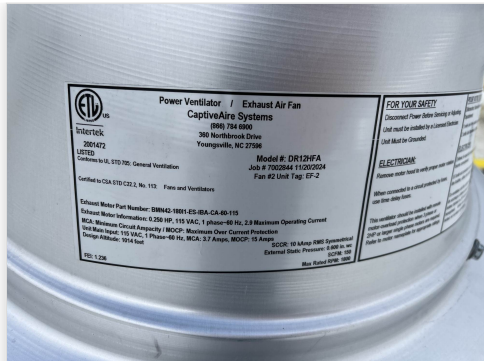
Unit Data - PHOTO LOG

Unit Data		
	Design	Actual
MFG	CAPTIVE-AIRE	CAPTIVE-AIRE
Model Num	DR12HFA	DR12HFA
Serial Num	-	7002844
Type	DOWNBLAST	DOWNBLAST
Configuration	VERTICAL	VERTICAL

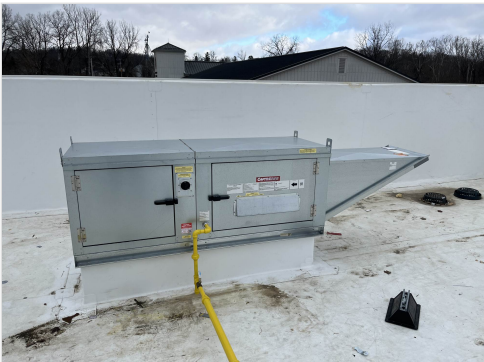
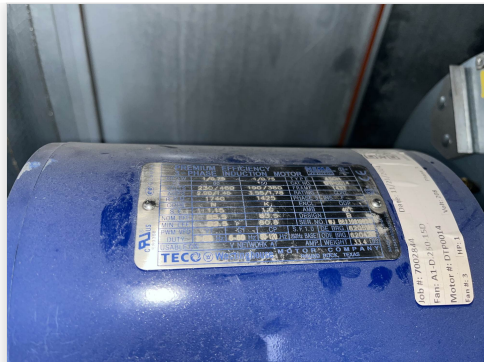
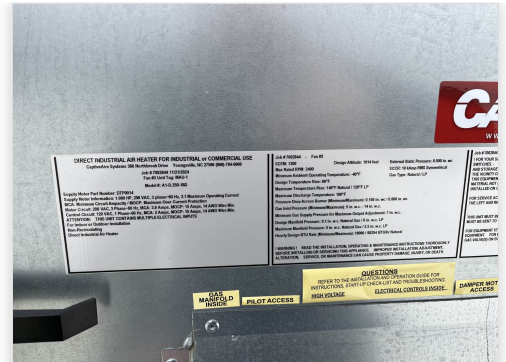
Unit Data - PHOTO LOG

Unit Data		
	Design	Actual
MFG	CAPTIVE-AIRE	CAPTIVE-AIRE
Model Num	A1-D.250-15D	A1-D.250-15D
Serial Num	-	7002744
Type	MUA	MUA
Configuration	VERTICAL	VERTICAL

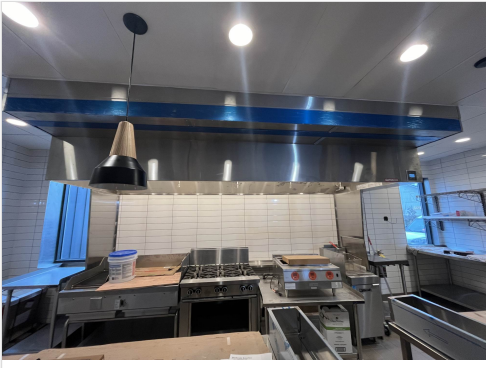
Unit Data - PHOTO LOG

Unit Data		
	Design	Actual
MFG	CAPTIVERA-AIRE	CAPTIVERA-AIRE
Model Num	5424 ND-2ACPSP-F	5424 ND-2ACPSP-F
Job / Serial Num	-	7002844
Type	TYPE 1CONOPY	TYPE 1 CANOPY
Hood length	153"	153"
Hood Width	54"	54"
Supply Plenum Type	-	ACPSP
Supply Plenum Width	9"	9"
Supply Plenum Length	165"	165"

Unable to distribute airflow across the supply plenum due to lack of access due to lights installed in ceiling tile in front of the hood.
