**Report: TAB Report**  
**Function: Test, Adjust, & Balance**  
**Date: 02/05/2025**  
**Completed By: National TAB**

**02-03-25 CHIPOTLE #5144 GRANVILLE, OH**

520 S MAIN ST

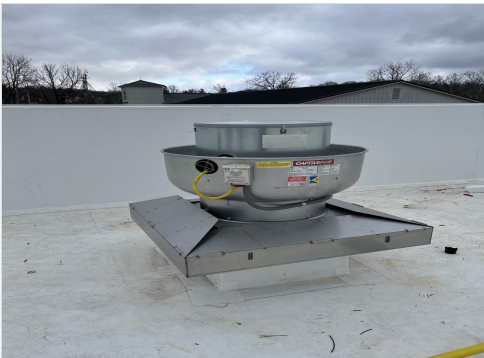
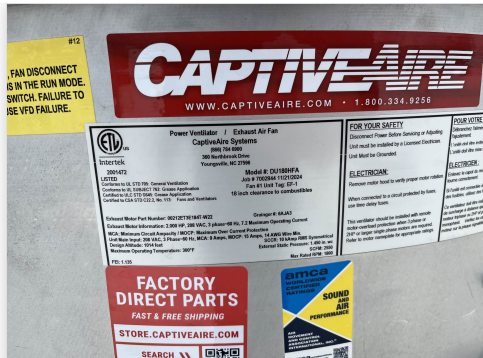
Asset: EF1

Unit Data		
	Design	Actual
MFG	CAPTIVIE-AIRE	CAPTIVIE-AIRE
Model Num	DU180HFA	DU180HFA
Serial Num	-	7002844
Type	UPBLAST	UPBLAST
Configuration	VERTICAL	VERTICAL

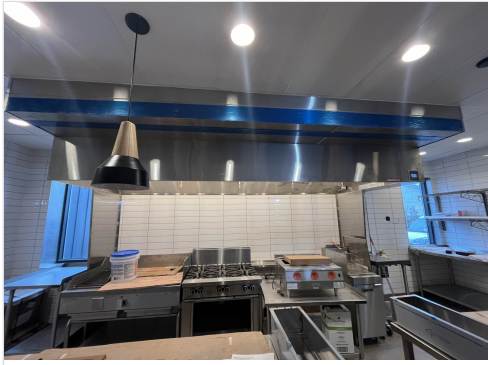
Asset: HD1

Unit Data		
	Design	Actual
MFG	CAPTIVE-AIRE	CAPTIVE-AIRE
Model Num	5424 ND-2ACPSP-F	5424 ND-2ACPSP-F
Job / Serial Num	-	7002844
Type	TYPE 1 CONOPY	TYPE 1 CANOPY
Hood length	153"	153"
Hood Width	54"	54"
Supply Plenum Type	-	ACPSP
Supply Plenum Width	9"	9"
Supply Plenum Length	165"	165"

[2] Unable to distribute airflow across the supply plenum due to lack of access due to lights installed in ceiling tiles in front of the hood.
