Report: TAB Report
Function: Test, Adjust, & Balance
Date: 02/05/2025
Completed By: National TAB

02-03-25 CHIPOTLE #5144 GRANVILLE, OH

Project: 02-03-25 CHIPOTLE #5144 GRANVILLE, OH

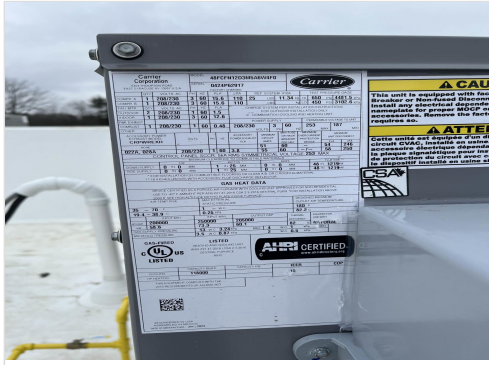
Unit Data - PHOTO LOG

Notes:
MIN OA 4.4 V

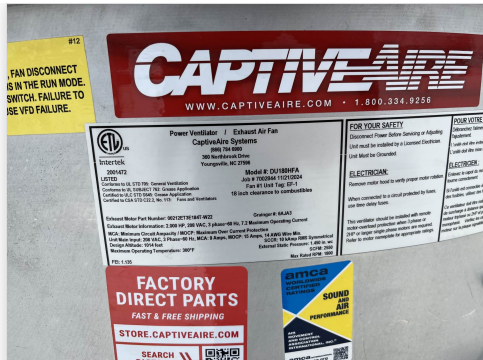
Unit Data - PHOTO LOG

Test Data		
	Design	Actual
CFM	2550	2522
Fan RPM	-	1002
Fan Rotation	-	CCW
Motor RPM	-	1002
System SetPt	-	51.4HZ
RL Voltage	208	114
RL Amperage	-	4.75
Total ESP	1.450"	0.717"
Fan Inlet SP	-	-0.717
Fan Discharge SP	-	ATM

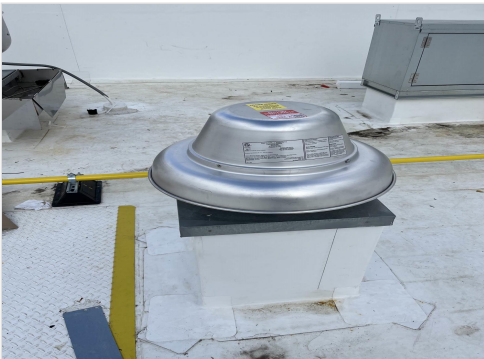
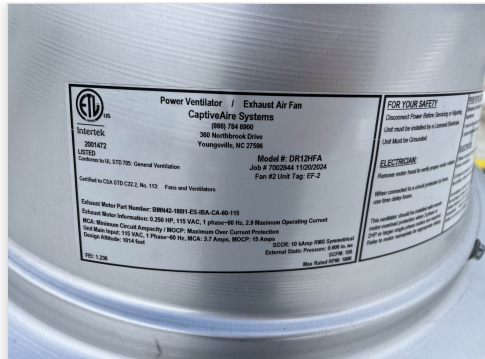
Unit Data - PHOTO LOG

Test Data		
	Design	Actual
CFM	150	144
Fan RPM	1304	614
Fan Rotation	-	CCW
Motor RPM	-	614
System SetPt	-	35%
RL Voltage	115	124
RL Amperage	-	.21
Total ESP	0.600"	0.07"
Fan Inlet SP	-	0.07"
Fan Discharge SP	-	ATM

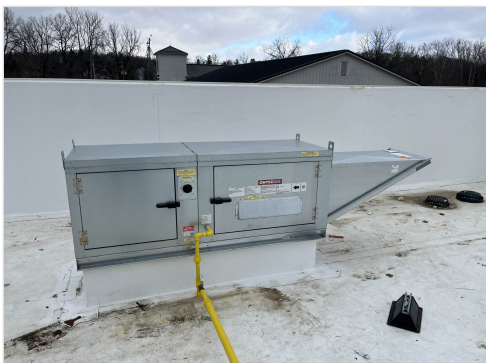
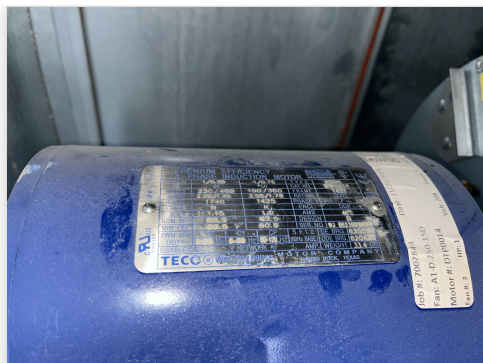
Unit Data - PHOTO LOG

Test Data		
	Design	Actual
CFM	1300	1303
SF RPM	1559	1551
Motor RPM	-	1551
SF System SetPt	-	53.5hz
RL Voltage	-	165
RL Amperage	-	2.37

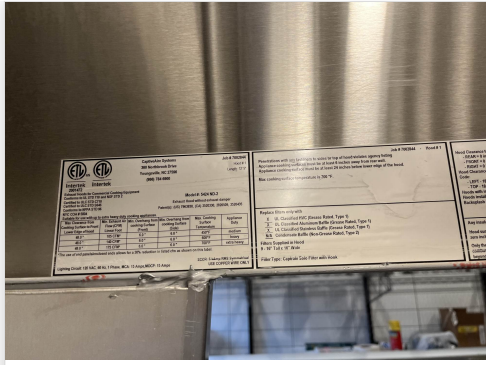
Unit Data - PHOTO LOG

Exhaust and supply reading taken from left to right.

Unable to distribute airflow across the supply plenum due to lack of access due to lights installed in ceiling tile in front of the hood.
