Report: TAB REPORT
Function: Test, Adjust, & Balance
Date: 03/16/2023

PROJECT
03-13-23 FAMILY DOLLAR - LAMONI, IA

Project: 03-13-23 FAMILY DOLLAR - LAMONI, IA

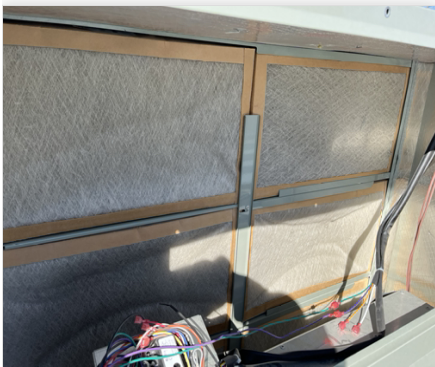
Filters.jpeg

Issue Name : RTUS Final Filters need installed

Description : Construction filters for each RTU are still in place. Final filters will need to be put in later. This does not affect scope of TAB.

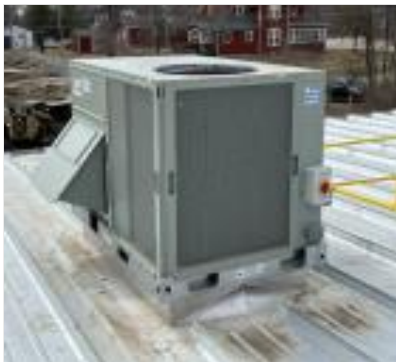
RTU-1

Notes: UNIT IS SCHEDULED FOR 1750 TOTAL BUT DIFFUSERS ONLY ADD UP TO 1400. UNIT WAS BALANCED TO 1400.

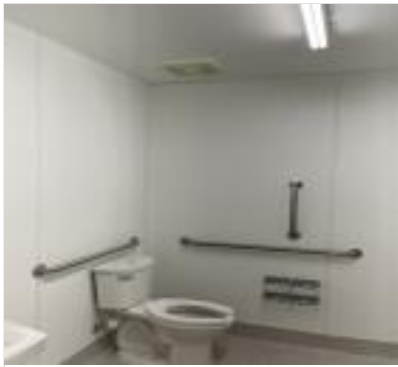
EF-1

Notes: UNIT WAS ALREADY SEALED INTO CEILING UPON ARRIVAL. UNIT AND MOTOR LABEL INACCESSIBLE. DATA TAKEN FROM SUBMITTALS.

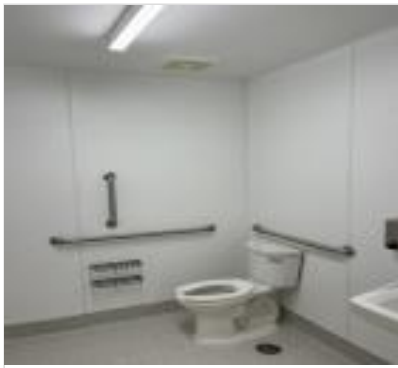
EF-2

Notes: UNIT WAS ALREADY SEALED INTO CEILING UPON ARRIVAL. UNIT AND MOTOR LABEL INACCESSIBLE. DATA TAKEN FROM SUBMITTALS.
