Report: TAB Report
Function: Test, Adjust, & Balance
Date: 12/10/2025
Completed By: National TAB

PROJECT
12-07-25 QT #4236 WESTMINSTER, CO

8691 SHERIDAN BLVD

WESTMINSTER, CO

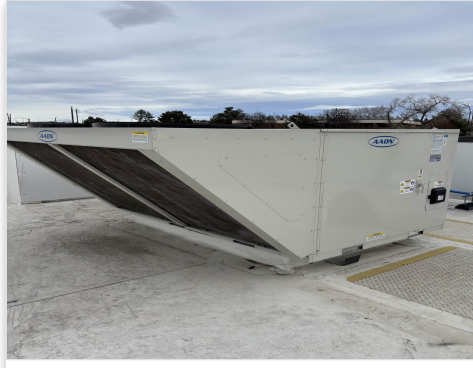
Unit Data - PHOTO LOG

Unit Data	
	Actual
MFG	AAON
Serial Num	202407-ANEK31178
Model Num	RN-013-8-0-HA0A-152
Num OA Filters 1	1
OA Filter Size 1	22X45
Num Final Filter 1	4
Final Filter Size 1	20X25X2

Test Data		
	Design	Actual
SF CFM	4200	4251
SF RPM	-	1408
OA CFM (Hoods On)	800	812
OA CFM (Hoods Off)	350	364
RL Voltage	-	168 VFD
RL Amperage	-	7.27 VFD
VFD Max SetPt	-	48 HZ
VFD Min SetPt	-	24 HZ
OA Damper Position (Hoods On)	-	46%
OA Damper Position (Hoods Off)	-	26%

General	
	Actual
Fan Rotation Correct	YES
Unit Filters Clean	YES
Condensate Drain Installed	YES

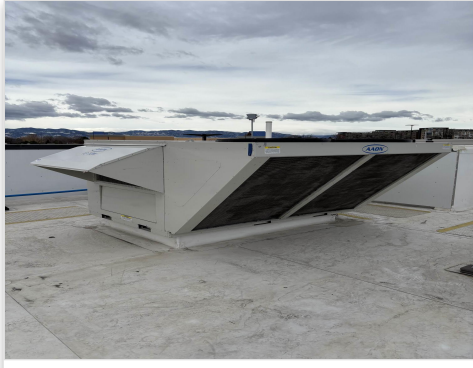
Unit Data - PHOTO LOG

Unit Data	
	Actual
MFG	AAON
Serial Num	202407-ANEK31180
Model Num	RN-013-8-0-HA0A-152
Num OA Filters 1	1
OA Filter Size 1	22X45
Num Final Filter 1	4
Final Filter Size 1	20X25X2

Test Data		
	Design	Actual
SF CFM	4200	4148
SF RPM	-	1408
OA CFM (Hoods On)	800	784
OA CFM (Hoods Off)	350	337
RL Voltage	-	168 VFD
RL Amperage	-	7.43 VFD
VFD Max SetPt	-	48 HZ
VFD Min SetPt	-	24 HZ
OA Damper Position (Hoods On)	-	46%
OA Damper Position (Hoods Off)	-	26%

General	
	Actual
Fan Rotation Correct	YES
Unit Filters Clean	YES
Condensate Drain Installed	YES

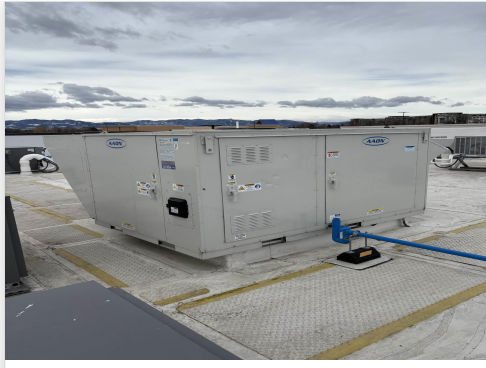
Unit Data - PHOTO LOG

Unit Data	
	Actual
MFG	AAON
Serial Num	202407-ANEK31179
Model Num	RN-013-8-0-HA0A-152
Num OA Filters 1	1
OA Filter Size 1	22X45
Num Final Filter 1	4
Final Filter Size 1	20X25X2

Test Data		
	Design	Actual
SF CFM	4200	4194
SF RPM	-	1408
OA CFM (Hoods On)	800	763
OA CFM (Hoods Off)	350	344
RL Voltage	-	168 VFD
RL Amperage	-	7.46 VFD
VFD Max SetPt	-	48 HZ
VFD Min SetPt	-	24 HZ
OA Damper Position (Hoods On)	-	46%
OA Damper Position (Hoods Off)	-	26%

General	
	Actual
Fan Rotation Correct	YES
Unit Filters Clean	YES
Condensate Drain Installed	YES

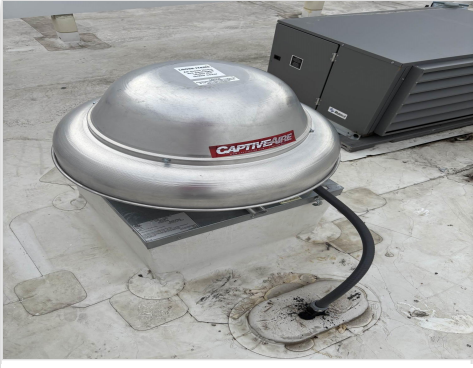
Unit Data - PHOTO LOG

Unit Data		
	Design	Actual
MFG	NA	CAPTIVEAIRE
Model Num	NA	DR33HFA
Serial Num	-	7097101
Type	-	DOWNBLAST
Configuration	-	VERTICAL

Test Data		
	Design	Actual
CFM	775	771
Fan RPM	-	1159
Fan Rotation	-	CCW
Motor RPM	-	1159
System SetPt	-	58 P
RL Voltage	-	[1]
RL Amperage	-	[1]
Total ESP	-	0.28"
Fan Inlet SP	-	-0.28"
Fan Discharge SP	-	ATM

Notes:
[1] UNABLE TO READ VOLTS AND AMPS SAFELY

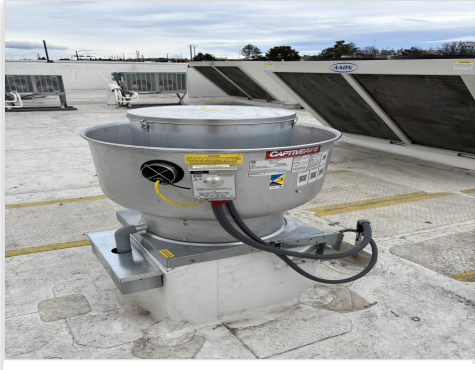
Unit Data - PHOTO LOG

Unit Data		
	Design	Actual
MFG	NA	CAPTIVEAIRE
Model Num	NA	DU50HFA
Serial Num	-	7644898
Type	UPBLAST	UPBLAST
Configuration	VERTICAL	VERTICAL

Test Data		
	Design	Actual
CFM	1350	1373
Fan RPM	-	1195
Fan Rotation	-	CCW
Motor RPM	-	1195
System SetPt	-	52.8 HZ
RL Voltage	-	214
RL Amperage	-	1.6
Total ESP	-	0.24"
Fan Inlet SP	-	-0.24"
Fan Discharge SP	-	ATM

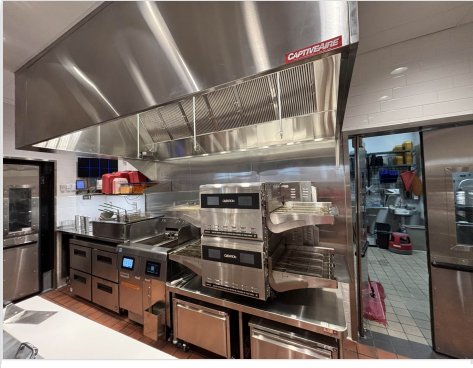
Unit Data - PHOTO LOG

Unit Data		
	Design	Actual
MFG	CAPTIVEAIRE	CAPTIVEAIRE
Model Num	6030ND-2-F	6030ND-2-F
Job / Serial Num	-	7644898
Type	-	TYPE I CANOPY
Hood length	-	108"
Hood Width	-	60"

Test Data Exhaust		
	Design	Actual
Filter Type	-	CAPTRATE SOLO FILTER
Filter Size 1	-	16X20
Filter Qty 1	-	6
Filter AK factor size 1	-	2.08
Filter Total AK Area	-	12.48
Filter1 FPM	-	104
Filter2 FPM	-	121
Filter3 FPM	-	127
Filter4 FPM	-	117
Filter5 FPM	-	104
Filter6 FPM	-	87
Filter Ave FPM(corr)	-	110
CFM	1350	1373
