Report: TAB REPORT
Function: Test, Adjust, & Balance
Date: 11/21/2024
Completed By: National TAB

PROJECT
11-18-24 FREDDY'S - ALEXANDRIA, LA

1802 Macarthur Drive

ALEXANDRIA, LA 71301

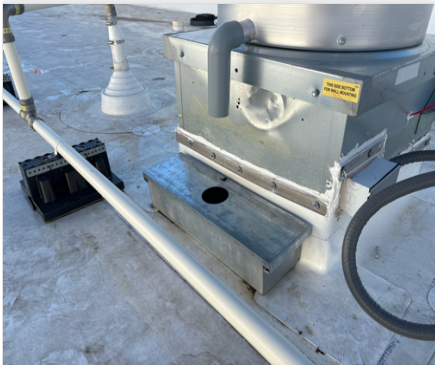
Issue Name : EF-2 Grease Cup
Description : EF-2 grease cup is sitting on roof not attached to fan. Recommend attaching grease cup.
Created By : National TAB **Assigned To :** National TAB - Wesley John
Status : Open
Priority : **Asset Tag :**
Originated Date : 11/21/2024 - Wesley John - National TAB

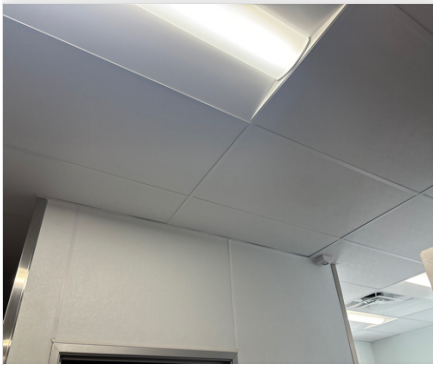
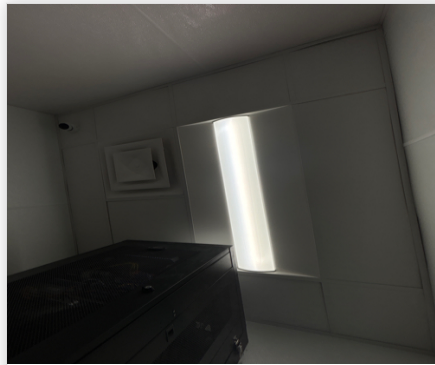
Issue Name : Office Transfer Grille
Description : The transfer grille between the office and kitchen space is missing. Recommend installing per plans to allow design amount of supply air into office.
Created By : National TAB **Assigned To :** National TAB - Wesley John
Status : Open
Priority : **Asset Tag :**
Originated Date : 11/21/2024 - Wesley John - National TAB

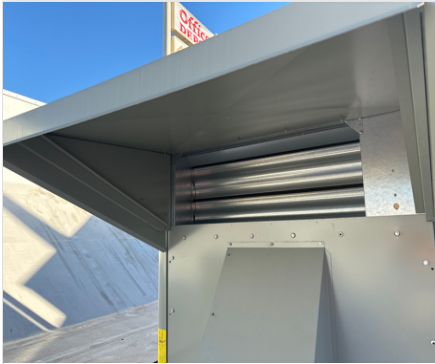
Issue Name : RTU-1 Outside Air Filters
Description : RTU-1 outside air filters are not installed. Could not locate. Recommend installing.
Created By : National TAB **Assigned To :** National TAB - Wesley John
Status : Open
Priority : **Asset Tag :**
Originated Date : 11/21/2024 - Wesley John - National TAB

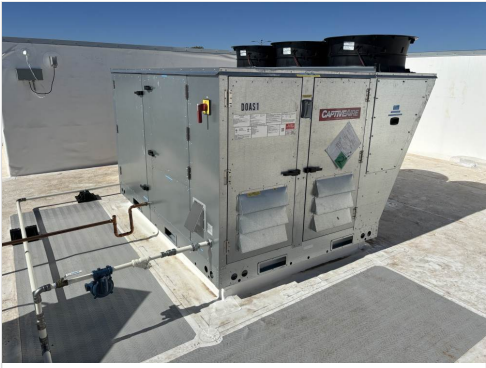
Unit Data - PHOTO LOG

Unit Data		
	Design	Actual
MFG	CAPTIVE-AIRE	CAPTIVE-AIRE
Serial Num	-	5976146
Model Num	CASRTU3-I.200-15-20T	CAS-HVAC3-I.200-15-20T
Type	-	5976146
Configuration	VERTICAL DISCHARGE	VERTICAL DISCHARGE
Num OA Filters 1	-	4
OA Filter Size 1	-	16x25x2
Num Final Filter 1	-	8
Final Filter Size 1	-	20x25x2

UNIT SCHEDULED FOR 2650 CFM SUPPLY. GRILLES ADD TO 2790. GRILLES PROPORTIONALLY ADJUSTED TO MEET SCHEDULED DESIGN OF 2650 CFM.
UNABLE TO SAFELY DRILL INTO UNIT TO TAKE STATIC PRESSURE READINGS.

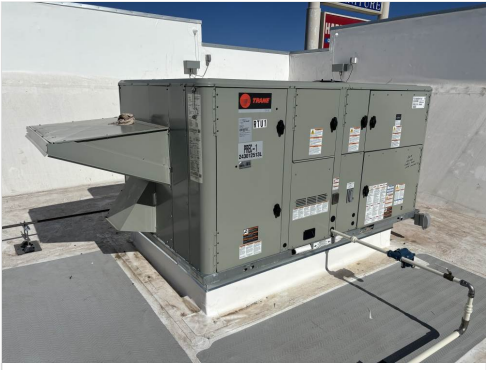
Unit Data - PHOTO LOG

Unit Data		
	Design	Actual
MFG	TRANE	TRANE
Serial Num	-	243012513L
Model Num	YSJ150	YSJ150B3S0H07K2C0A201A0A20
Type	RTU	RTU
Configuration	VERTICAL DISCHARGE	VERTICAL DISCHARGE
Num OA Filters 1	-	MISSING
OA Filter Size 1	-	MISSING
Num Final Filter 1	-	3
Final Filter Size 1	-	18x18x2
Num Final Filter 2	-	3
Final Filter Size 2	-	18x24x2

Notes:
 SUPPLY FAN SPEED SET POINT 78%.
 NO DAMPERS ON RTU-1 GRILLES. SEE ISSUES.

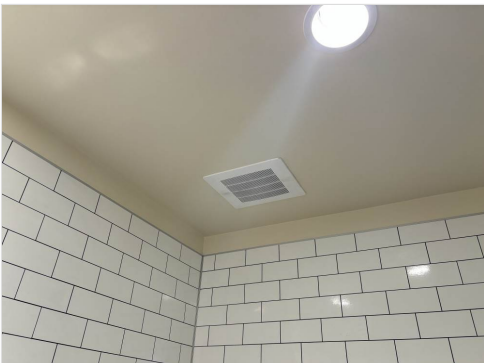
Unit Data - PHOTO LOG

Unit Data		
	Design	Actual
MFG	GREENHECK	COOK
Model Num	SP-A200-390	GEMINI 120
Serial Num	-	NL
Type	CENTRIFUGAL	CENTRIFUGAL
Configuration	CEILING	CEILING

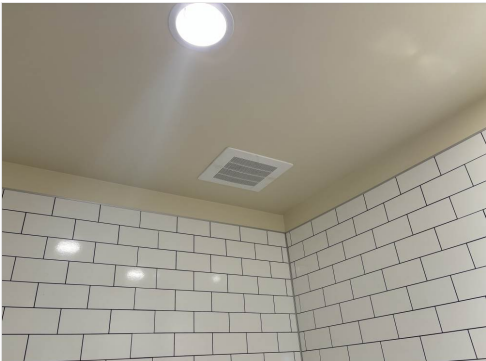
Unit Data - PHOTO LOG

Unit Data		
	Design	Actual
MFG	GREENHECK	COOK
Model Num	SP-A200-390	GEMINI 120
Serial Num	-	NL
Type	CENTRIFUGAL	CENTRIFUGAL
Configuration	CEILING	CEILING

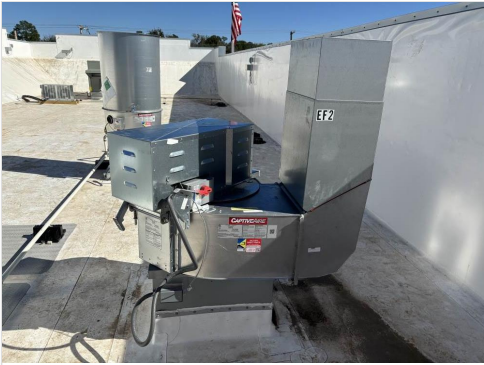
Unit Data - PHOTO LOG

Unit Data		
	Design	Actual
MFG	GREENHECK	CAPTIVEAIRE
Model Num	SP-A200-390	CASRE18DD
Serial Num	-	5976146
Type	CENTRIFUGAL	CENTRIFUGAL
Configuration	UTILITY	UTILITY

Notes:
[1] FAN IS UTILITY SET. NO ACCESS TO TAKE STATIC PRESSURE READING.

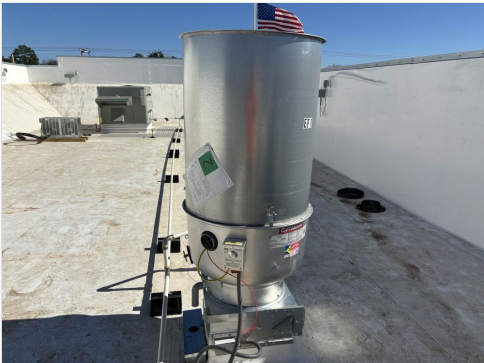
Unit Data - PHOTO LOG

Unit Data		
	Design	Actual
MFG	GREENHECK	CAPTIVE-AIRE
Model Num	SP-A200-390	DU50HFA
Serial Num	-	5976146
Type	CENTRIFUGAL	CENTRIFUGAL
Configuration	UPBLAST	UPBLAST

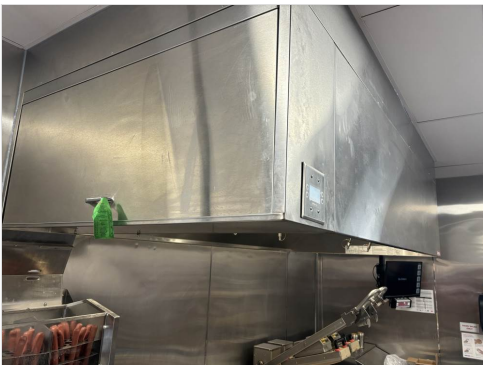
Unit Data - PHOTO LOG

Unit Data		
	Design	Actual
MFG	CAPTIVE-AIRE	CAPTIVE-AIRE
Model Num	5424 ND-2	5424 ND-2
Job / Serial Num	-	7025802
Type	TYPE I CANOPY	TYPE I CANOPY
Hood length	-	96"
Hood Width	-	54"

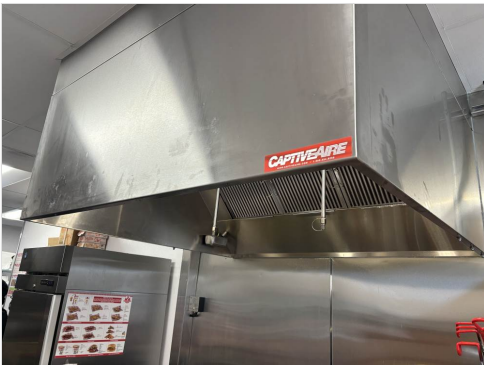
Unit Data - PHOTO LOG

Unit Data		
	Design	Actual
MFG	CAPTIVE-AIRE	CAPTIVE-AIRE
Model Num	5424 ND-2	5424 ND-2
Job / Serial Num	-	7025802
Type	TYPE I CANOPY	TYPE I CANOPY
Hood length	-	60"
Hood Width	-	54"
