**Report: INITIAL REPORT**  
**Function: Test, Adjust, & Balance**  
**Date: 03/31/2026**  
**Completed By: National TAB**

**PROJECT**  
**Habit Burger (Eureka, CA)**

1917 5th Street

Eureka, CA 95501

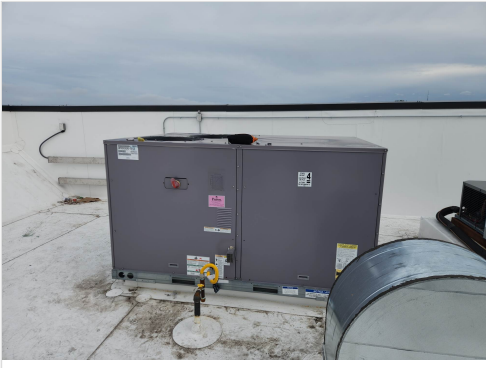
## Unit Data - PHOTO LOG

Asset: RTU-1

Unit Data	
	Actual
MFG	CARRIER
Serial Num	4024P664237
Model Num	48FCEM12A2A5A8U1C0
Configuration	VERTICAL
Num OA Filters 1	1
OA Filter Size 1	35X19
Num Final Filter 1	4
Final Filter Size 1	20X20X2

Test Data		
	Design	Actual
SF CFM	4000	3685
SF RPM	-	1911
RA CFM	3200	2884
OA CFM	800	801
RL Voltage	208	211/211/211
RL Amperage	-	6.34/6.34/6.34
SF System SetPt	-	8.1VDC
OA Damper Position	-	25%

Notes:  
 AIR BALANCE SCHEDULE DESIGN IS 4000 CFM SUPPLY AND 800 CFM OA  
 UNIT DESIGN TOTAL IS 3400 CFM SUPPLY AND 800CFM OA. AIR BALANCE SCHEDULE USED TO MEET DIFFUSER  
 TOTALS

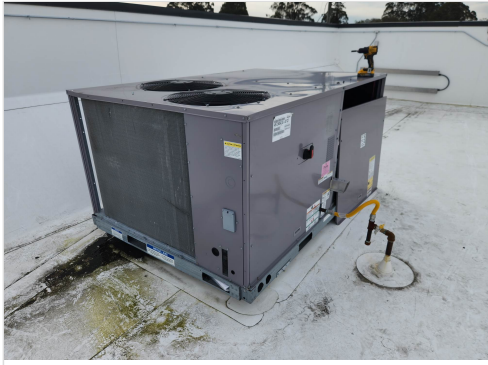
## Unit Data - PHOTO LOG

Asset: RTU-2

Unit Data	
	Actual
MFG	CARRIER
Serial Num	3924P63935
Model Num	48FCEN08A2A5A8U1C0
Configuration	VERTICAL
Num OA Filters 1	1
OA Filter Size 1	35X19
Num Final Filter 1	4
Final Filter Size 1	16X20X2

Test Data		
	Design	Actual
SF CFM	3000	3119
SF RPM	-	1499
RA CFM	2200	2316
OA CFM	800	803
RL Voltage	208	209/209/209
RL Amperage	-	3.57/3.57/3.57
SF System SetPt	-	5.9VDC
OA Damper Position	-	29%

AIR BALANCE SCHEDULE DESIGN IS 3000 CFM SUPPLY AND 800 CFM OA  
 DESIGN IS 2000 CFM SUPPLY AND 800 CFM OA  
 AIR BALANCE SCHEDULE USED TO MATCH DIFFUSER TOTALS

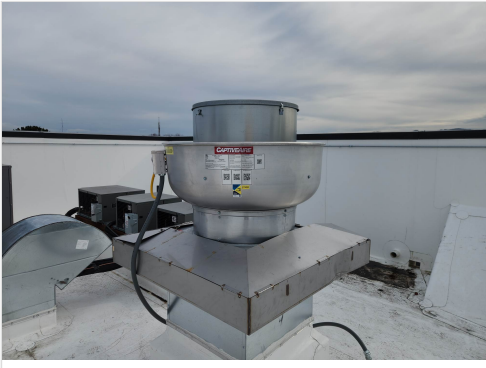
## Unit Data - PHOTO LOG

Asset: EF-1

Unit Data	
	Actual
<b>MFG</b>	CAPTIVEAIRE
<b>Model Num</b>	DU180HFA
<b>Serial Num</b>	6815900
<b>Type</b>	KEF UPBLAST

Test Data		
	Design	Actual
<b>CFM</b>	1800	1809.5
<b>Motor Frequency</b>	-	46.5HZ
<b>System SetPt</b>	-	46.5HZ
<b>RL Voltage</b>	208	153/153/153
<b>RL Amperage</b>	7.3	4.73/4.73/4.73
<b>Suction ESP</b>	-	-1.41"
<b>Total ESP</b>	1.750	1.41"
<b>Brake Horse Power</b>	-	1.44

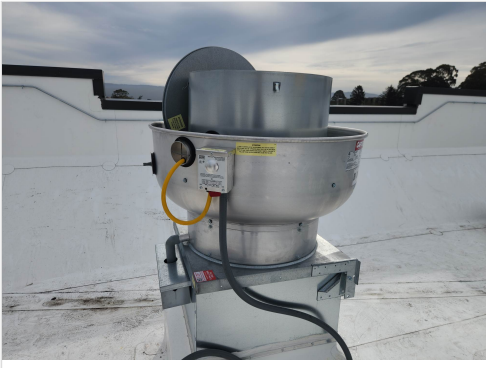
## Unit Data - PHOTO LOG

Asset: EF-3

Unit Data	
	Actual
<b>MFG</b>	CAPTIVEAIRE
<b>Model Num</b>	DU180HFA
<b>Serial Num</b>	6815900
<b>Type</b>	KEF

Test Data		
	Design	Actual
<b>CFM</b>	1750	1753
<b>Motor Frequency</b>	-	38.5HZ
<b>System SetPt</b>	-	38.5HZ
<b>RL Voltage</b>	208	190/190/190
<b>RL Amperage</b>	6.1	4.82/4.82/4.82
<b>Suction ESP</b>	-	-1.37"
<b>Total ESP</b>	1.750	1.37"
<b>Brake Horse Power</b>	-	1.7

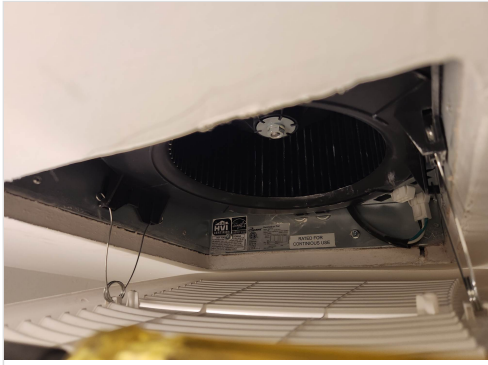
## Unit Data - PHOTO LOG

Asset: EF-4

Unit Data	
	Actual
<b>MFG</b>	AIRZONE
<b>Model Num</b>	SEP150
<b>Serial Num</b>	240514414
<b>Type</b>	CEILING

Test Data		
	Design	Actual
<b>CFM</b>	150	144
<b>RL Voltage</b>	120	NA
<b>RL Amperage</b>	-	NA
<b>Discharge ESP</b>	-	0.32"
<b>Total ESP</b>	0.375"	0.32"

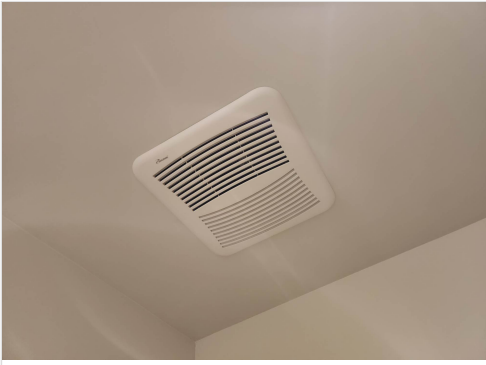
**Unit Data - PHOTO LOG**

Asset: EF-5

Unit Data	
	Actual
<b>MFG</b>	AIRZONE
<b>Model Num</b>	SEP150
<b>Serial Num</b>	240514415
<b>Type</b>	CEILING

Test Data		
	Design	Actual
<b>CFM</b>	150	147
<b>RL Voltage</b>	120	NA
<b>RL Amperage</b>	-	NA
<b>Discharge ESP</b>	-	0.31"
<b>Total ESP</b>	0.375"	0.31"

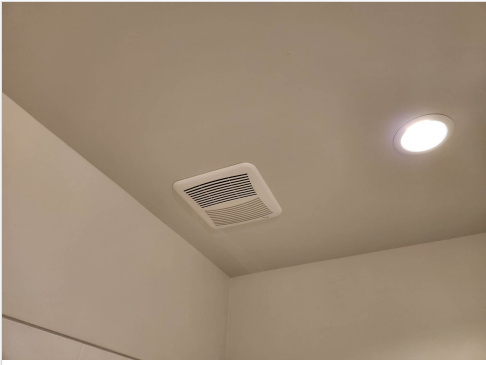
**Unit Data - PHOTO LOG**

Asset: EF-6

Unit Data	
	Actual
<b>MFG</b>	AIRZONE
<b>Model Num</b>	SEP150
<b>Serial Num</b>	240514416
<b>Type</b>	CEILING

Test Data		
	Design	Actual
<b>CFM</b>	150	148
<b>RL Voltage</b>	120	NA
<b>RL Amperage</b>	-	NA
<b>Discharge ESP</b>	-	0.33"
<b>Total ESP</b>	0.375"	0.33"

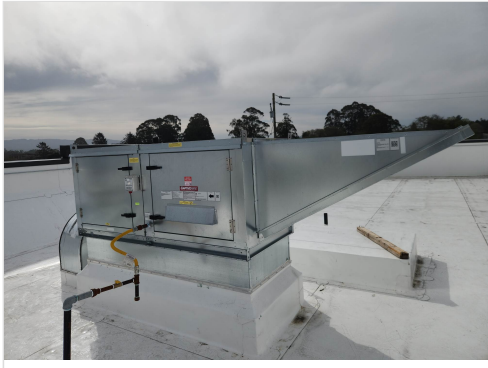
## Unit Data - PHOTO LOG

Asset: MAU-1

Unit Data	
	Actual
MFG	CAPTIVEAIRE
Model Num	A2-D.250-20D
Serial Num	6815900
Type	MAU
Configuration	VERTICAL

Gas Heat		
	Design	Actual
Heater Operates (y/n)	-	NO
Flame Status (pass/fail)	-	FAIL
Inlet Air Temp SetPt	-	55
Discharge Air Temp SetPt	-	60
Air Flow Switch SP Actual	-	0.57"

Test Data		
	Design	Actual
CFM	4300	4329
SF RPM	1596	1633
Motor RPM	-	1633
SF System SetPt	-	57.0HZ
RL Voltage	208	211/211/211
RL Amperage	15.0	10.75/10.73/10.74
Total ESP	-	0.69"
Fan Discharge SP	-	0.69"

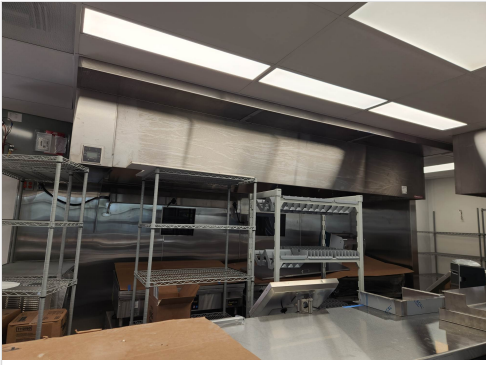
## Unit Data - PHOTO LOG

Asset: HD-1

Unit Data	
	Actual
MFG	CAPTIVAIRE
Model Num	5430 ND-2-PSP-F
Job / Serial Num	6815900
Type	TYPE I
Hood length	159"
Hood Width	51"
Supply Plenum Type	MUA
Supply Plenum Width	16"
Supply Plenum Length	172"

Test Data Exhaust		
	Design	Actual
Filter Type	CAPTRATE COMBO WITH	CAPTRATE SOLO
Filter Size 1	20"X16"	20X16
Filter Qty 1	10	10
Filter AK factor size 1	-	2.08
Filter Total AK Area	-	20.8
Filter1 FPM	-	175
Filter2 FPM	-	183
Filter3 FPM	-	186
Filter4 FPM	-	166
Filter5 FPM	-	159
Filter6 FPM	-	161
Filter7 FPM	-	177
Filter8 FPM	-	183
Filter9 FPM	-	171
Filter10 FPM	-	185
Filter Ave FPM(corr)	-	174
CFM	3600	3619

Test Data Supply		
	Design	Actual
Total Area	-	19.11
Kv factor (Vel)	-	0.92
Num of Readings	-	12
Reading1 FPM	-	181
Reading2 FPM	-	154
Reading3 FPM	-	177
Reading4 FPM	-	168
Reading5 FPM	-	149
Reading6 FPM	-	183
Reading7 FPM	-	168
Reading8 FPM	-	141
Reading9 FPM	-	162
Reading10 FPM	-	188
Reading11 FPM	-	156
Reading12 FPM	-	185
Ave FPM(corr)	-	167
CFM	2900	2936

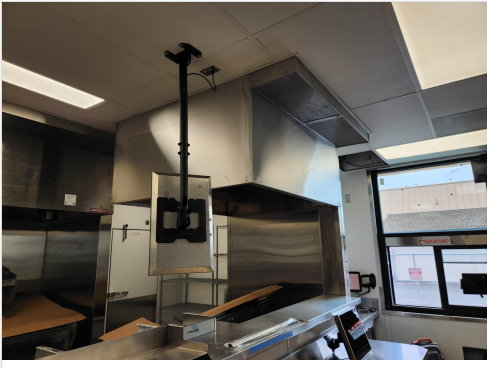
**Unit Data - PHOTO LOG**

Asset: HD-2

Unit Data	
	Actual
MFG	CAPTIVEAIRE
Model Num	5430 ND-2WI
Job / Serial Num	6815900
Type	TYPE I NO PSP
Hood length	60"
Hood Width	51"

Test Data Exhaust		
	Design	Actual
Filter Type	CAPTRATE COMBO WITH	CAPTRATE SOLO
Filter Size 1	20"X16"	20X16
Filter Qty 1	3	3
Filter AK factor size 1	-	2.08
Filter Total AK Area	-	6.24
Filter1 FPM	-	267
Filter2 FPM	-	301
Filter3 FPM	-	276
Filter Ave FPM(corr)	-	281
CFM	1750	1753

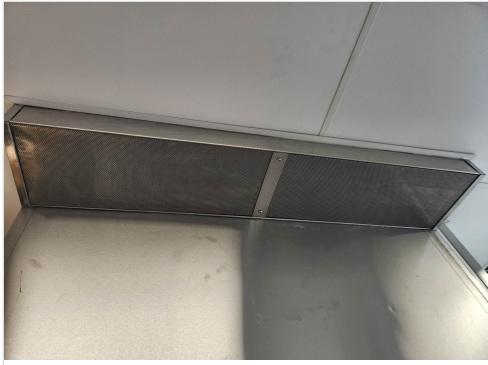
**Unit Data - PHOTO LOG**

Asset: HD-3

Unit Data	
	Actual
MFG	CAPTIVEAIRE
Model Num	126 MISC-PSP
Supply Plenum Type	MUA
Supply Plenum Width	12"
Supply Plenum Length	61"

Test Data Supply		
	Design	Actual
Total Area	-	5.08
Kv factor (Vel)	-	0.81
Num of Readings	-	4
Reading1 FPM	-	177
Reading2 FPM	-	178
Reading3 FPM	-	191
Reading4 FPM	-	131
Ave FPM(corr)	-	169
CFM	700	696

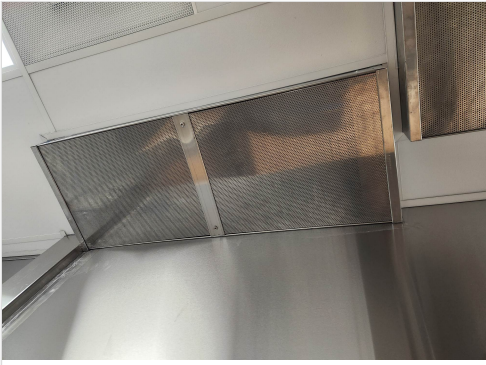
**Unit Data - PHOTO LOG**

Asset: HD-4

Unit Data	
	Actual
MFG	CAPTIVEAIRE
Model Num	166 MISC-PSP
Supply Plenum Type	MUA
Supply Plenum Width	16"
Supply Plenum Length	42"

Test Data Supply		
	Design	Actual
Total Area	-	4.667
Kv factor (Vel)	-	0.92
Num of Readings	-	4
Reading1 FPM	-	167
Reading2 FPM	-	156
Reading3 FPM	-	166
Reading4 FPM	-	161
Ave FPM(corr)	-	162.5
CFM	700	697
