**Report: TAB REPORT**  
**Function: Test, Adjust, & Balance**  
**Date: 08/22/2024**

**PROJECT**  
**07-29-24 PF CHANGS SAN ANTONIO, TX**

Project: 07-29-24 PF CHANGS SAN ANTONIO, TX

National TAB was called to P.F. Chang's San Antonio to address concerns of humidity/condensation, and warm temperatures in the space.

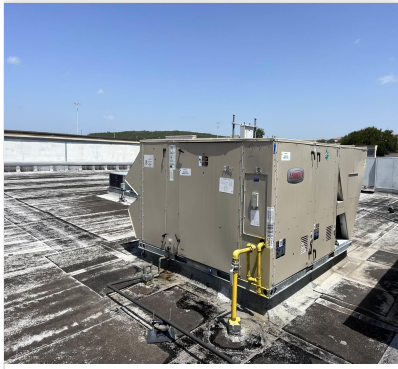
**Issue Name :** RTU-2  
**Description :** RTU-2 is low on air flow (85%). Fan speed is maximized, motor is operating at full load amp rating. Unit static pressure readings may indicate some duct blockage in supply duct. Recommend bringing in mechanical contractor to further inspect duct. Remove any blockages, open any hidden dampers etc.  
**Created By :** National TAB                      **Assigned To :** National TAB - Will Turnbough  
**Status :** Open  
**Priority :** Urgent                                      **Asset Tag :**  
**Originated Date :** 08/22/2024 - Wesley John - National TAB

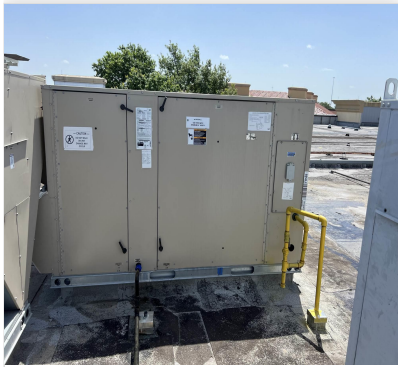
**RTU-3**

**Issue Name :** RTU-3  
**Description :** RTU-3 is low on air flow (78%). Static pressure measured at unit is low. Motor is operating below full load amp rating. Recommend pulley change on unit to bring air flow to within tolerance.  
**Created By :** National TAB                      **Assigned To :** National TAB - Will Turnbough  
**Status :** Open  
**Priority :** Urgent                                      **Asset Tag :**  
**Originated Date :** 08/22/2024 - Wesley John - National TAB

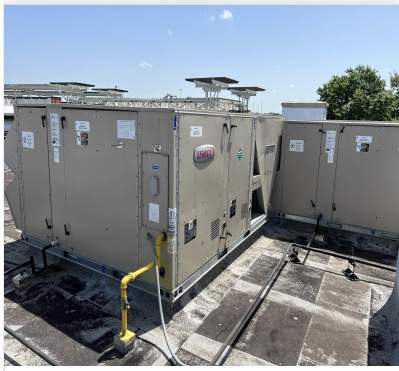
**RTU-4**

**Issue Name :** RTU-4  
**Description :** RTU-4 is low on air flow (73%). Static pressure measured at unit is low. Motor is operating below full load amp rating. Recommend pulley change on unit to bring air flow to within tolerance.  
**Created By :** National TAB                      **Assigned To :** National TAB - Will Turnbough  
**Status :** Open  
**Priority :** Urgent                                      **Asset Tag :**  
**Originated Date :** 08/22/2024 - Wesley John - National TAB

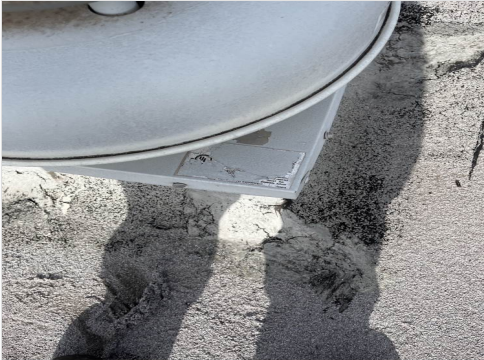
EF\_7\_740252443

Test Data		
	Design	Actual
CFM	75	0
Fan RPM	-	(1)
Fan Rotation	-	(1)
Motor RPM	-	(1)
System SetPt	-	(1)
RL Voltage	-	(1)
RL Amperage	-	(1)
Total ESP	0.25"	(1)
Fan Inlet SP	-	(1)
Fan Discharge SP	-	(1)

Notes:  
(1) MOTOR NOT RUNNING.

**Issue Name :** EF-7  
**Description :** EF-7 (Employee Restroom) is not operational. Recommend repair/replacement.  
**Created By :** National TAB                      **Assigned To :** National TAB - Will Turnbough  
**Status :** Open  
**Priority :** Urgent                                      **Asset Tag :**  
**Originated Date :** 08/22/2024 - Wesley John - National TAB
