Report: TAB Report
Function: Test, Adjust, & Balance
Date: 05/05/2025
Completed By: National TAB

PROJECT
04-28-25 ALBERTSONS #991 PEORIA, AZ

Project: 04-28-25 ALBERTSONS #991 PEORIA, AZ

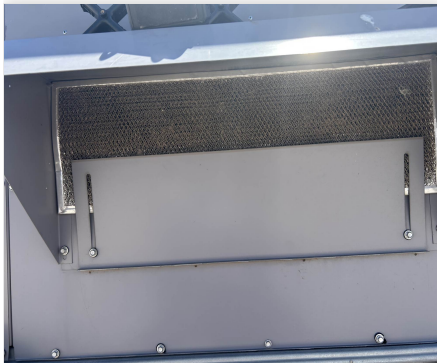
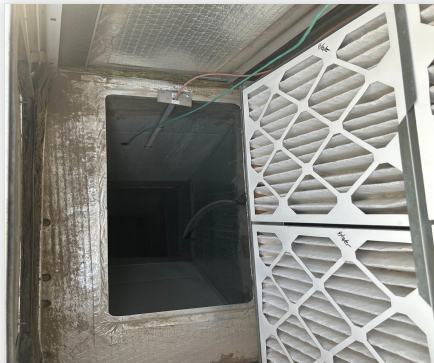
Issue Name : AC-1 NO OA & RETURN DAMPER INSTALLED
Description : Outside air and return dampers not installed. Unable to set OA.
Recommend installing dampers to set OA to design.
Created By : National TAB **Assigned To :** National TAB - Will Turnbough
Status : Open
Priority : Medium **Asset Tag :**
Originated Date : 04/29/2025 - David Nicolas Sanchez - National TAB

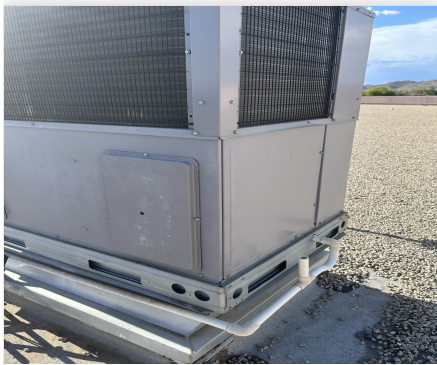
Issue Name : AC-3 OA VENT NOT INSTALLED
Description : AC-3 OA vent not installed. Unable to set OA for unit. Recommend installing OA and OA damper in order to set OA to design.
Created By : National TAB **Assigned To :** National TAB - Will Turnbough
Status : Open
Priority : High **Asset Tag :**
Originated Date : 04/30/2025 - David Nicolas Sanchez - National TAB

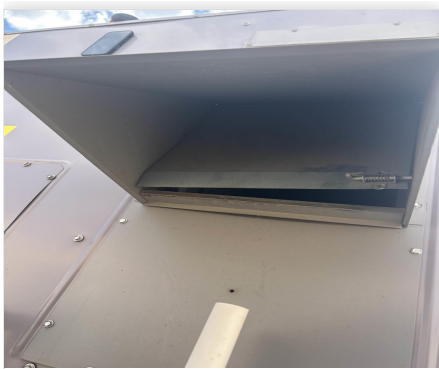
Issue Name : AC-4 HIGH OA
Description : Unable to achieve design CFM. Manual damper set to lowest position. Minimum OA set to 974 CFM.
Created By : National TAB **Assigned To :** National TAB - Will Turnbough
Status : Open
Priority : Medium **Asset Tag :**
Originated Date : 04/29/2025 - David Nicolas Sanchez - National TAB

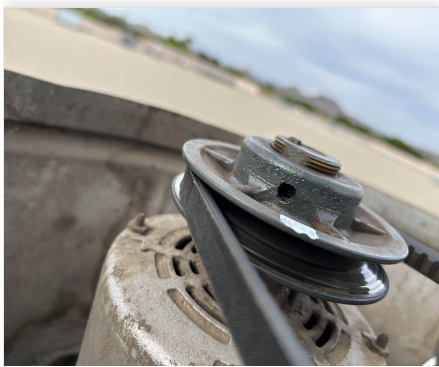
Issue Name : HEF-1 MOTOR SHEAVE SEIZED
Description : HEF-1 motor sheave is seized, unable to slow down the unit to achieve design airflow. Recommend replacing motor sheave.
Created By : National TAB **Assigned To :** National TAB - Will Turnbough
Status : Open
Priority : High **Asset Tag :**
Originated Date : 04/30/2025 - David Nicolas Sanchez - National TAB

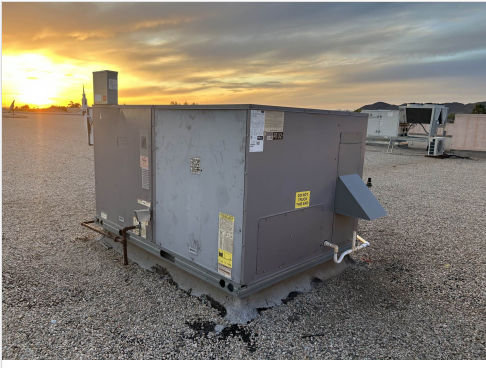
Asset: AC4

Test Data		
	Design	Actual
SF CFM	4800	4565
SF RPM	-	841
RA CFM	4320	3590
OA CFM	480	974
RL Voltage	-	205/206/208
RL Amperage	-	6.04/6.05/5.79
SF Rotation	-	CCW
SF System SetPt	-	N/A
RA Damper Position	-	N/A
Min OA Damper Position	-	25%
Min OA Damper Type	-	MANUAL
OA Enthalpy Setpt	-	N/A

Notes:
UNABLE TO CHECK MOTOR SHEAVE SET-POINT. PULLEY SEIZED.

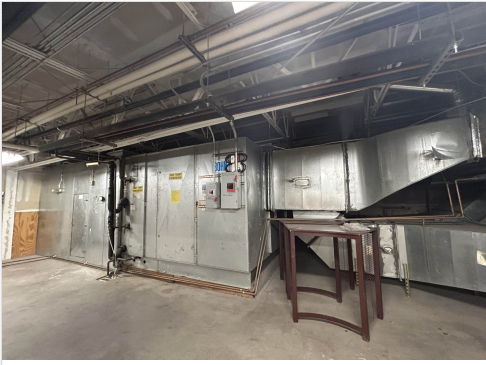
Asset: AHU1

OA supply fan not functional. Unable to set OA to design CFM.

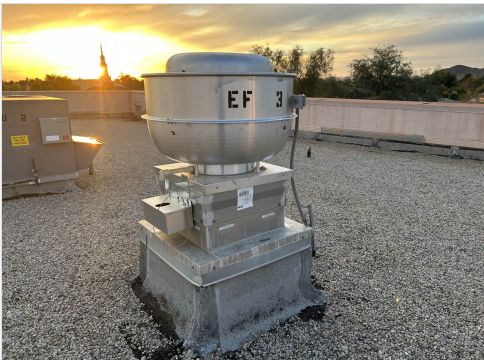
Asset: EF3

Test Data		
	Design	Actual
CFM	800	476
Fan RPM	-	DD
Fan Rotation	-	CCW
Motor RPM	-	DD
System SetPt	-	100
RL Voltage	-	119
RL Amperage	-	NA
Total ESP	-	NA
Fan Inlet SP	-	NA
Fan Discharge SP	-	NA
