Report: TAB Report
Function: Test, Adjust, & Balance
Date: 05/05/2025
Completed By: National TAB

PROJECT
04-28-25 ALBERTSONS #991 PEORIA, AZ

Project: 04-28-25 ALBERTSONS #991 PEORIA, AZ

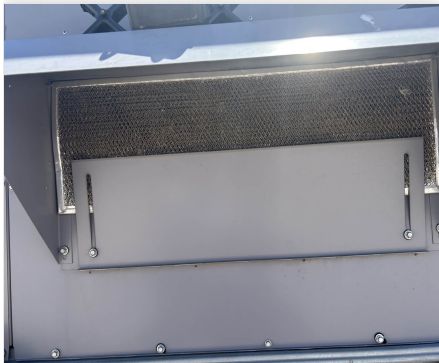
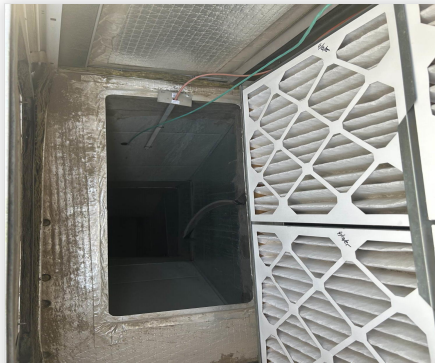
Issue Name : AC-1 NO OA & RETURN DAMPER INSTALLED
Description : Outside air and return dampers not installed. Unable to set OA.
Recommend installing dampers to set OA to design.
Created By : National TAB **Assigned To :** National TAB - Will Turnbough
Status : Open
Priority : Medium **Asset Tag :**
Originated Date : 04/29/2025 - David Nicolas Sanchez - National TAB

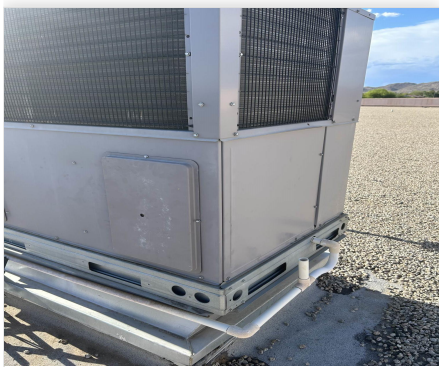
Issue Name : AC-3 OA VENT NOT INSTALLED
Description : AC-3 OA vent not installed. Unable to set OA for unit. Recommend installing OA and OA damper in order to set OA to design.
Created By : National TAB **Assigned To :** National TAB - Will Turnbough
Status : Open
Priority : High **Asset Tag :**
Originated Date : 04/30/2025 - David Nicolas Sanchez - National TAB

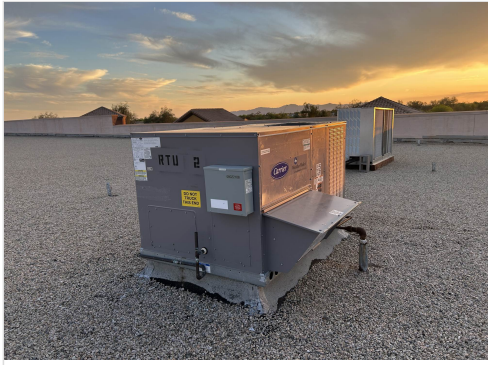
Asset: AC1

Test Data		
	Design	Actual
SF CFM	1990	2102
SF RPM	-	861
RA CFM	1800	1814
OA CFM	190	288
RL Voltage	-	208/208/207
RL Amperage	-	4.12/4.48/4.28
SF Rotation	-	CW
SF System SetPt	-	N/A
RA Damper Position	-	N/A
Min OA Damper Position	-	N/A
Min OA Damper Type	-	N/A
OA Enthalpy Setpt	-	N/A

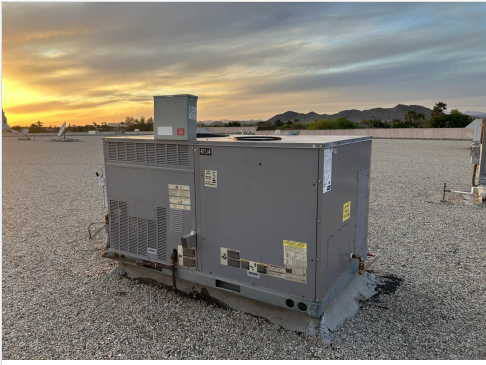
Asset: AC2

Test Data		
	Design	Actual
SF CFM	2400	2534
SF RPM	-	2434
RA CFM	-	2300
OA CFM	240	234
RL Voltage	-	206/207/205
RL Amperage	-	4.07/4.07/4.12
SF Rotation	-	CCW
SF System SetPt	-	C
RA Damper Position	-	7.50V
Min OA Damper Position	-	2.50V
Min OA Damper Type	-	ECONOMIZER
OA Enthalpy Setpt	-	N/A

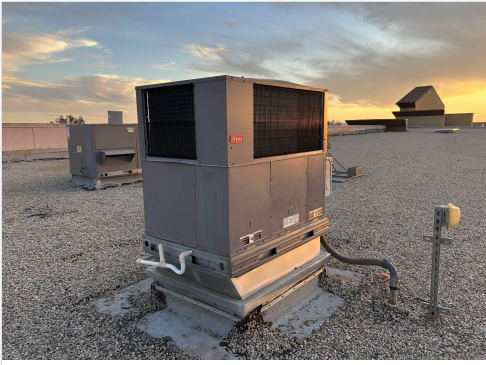
Asset: AC3

Test Data		
	Design	Actual
SF CFM	800	743
SF RPM	720	DD
RA CFM	720	743
OA CFM	80	0
RL Voltage	-	208
RL Amperage	-	0.90
SF Rotation	-	CCW
SF System SetPt	-	[1]
RA Damper Position	-	N/A
Min OA Damper Position	-	N/A
Min OA Damper Type	-	N/A
OA Enthalpy Setpt	-	N/A

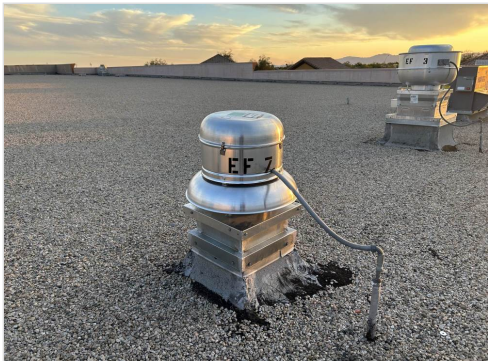
Asset: EF7

Test Data		
	Design	Actual
CFM	180	0
Fan RPM	-	DD
Fan Rotation	-	CCW
Motor RPM	-	DD
System SetPt	-	100
RL Voltage	-	0
RL Amperage	-	0
Total ESP	-	0
Fan Inlet SP	-	0
Fan Discharge SP	-	0
