**Report: TAB**

**Function: Test, Adjust, & Balance**

**Date: 06/10/2025**

**06-09-25 CHIPOTLE #5186 BOZEMAN, UT  
(NORTHWEST CROSSING)**

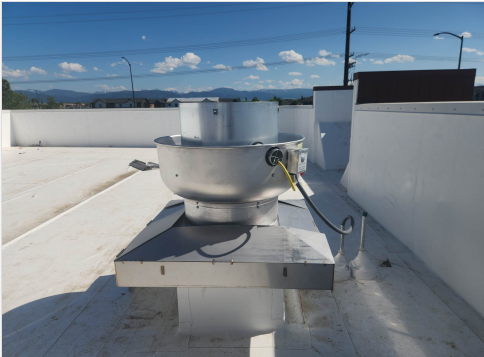
### Unit Data - PHOTO LOG

Asset: EF1

Unit Data		
	Design	Actual
MFG	CAPTIVEAIRE	CAPTIVEAIRE
Model Num	DU180HFA	DU180HFA
Serial Num	-	6891720
Type	UPBLAST	UPBLAST
Configuration	VERTICAL	VERTICAL
