**Report: TAB**

**Function: Test, Adjust, & Balance**

**Date: 07/29/2024**

## 07-22-24 WAWA #5422 OCALA, FL

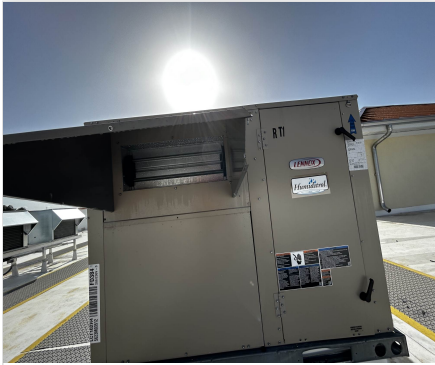
Project Issue File Details

**Issue Name :** RTU-1 OA FILTER  
**Description :** OUTSIDE AIR FILTER HAS NOT BEEN INSTALLED ON RTU-1.  
**Created By :** National TAB                      **Assigned To :** National TAB - Will Turnbough  
**Status :** Open  
**Priority :** Medium                                      **Asset Tag :**  
**Originated Date :** 07/22/2024 - Kristopher Passley - National TAB

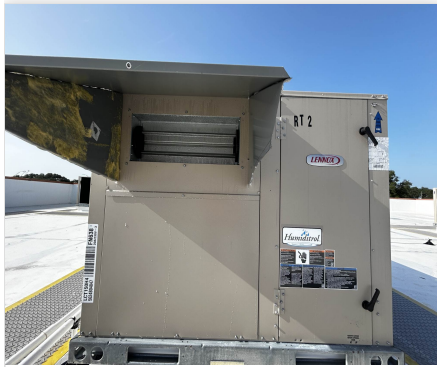
Project Issue File Details

**Issue Name :** RTU-2 OA FILTER  
**Description :** RTU-2 OUTSIDER AIR FILTER IS NOT INSTALLED.  
**Created By :** National TAB                      **Assigned To :** National TAB - Will Turnbough  
**Status :** Open  
**Priority :** Medium                                      **Asset Tag :**  
**Originated Date :** 07/22/2024 - Kristopher Passley - National TAB
