# 636 PRE-GRID CHECKLIST

Prepared by Ben Searles

Jun 19, 2025

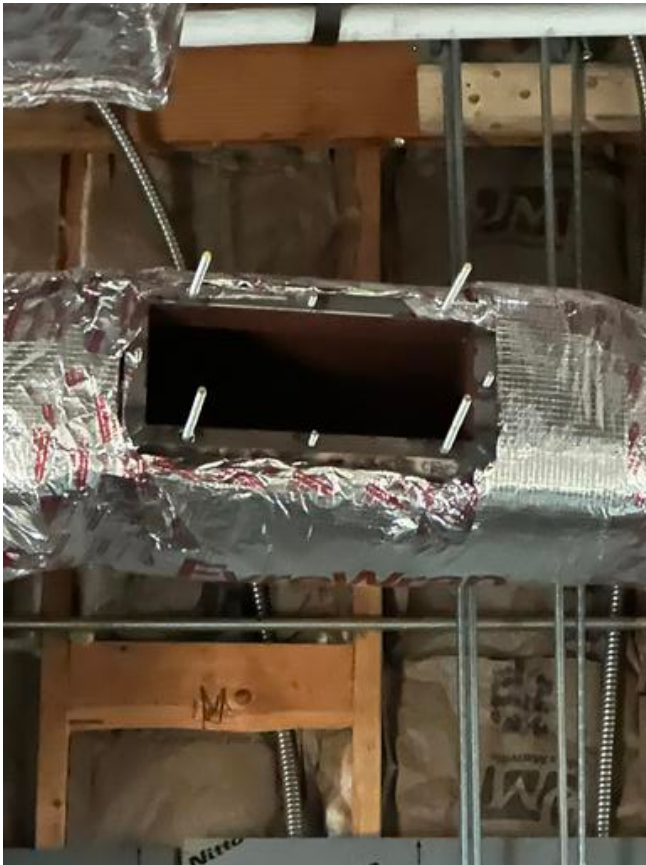
IMG\_1541

**#257 [EXHA 001] [NEW] CRITICAL – Grease duct access doors.**

Access doors are missing.

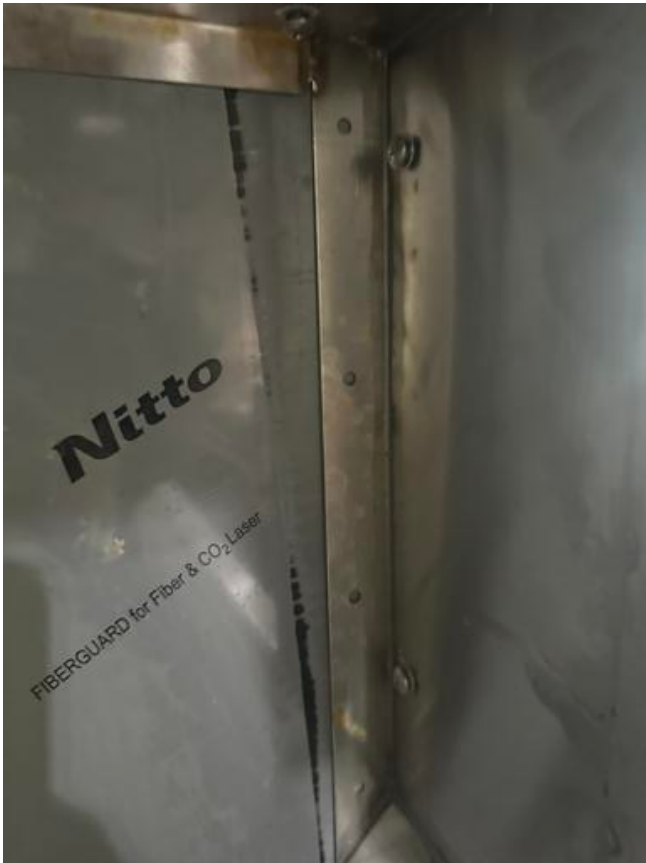
IMG\_1535

## #256 [HOOD 509] [NEW] Hood back panes.

Hoods are to be secured to back panes via pre-punch holes with stainless steel screws.

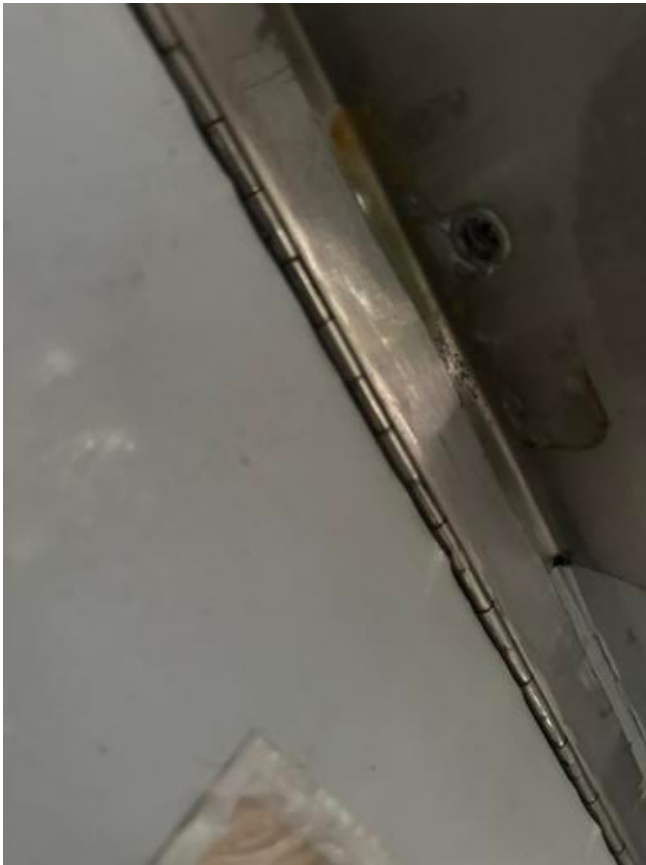
IMG\_1537

## #255 [HOOD 999] [NEW] (MISC) Gusset bolts.

Hood gusset bracket bolts  
are missing.

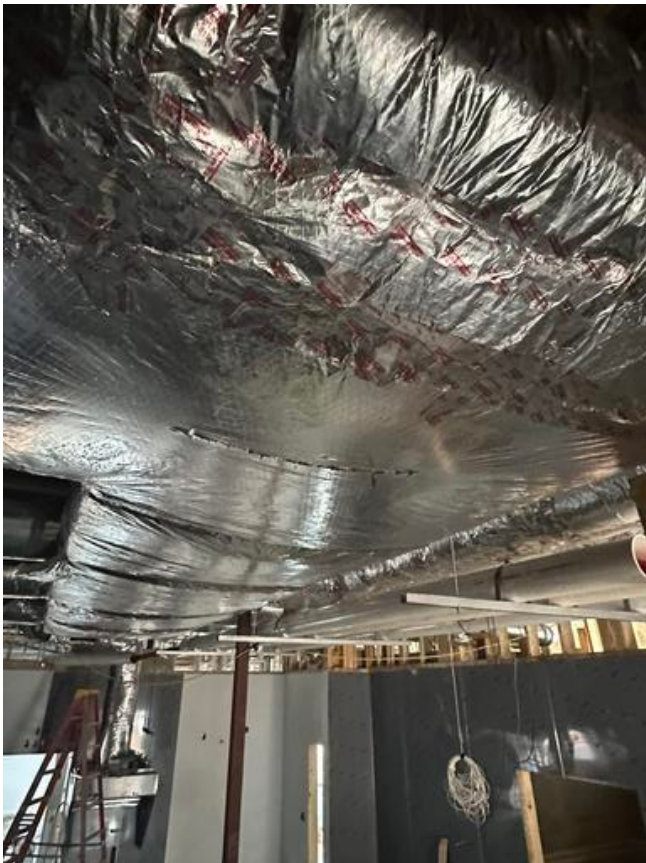
IMG\_1542

## #254 [DUCT 501] [NEW] Insulation stick pins.

External insulation on bottom of ducts 24" or wider is to be supported by stick pins 18" on center. Cut pins and apply tape or mastic over stick pin washers.

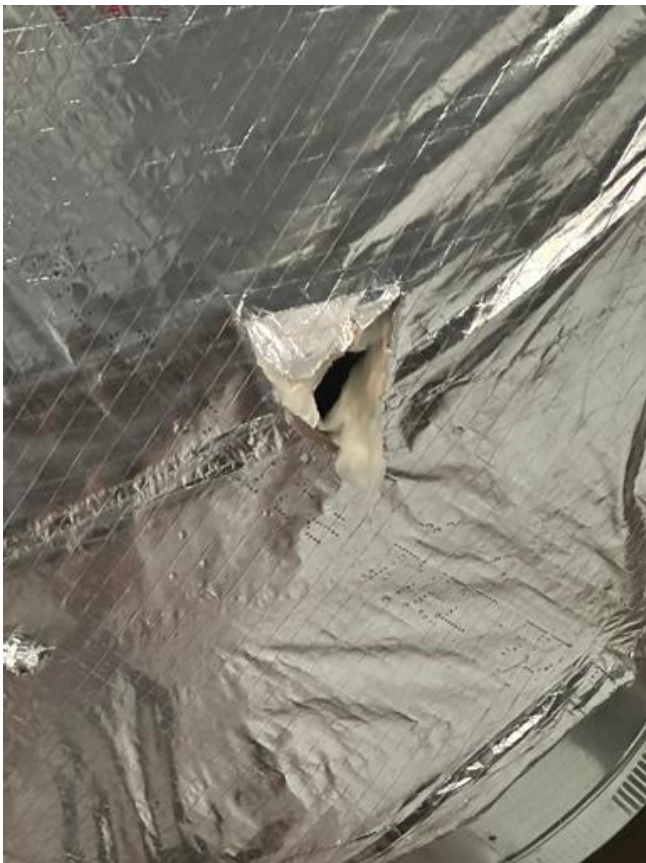
IMG\_1534

## #253 [DUCT 506] [NEW] Incorrect, missing, or damaged insulation.

Duct insulation is damaged and full of water. Review and replace.

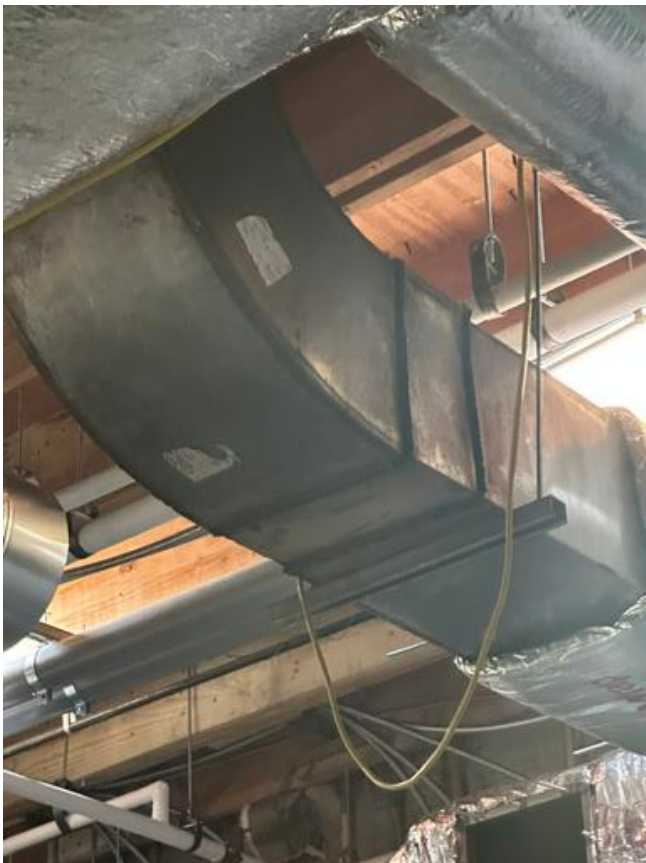
IMG\_1538  
Ben Searles  
Jun 19, 2025 12:35 PM

## #252 [DUCT 507] [NEW] Ductwork is not fully insulated.

Ductwork has exposed metal ductwork in some areas needs to be fully wrapped.

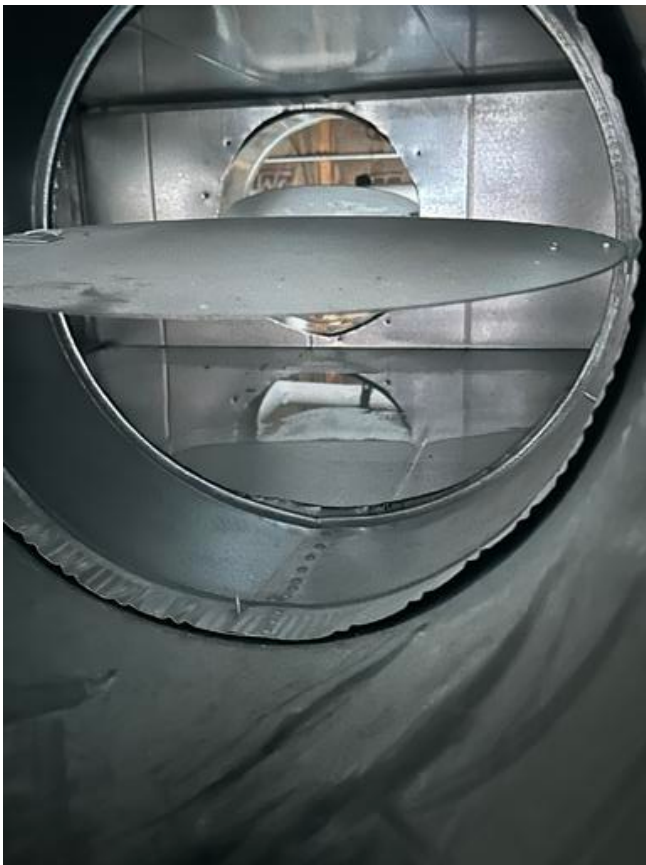
IMG\_1543

## #251 [DUCT 999] [NEW] (MISC) Ductwork is holding water.

The kitchen ductwork is currently full of water. The water will need to be removed before the ductwork is finished.
