**Report: TAB Report**  
**Function: Test, Adjust, & Balance**  
**Date: 11/18/2025**  
**Completed By: National TAB**

## 11-10-25 WAWA #6901 RANSON, WV

1740 N Fairfax Blvd

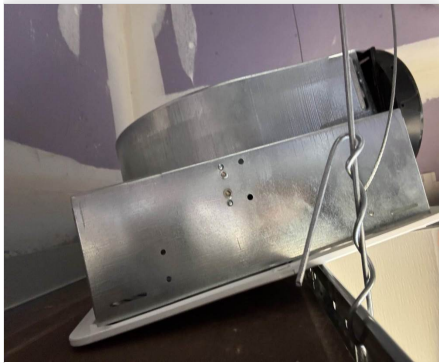
**Issue Name :** EF3: Airflow Low  
**Description :** Airflow for EF3 is low. Unable to open up fan and diagnose. Supply adjusted down to match. Verify that the backdraft damper is fully opening and not getting stuck partially closed.  
**Created By :** National TAB                      **Assigned To :** National TAB - Brianna Biggs  
**Status :** Open  
**Priority :** Low    **Asset Tag :**  
**Originated Date :** 11/18/2025 - Ryan Smith - National TAB

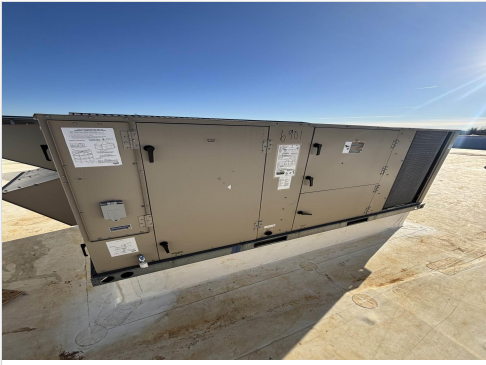
Asset: RTU1

Unit Data		
	Design	Actual
MFG	LENNOX	LENNOX
Serial Num	-	5624L03274
Model Num	LCT150H4E	LCT150H4EN2Y
Type	RTU	RTU
Configuration	VERTICAL	VERTICAL
Num OA Filters 1	-	2
OA Filter Size 1	-	24X14
Num Final Filter 1	-	4
Final Filter Size 1	-	20X25X2

Test Data		
	Design	Actual
SF CFM	4500	4118
RA CFM	3800	3381
OA CFM	700	737
RL Voltage	-	208
RL Amperage	-	7.8
SF System SetPt	-	97%
RA Damper Position	-	83%
RA Damper Type	-	ECON
OA Damper Position	-	17%
OA Damper Type	-	ECON

Performance Data		
	Design	Actual
MA Plenum SP	-	0.76"
Fan Suction SP	-	1.18"
Fan Discharge SP	-	0.89"
Total ESP	0.70"	1.65"
Fan Total SP	-	2.07"

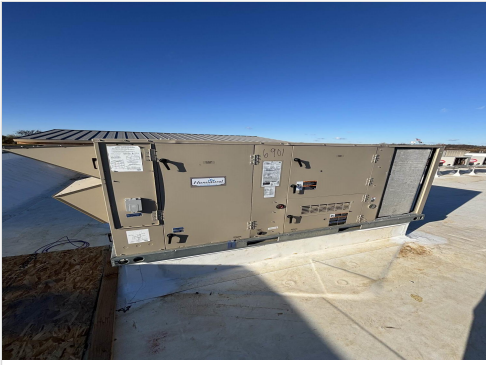
Asset: RTU2

Unit Data		
	Design	Actual
MFG	LENNOX	LENNOX
Serial Num	-	5624K03959
Model Num	LCT102H4E	LCT102H4ES1Y
Type	RTU	RTU
Configuration	VERTICAL	VERTICAL
Num OA Filters 1	-	1
OA Filter Size 1	-	24X14
Num Final Filter 1	-	4
Final Filter Size 1	-	20X25X2

Test Data		
	Design	Actual
SF CFM	3400	3453
RA CFM	3020	3096
OA CFM	380	357
RL Voltage	-	208
RL Amperage	-	3.6
SF System SetPt	-	72%
RA Damper Position	-	72%
RA Damper Type	-	ECON
OA Damper Position	-	28%
OA Damper Type	-	ECON

Performance Data		
	Design	Actual
MA Plenum SP	-	0.32"
Fan Suction SP	-	0.62"
Fan Discharge SP	-	0.72"
Total ESP	1.00"	1.04"
Fan Total SP	-	1.34"

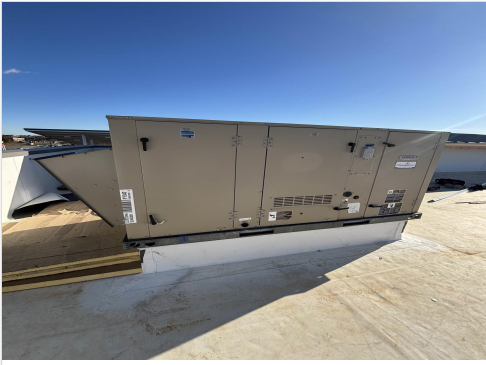
Asset: RTU3

Unit Data		
	Design	Actual
MFG	LENNOX	LENNOX
Serial Num	-	5624K03089
Model Num	LCT072H4E	LCT072H4EQ1Y
Type	RTU	RTU
Configuration	VERTICAL	VERTICAL
Num OA Filters 1	-	1
OA Filter Size 1	-	30X14
Num Final Filter 1	-	4
Final Filter Size 1	-	20X25X2

Test Data		
	Design	Actual
SF CFM	2400	2298
RA CFM	2200	2077
OA CFM	200	221
RL Voltage	-	207
RL Amperage	-	3.2
SF System SetPt	-	90%
RA Damper Position	-	82%
RA Damper Type	-	ECON
OA Damper Position	-	18%
OA Damper Type	-	ECON

Performance Data		
	Design	Actual
MA Plenum SP	-	0.54"
Fan Suction SP	-	0.75"
Fan Discharge SP	-	0.70"
Total ESP	0.50"	1.24"
Fan Total SP	-	1.45"

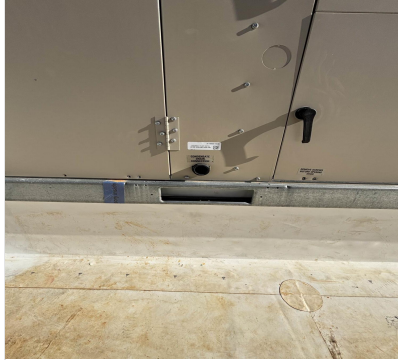
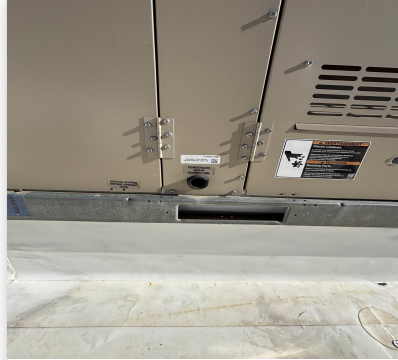
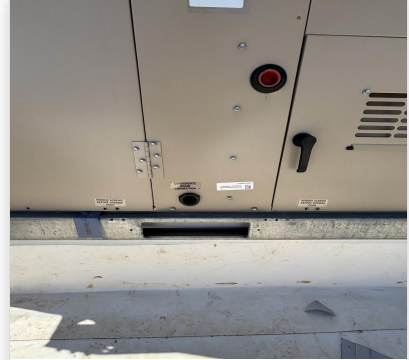
**Condensate drains are installed?**

Fail

No drains installed into units

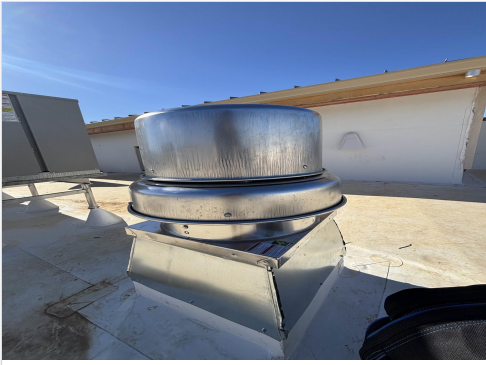
Asset: EF2

Unit Data		
	Design	Actual
MFG	GREENHECK	GREENHECK
Model Num	GB-098-6	GB-098-6119XQD
Serial Num	-	27935975
Type	DOWNBLAST	DOWNBLAST
Configuration	VERTICAL	VERTICAL

Test Data		
	Design	Actual
CFM	400	398
Fan Rotation	-	CW
Suction ESP	-	-0.20"
Discharge ESP	-	ATM
Total ESP	0.38"	0.20"

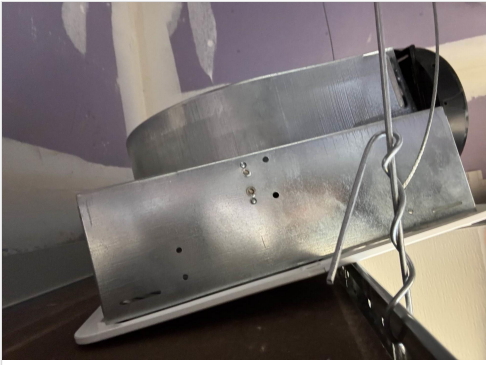
Asset: EF3

Test Data		
	Design	Actual
CFM	200	122
Fan Rotation	-	CCW
System SetPt	-	60Hz

Airflow is low and fan adjustment is not accessible.  
Fan info not available.
