**Report: TAB Report**  
**Function: Test, Adjust, & Balance**  
**Date: 12/13/2024**  
**Completed By: National TAB**

## 12-09-2024 FREDDY'S - HUNTSVILLE, AL

7001 Cabela Drive

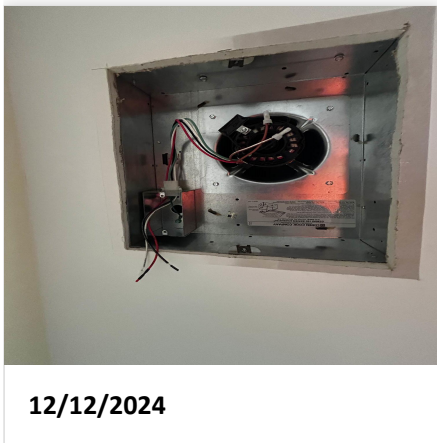
**Issue Name :** EF-1  
**Description :** EF-1 is not wired to power. Unable to balance unit until this is resolved.  
**Created By :** National TAB                      **Assigned To :** National TAB - Kristopher Passley  
**Status :** Closed  
**Priority :** Urgent                                      **Asset Tag :**  
**Originated Date :** 12/12/2024 - Kristopher Passley - National TAB

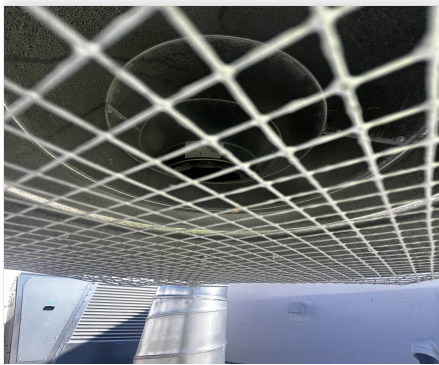
**Issue Name :** EF-1 & EF-2 Backdraft damper  
**Description :** Back draft damper is not installed. Recommend mechanical install as per plans. See plans MP0>14. Exhaust fans:> "B"  
**Created By :** National TAB                      **Assigned To :** National TAB - Kristopher Passley  
**Status :** Open  
**Priority :** High                                      **Asset Tag :**  
**Originated Date :** 12/12/2024 - Kristopher Passley - National TAB

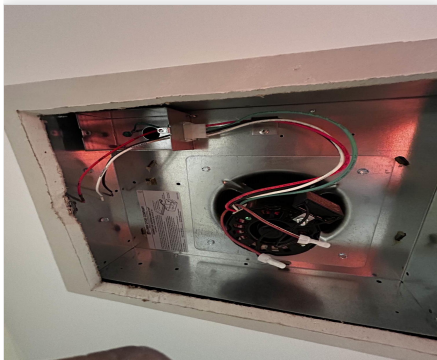
**Issue Name :** EF-2  
**Description :** EF-2 is not wired to power. Unable to balance unit until this is resolved.  
**Created By :** National TAB                      **Assigned To :** National TAB - Kristopher Passley  
**Status :** Closed  
**Priority :** Urgent                                      **Asset Tag :**  
**Originated Date :** 12/12/2024 - Kristopher Passley - National TAB

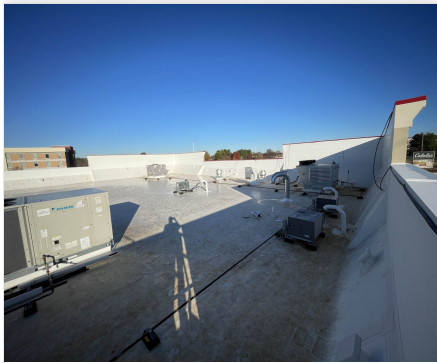
**Issue Name :** Gas Piping  
**Description :** See Plans MP0> 7. PIPING> H. NATURAL GAS> 2) GAS PIPING PAINTING  
All black steel gas piping located exterior to the building shall be primed and painted to either match adjacent exterior where located on or near exterior wall and painted safety yellow where located on the roof.  
**Created By :** National TAB                      **Assigned To :** National TAB - Kristopher Passley  
**Status :** Open  
**Priority :** Medium                                      **Asset Tag :**  
**Originated Date :** 12/12/2024 - Kristopher Passley - National TAB

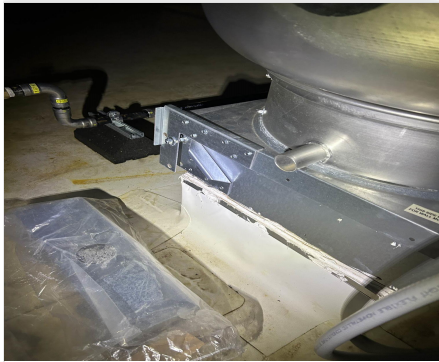
**Issue Name :** KEF-2 Grease Pan  
**Description :** Grease pan was not installed on KEF-2. Recommend having mechanical install.  
**Created By :** National TAB                      **Assigned To :** National TAB - Kristopher Passley  
**Status :** Open  
**Priority :** Medium                                      **Asset Tag :**  
**Originated Date :** 12/12/2024 - Kristopher Passley - National TAB

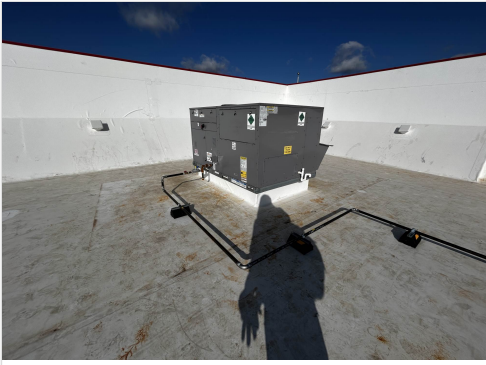
## Unit Data - PHOTO LOG

Unit Data		
	Design	Actual
MFG	CAPTIVEAIRE	CARRIER
Serial Num	-	4023P72927
Model Num	CASRTU3-1.400-18-15T	48FCDN14K3M5A3U3CO
Type	RTU	RTU
Configuration	VERTICAL	VERTICAL
Num OA Filters 1	-	1
OA Filter Size 1	-	19"X35"
Num Final Filter 1	-	4
Final Filter Size 1	-	20"X20"x2"

Test Data		
	Design	Actual
SF CFM	5000	4689
RA CFM	4100	3787
OA CFM	900	902
RL Voltage	-	210/211/212
RL Amperage	-	12.65/11.71/11.65
SF Rotation	-	CORRECT
SF System SetPt	-	
RA Damper Position	-	60%
Min OA Damper Position	-	40%
Min OA Damper Type	-	ECONOMIZER
OA Enthalpy Setpt	-	28 BTU/LB

Notes:  
NO DAMPERS AT FACE OF DIFFUSER OR TAKEOFFS.

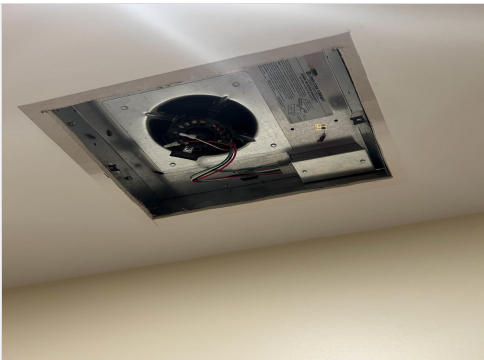
### Unit Data - PHOTO LOG

Unit Data		
	Design	Actual
MFG	COOK	LOREN COOK
Model Num	GC-184	GEMINI 160
Serial Num	-	
Type	CEILING	CEILING
Configuration	VERTICAL	VERTICAL

Test Data		
	Design	Actual
CFM	150	157
Fan RPM	-	895
Fan Rotation	-	CORRECT
Motor RPM	-	895
System SetPt	-	MAX
RL Voltage	-	120
RL Amperage	-	0.43
Total ESP	1/4"	0.215"
Fan Inlet SP	-	-0.215"
Fan Discharge SP	-	ATM

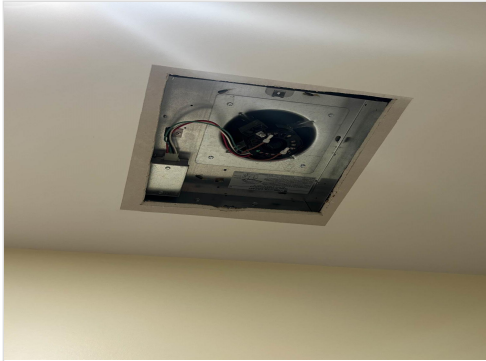
## Unit Data - PHOTO LOG

Unit Data		
	Design	Actual
MFG	COOK	LOREN COOK
Model Num	GC-184	GEMINI 160
Type	CEILING	CEILING
Configuration	VERTICAL	VERTICAL

Test Data		
	Design	Actual
CFM	-	141
Fan RPM	-	875
Fan Rotation	-	CORRECT
Motor RPM	-	875
System SetPt	-	MAX
RL Voltage	-	119
RL Amperage	-	0.42
Total ESP	-	0.241"
Fan Inlet SP	-	-0.242"
Fan Discharge SP	-	ATM

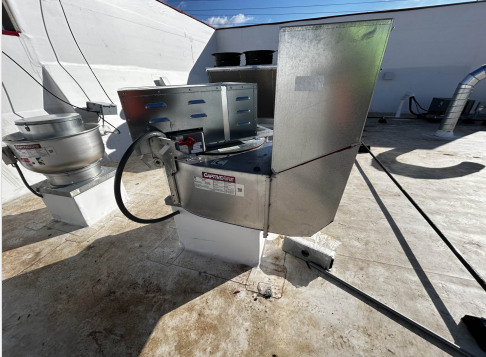
## Unit Data - PHOTO LOG

Unit Data		
	Design	Actual
MFG	COOK	CAPTIVEAIRE
Model Num	GC-184	CASRE18DD
Serial Num	-	5537600
Type	DOWNBLAST	UPBLAST
Configuration	VERTICAL	VERTICAL

Test Data		
	Design	Actual
CFM	1600	1579
Fan Rotation	-	CORRECT
System SetPt	-	53.7 HZ
RL Voltage	-	211/212/212
RL Amperage	-	2.79/2.78/2.81
Total ESP	1.500"	0.712"
Fan Inlet SP	-	-0.712"
Fan Discharge SP	-	ATM

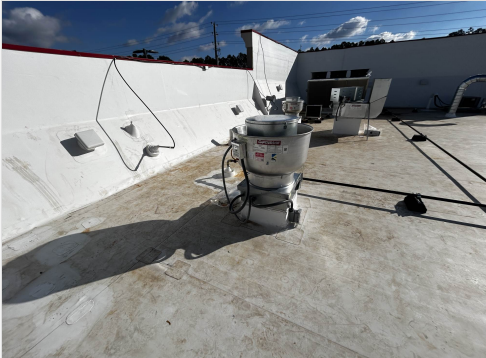
### Unit Data - PHOTO LOG

Unit Data		
	Design	Actual
MFG	COOK	CAPTIVEAIRE
Model Num	GC-184	DU50HFA
Serial Num	-	5537600
Type	UPBLAST	UPBLAST
Configuration	VERTICAL	VERTICAL

Test Data		
	Design	Actual
CFM	-	772
Fan Rotation	-	CORRECT
System SetPt	-	56%
RL Voltage	-	122
RL Amperage	-	2.3
Total ESP	-	0.550"
Fan Inlet SP	-	-0.550"
Fan Discharge SP	-	ATM

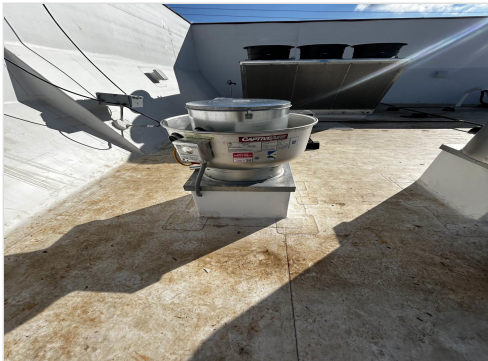
## Unit Data - PHOTO LOG

Unit Data		
	Design	Actual
MFG	COOK	CAPTIVEAIRE
Model Num	GC-184	DU33HFA
Serial Num	-	5537600
Type	UPBLAST	UPBLAST
Configuration	VERTICAL	VERTICAL

Test Data		
	Design	Actual
CFM	525	527
Fan RPM	-	948
Fan Rotation	-	CORRECT
Motor RPM	-	948
System SetPt	-	48%
RL Voltage	-	122
RL Amperage	-	.9
Total ESP	1/4"	0.130"
Fan Inlet SP	-	-0.130"
Fan Discharge SP	-	ATM

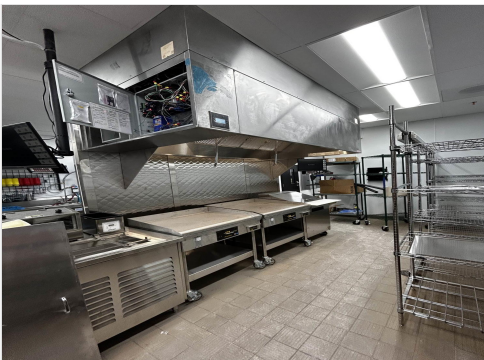
## Unit Data - PHOTO LOG

Unit Data		
	Design	Actual
MFG	CAPTIVEAIRE	CAPTIVEAIRE
Model Num	5424 ND-2	5424 ND-2
Job / Serial Num	-	5537600
Type	TYPE I CANOPY	TYPE I CANOPY
Hood length	96"	96"
Hood Width	54"	54"

Test Data Exhaust		
	Design	Actual
Filter Type	CAPTRATE SOLO FILTER	CAPTRATE SOLO FILTERS
Filter Size 1	16X16	16"X16"
Filter Qty 1	5	5
Filter AK factor size 1	1.62	1.62
Filter Total AK Area	8.1	8.1
Filter1 FPM	-	179
Filter2 FPM	-	205
Filter3 FPM	-	206
Filter4 FPM	-	206
Filter5 FPM	-	179
Filter Ave FPM(corr)	-	195
CFM	1600	1579

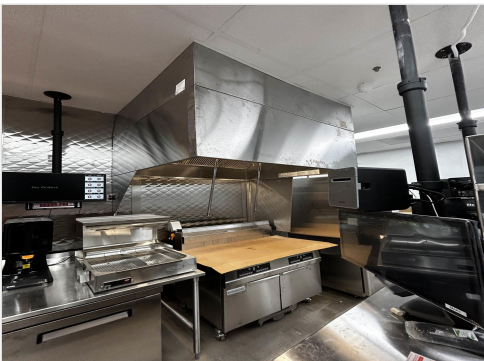
## Unit Data - PHOTO LOG

Unit Data		
	Design	Actual
MFG	CAPTIVEAIRE	CAPTIVEAIRE
Model Num	5424 ND-2	5424 ND-2
Job / Serial Num	-	5537600
Type	TYPE I CANOPY	TYPE I CANOPY
Hood length	60"	60"
Hood Width	54"	54"

Test Data Exhaust		
	Design	Actual
Filter Type	CAPTRATE SOLO FILTER	CAPTRATE SOLO FILTER
Filter Size 1	16X16	16"X16"
Filter Qty 1	3	3
Filter AK factor size 1	1.62	1.62
Filter Total AK Area	4.86	4.86
Filter1 FPM	-	161
Filter2 FPM	-	169
Filter3 FPM	-	147
Filter Ave FPM(corr)	-	159
CFM	775	772
