**Report: TAB REPORT**  
**Function: Test, Adjust, & Balance**  
**Date: 03/03/2026**  
**Completed By: National TAB**

**02-23-26 WAWA #6902 MARTINSBURG, WV**

HEDGESVILLE RD & ROCK CLIFF RD

MARTINSBURG, WV 25403

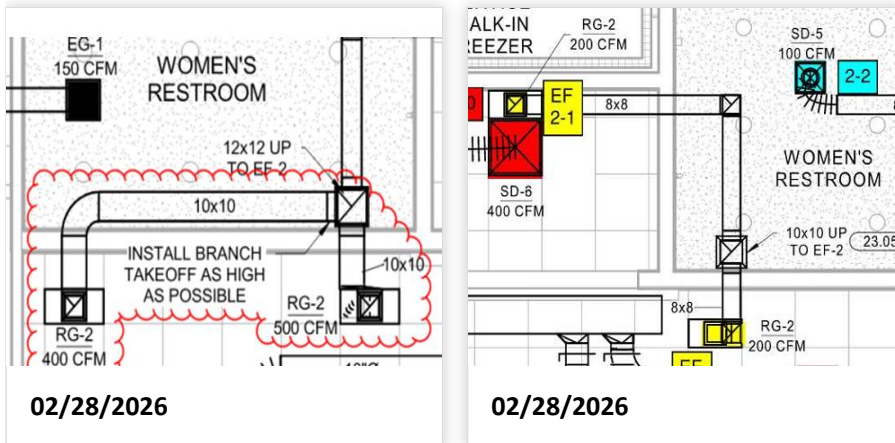
**Issue Name :** EF-2 Duct Drop Sizing  
**Description :** Duct going up to roof is 10"x10", needs to be 12"x12" as per change "CI-2025-090-M1".  
**Created By :** National TAB **Assigned To :** National TAB - Brianna Biggs  
**Status :** Open  
**Priority :** Medium **Asset Tag :** EF2  
**Originated Date :** 02/28/2026 - John Barresi - National TAB

Duct going up to roof is 10x10, needs to be 12x12 as per change "CI-2025-090-M1".

Given GRD does not have CI applied, showing 2 exhaust grilles for EF-2 instead of the 3 present in-store.

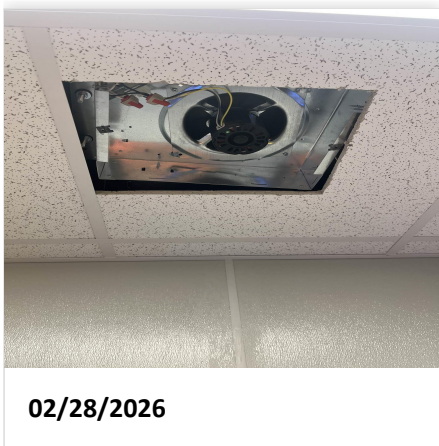
**Issue Name :** EF-3 Not Running  
**Description :** Not running at time of balance, missing grille cover. Unit is also missing a speed controller.  
**Created By :** National TAB                      **Assigned To :** National TAB - Brianna Biggs  
**Status :** Open  
**Priority :** High                                      **Asset Tag :** EF3  
**Originated Date :** 02/28/2026 - John Barresi - National TAB

Not running at time of balance, missing grille cover.

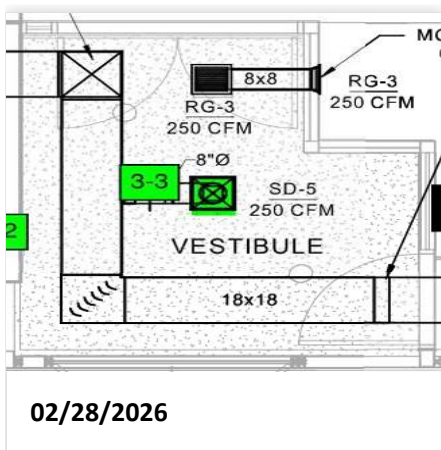
**Issue Name :** Front Vestibule Supply Grille  
**Description :** Cannot reach duct damper for Supply 3-3. Supply Grille 3-3 does not have a face damper installed.  
**Created By :** National TAB                      **Assigned To :** National TAB - Brianna Biggs  
**Status :** Open  
**Priority :** Medium                                      **Asset Tag :** RTU3  
**Originated Date :** 02/28/2026 - John Barresi - National TAB

Cannot reach duct damper for Supply 3-3; Supply grille does not have a face grille installed.
