# Final TAB Punchlist

**5774 Burlington (IA) FSU**

241 Legacy Dr, Burlington, Iowa

L1020005774

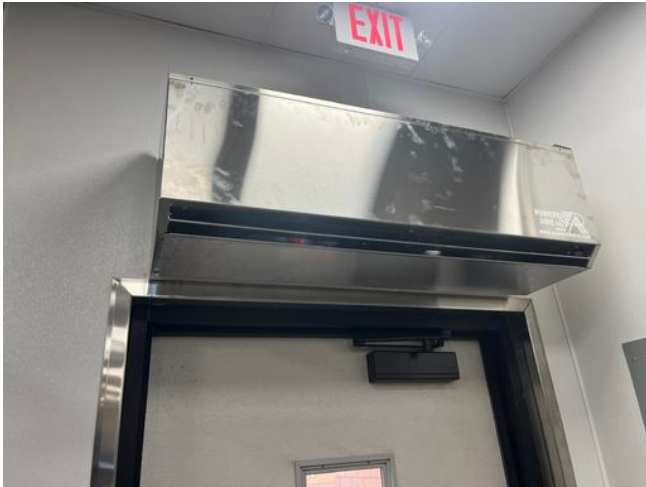
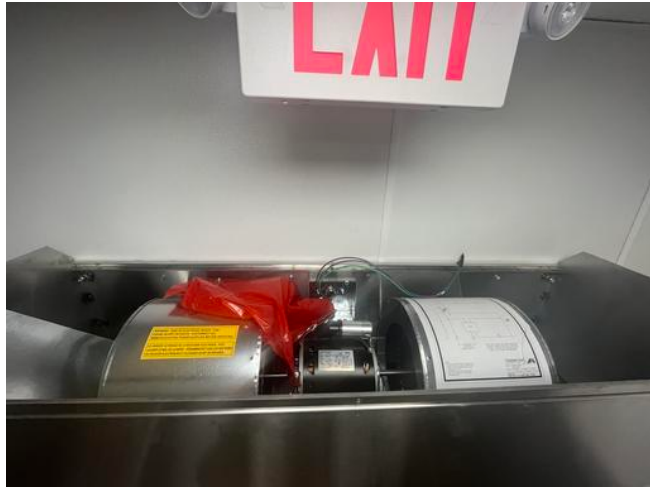
## #140 [CURT 501] [NEW] Air curtain power.

Air curtain power does not cycle properly from local disconnect at time of TAB inspection.

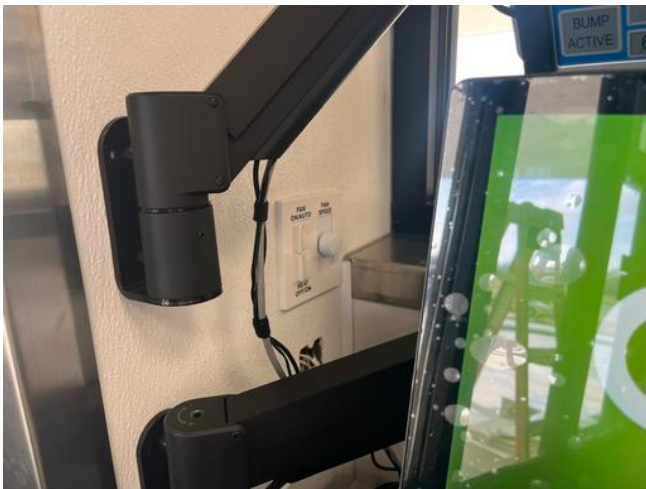
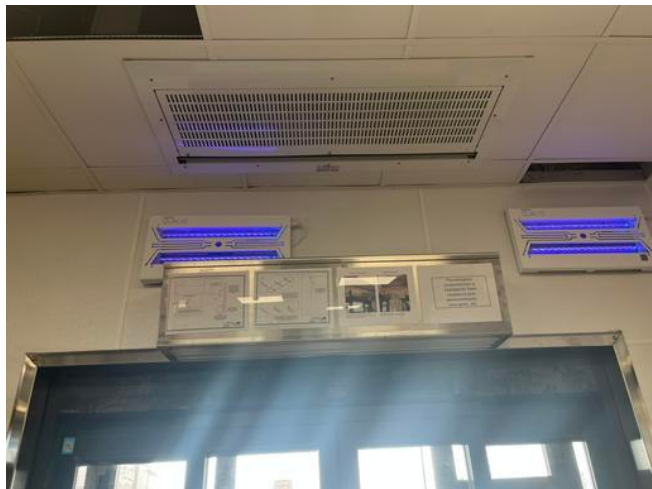
## #139 [CURT 503] [NEW] Air curtain door switches.

Air curtain magnetic door switches are not installed correctly or not properly controlling mode activation in Auto at time of TAB inspection.

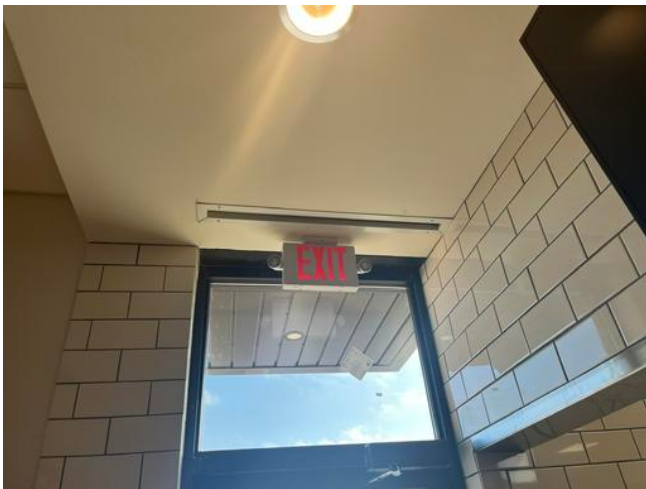
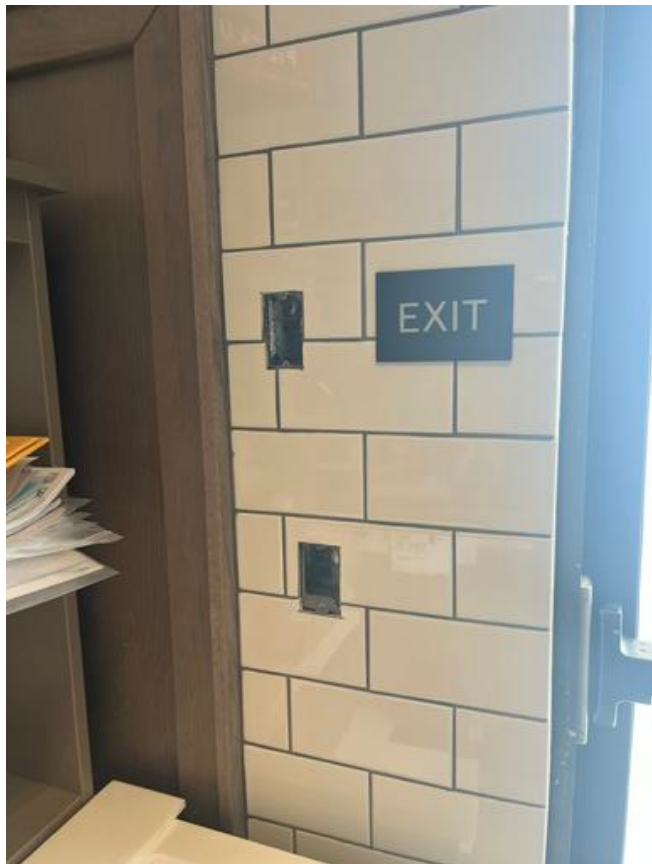
## #138 [CURT 505] [NEW] Air curtain remote switch installation.

Air curtain remote switches are not installed or do not control curtain functions properly between modes (fan on / auto, heat on / off) at time of TAB inspection.

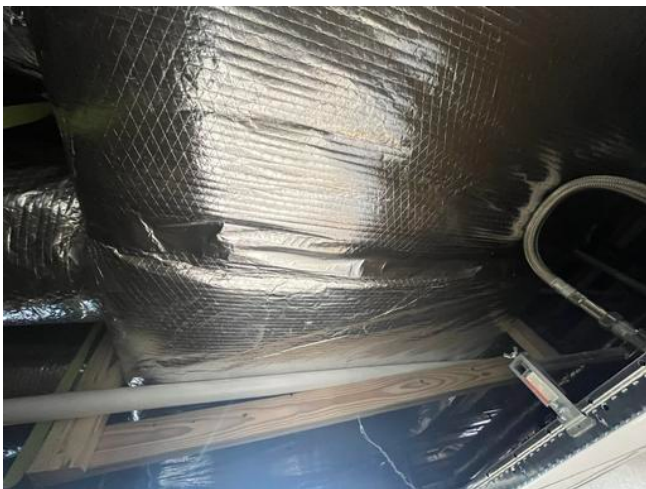
IMG\_0437

# #137 [DUCT 501] [NEW] Insulation stick pins.

External insulation on bottom of ducts 24" or wider is to be supported by stick pins 18" on center. Cut pins and apply tape or mastic over stick pin washers.

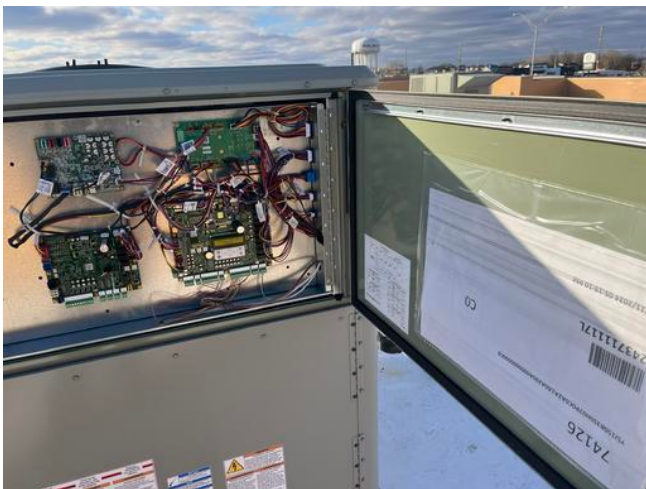
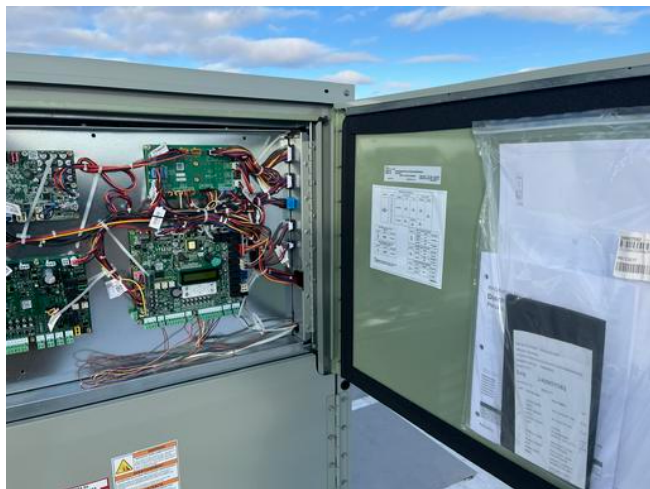
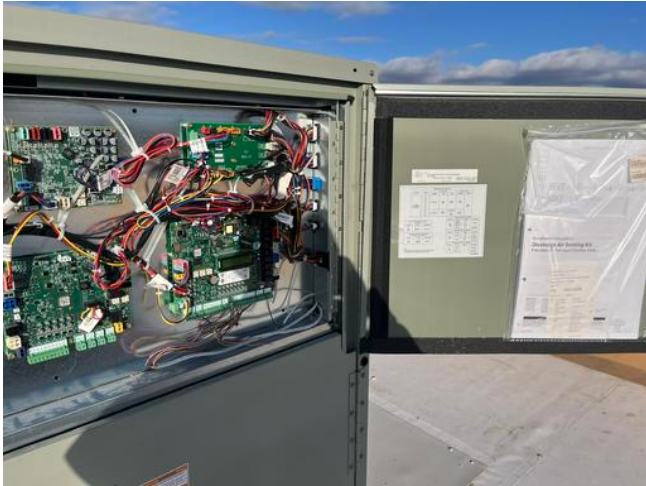
**#136 [UNIT 501] [NEW] Equipment low voltage diagrams**

Equipment missing  
laminated copy of controls  
detail low voltage wiring  
diagrams.

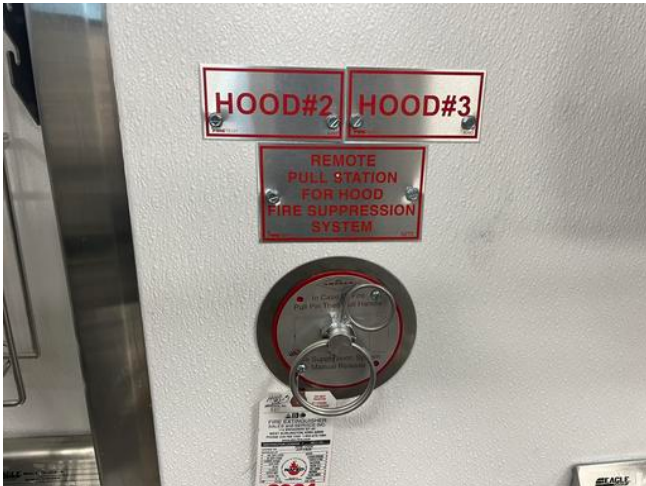
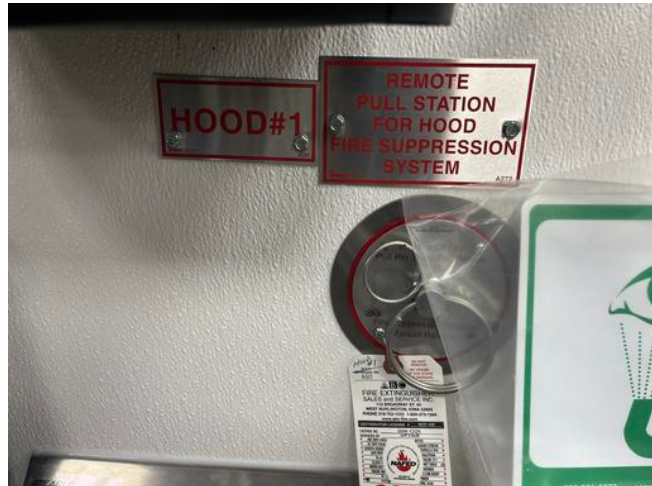
## #65 [CNTL 509] [NEW] Amerex pull labeling.

Label all Amerex pull stations for which hoods they serve. Per M-201 detail 1, label should be red bakelite label with 1/4" high white lettering indicating which hoods served.

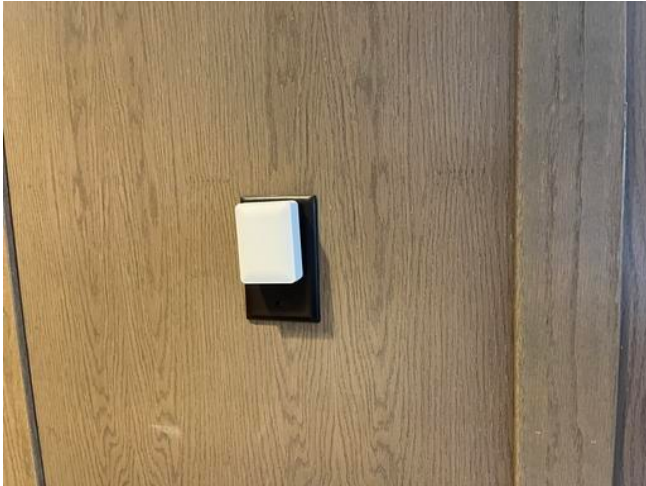
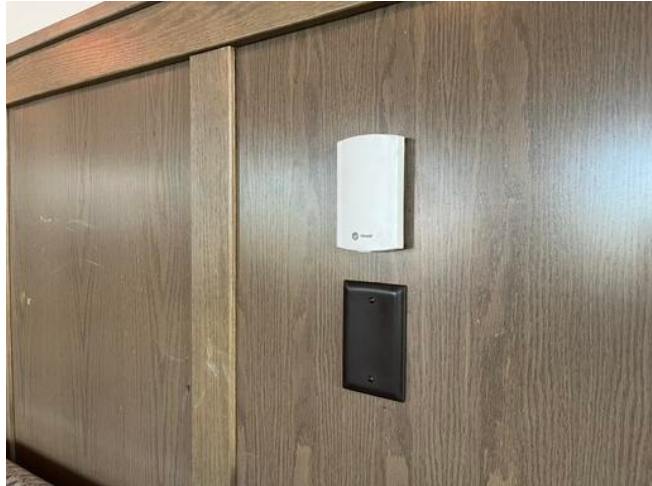
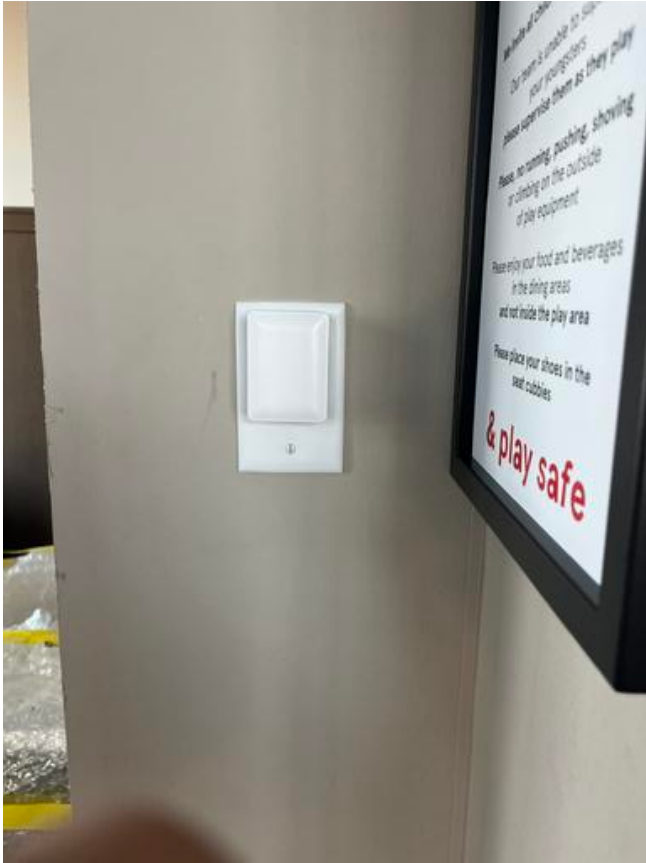
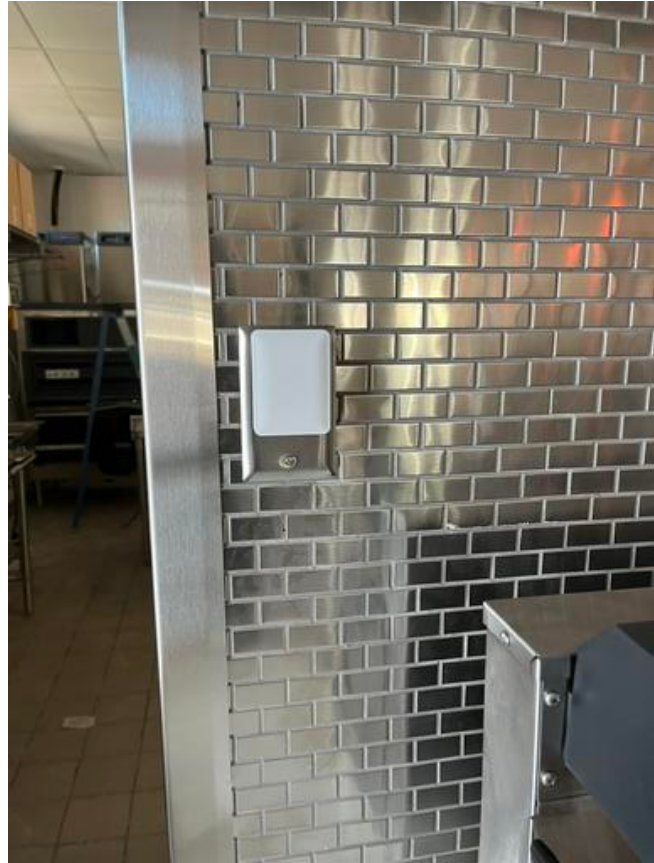
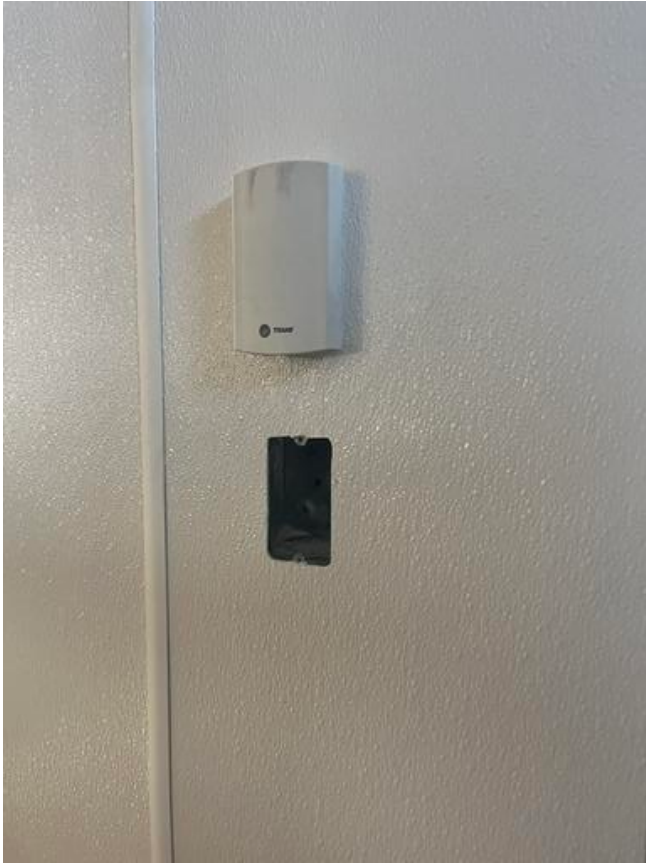
**#30 [CNTL 508] [NEW] Controls labeling.**

Label all sensors, humidistats, thermostats, smoke annunciators and remote space mounted OADs, MODs, VFD's for which piece of equipment they serve.

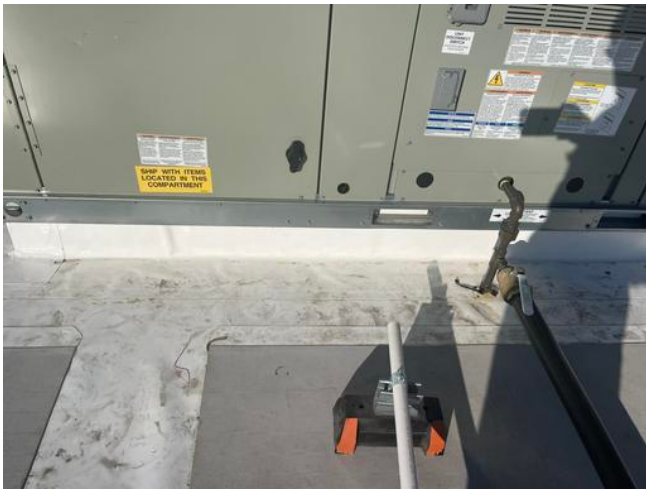
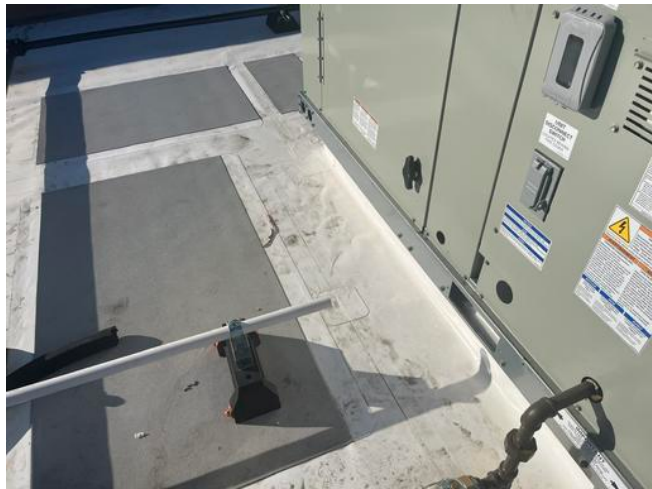
**#27 [UNIT 510] [NEW] Gas inlet grommet.**

AC gas inlet grommet is missing at the gas line/RTU penetration point on AC1 and AC3

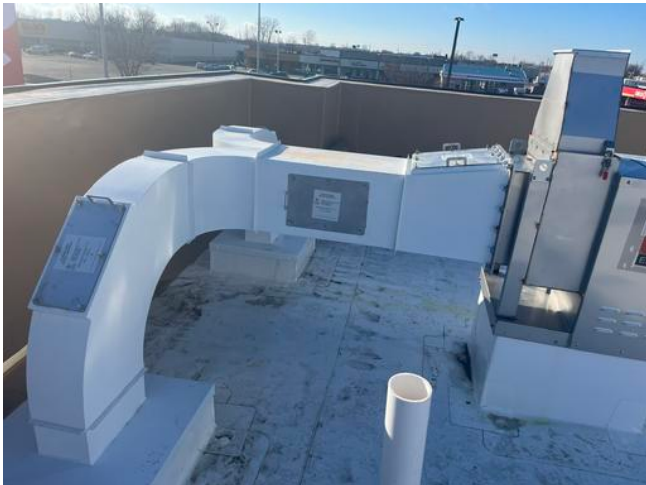
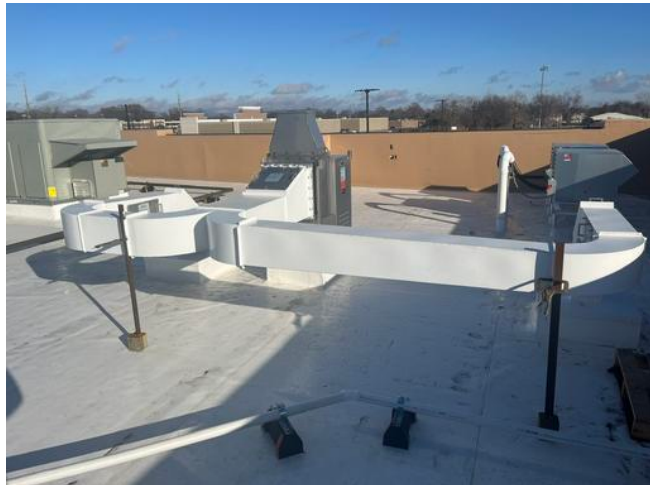
**#25 [EXHA 510] [NEW] Grease exhaust duct is not supported.**

Exhaust duct is to be supported per kitchen hood exhaust fan detail on 6'0" centers and at each drop into the space.

Stands are on order.

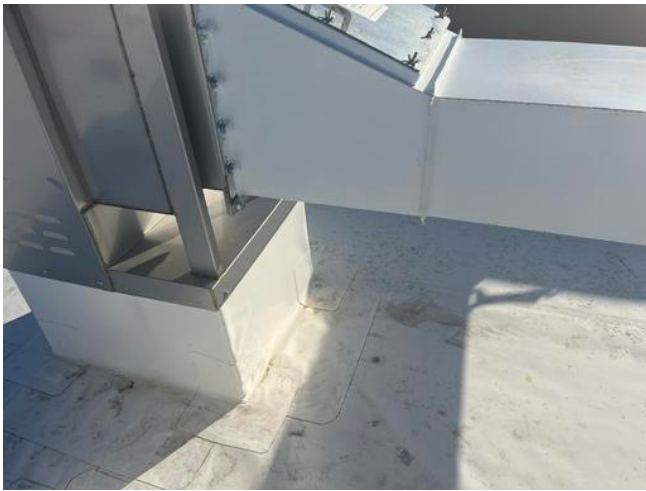
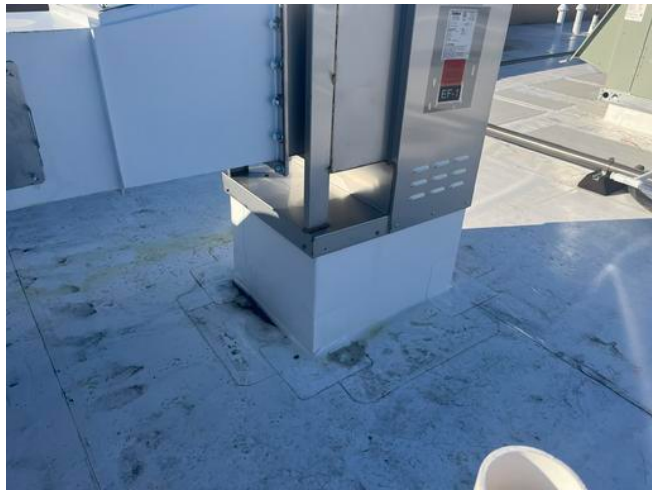
**#24 [EXHA 508] [NEW] Exhaust fan G2 Drip Guard**

Exhaust fan G2 Drip Guard is missing.
