**Report: TEST AND BALANCE**  
**Function: Test, Adjust, & Balance**  
**Date: 08/23/2023**

**PROJECT**  
**07-27-23 FREDDY'S - BARSTOW, CA**

BARSTOW, CA

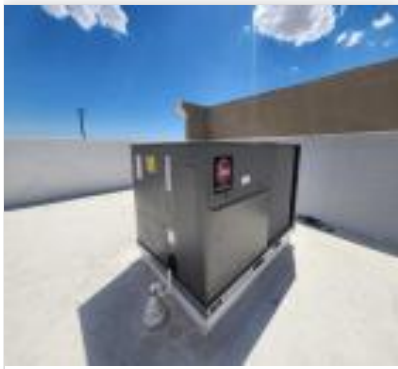
RTU-1

20230724\_145851  
07/26/2023

Asset: RTU1

AREA:DINING

Unit Data		
	Design	Actual
MFG	RHEEM	RHEEM
Serial Num	-	F4222201184
Model Num	RACDZT120ACH	RACDZT120ACH
Type	RTU	RTU
Configuration	VERTICAL	VERTICAL
Num Final Filter 1	-	4
Final Filter Size 1	-	20X20X2

Motor Data		
	Design	Actual
Motor MFG	-	PROTECH
Frame	-	NL
Horsepower	2	3
Motor Rpm	-	1725
Phase	3	3
Rated Voltage	208	208-230/460
Rated Amperage	-	9.0-9.2/4.6

Drive Data		
	Design	Actual
Motor Sheave Size	-	1VP60
Motor Bore Size	-	7/8"
Motor Sheave SetPt	-	1 TURN OPEN
Fan Sheave Size	-	8"
Fan Sheave Bore	-	1"
Belt CL Distance	-	17"
Num of Belts	-	1
Belt Size	-	A50
Belt Alignment	-	VERIFIED

Test Data		
	Design	Actual
SF CFM	4000	4073
SF RPM	-	972
RA CFM	3280	4073
OA CFM	720	0
RL Voltage	-	208/207/208
RL Amperage	-	7.2/7.1/7.2
SF Rotation	-	CCW
RA Damper Position	-	100%
Min OA Damper Position	-	0%
Min OA Damper Type	-	MOTORIZED
OA Enthalpy Setpt	-	N/A

Performance Data		
	Design	Actual
MA Plenum SP	-	-0.58"
Fan Suction SP	-	-1.05"
Fan Discharge SP	-	0.64"
Total ESP	1.0	1.22"
Fan Total SP	-	1.69"

General		
	Design	Actual
Fan Rotation Correct	-	YES
Unit Filters Clean	-	NO, CONSTRUCTION FILTERS
Condensate Drain Installed	-	YES

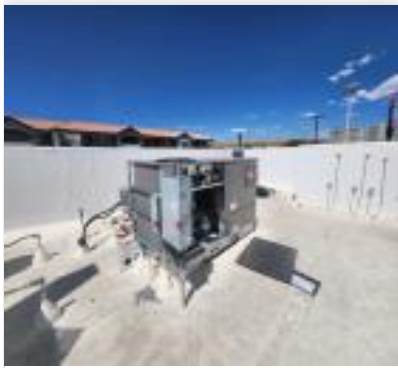
RTU-2

20230724\_145900  
07/26/2023

Asset: RTU2

AREA:KITCHEN

Unit Data		
	Design	Actual
MFG	RHEEM	RHEEM
Serial Num	-	F4222201185
Model Num	RACDZT120ACH	RACDZT120ACB
Type	RTU	RTU
Configuration	VERTICAL	VERTICAL
Num Final Filter 1	-	4
Final Filter Size 1	-	20X20X2

Motor Data		
	Design	Actual
Motor MFG	-	PROTECH
Frame	-	NL
Horsepower	5	3
Motor Rpm	-	1725
Phase	3	3
Rated Voltage	208	208-230/460
Rated Amperage	-	9.0-9.2/4.6

Drive Data		
	Design	Actual
Motor Sheave Size	-	3.5"
Motor Bore Size	-	3/4"
Motor Sheave SetPt	-	1 TURN OPEN
Fan Sheave Size	-	8"
Fan Sheave Bore	-	1"
Belt CL Distance	-	17
Num of Belts	-	1
Belt Size	-	A50
Belt Alignment	-	VERIFIED

Test Data		
	Design	Actual
SF CFM	4000	3917
SF RPM	-	981
RA CFM	3280	3917
OA CFM	720	0
RL Voltage	-	208/209/210
RL Amperage	-	7.4/7.3/7.3
SF Rotation	-	CCW
RA Damper Position	-	100%
Min OA Damper Position	-	0%
Min OA Damper Type	-	MOTORIZED
OA Enthalpy Setpt	-	N/A

Performance Data		
	Design	Actual
MA Plenum SP	-	-0.57"
Fan Suction SP	-	-0.97"
Fan Discharge SP	-	0.54"
Total ESP	1.0	1.11"
Fan Total SP	-	1.51"

General		
	Design	Actual
Fan Rotation Correct	-	YES
Unit Filters Clean	-	NO, CONSTRUCTION FILTERS
Condensate Drain Installed	-	YES

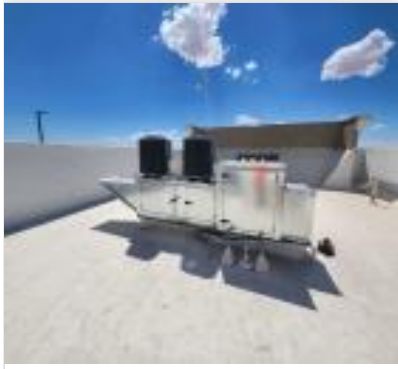
MAU-1

20230724\_145841  
07/26/2023

Asset: MUA1

AREA:KITCHEN HOODS

Unit Data		
	Design	Actual
MFG	CAPTIVEAIRE	CAPTIVEAIRE
Model Num	A1-D.250-15D-MPU	A1-D.500-15D-MPU
Serial Num	-	5
Type	MUA	MUA
Configuration	Vertical	VERTICAL

Motor Data		
	Design	Actual
Motor MFG	-	TECO
Frame	-	145T
Horsepower	3.000	3
Motor Rpm	-	3480
Phase	3	3
Voltage (rated)	208	230/460
Amperage (rated)	-	7.64/3.82
Service Factor	-	1.15

Gas Heat		
	Design	Actual
Heater Operates (y/n)	-	YES
Flame Status (pass/fail)	-	PASS
Inlet Air Temp SetPt	55	55
Discharge Air Temp SetPt	60	60
Air Flow Switch SP Actual	-	0.47"

Test Data		
	Design	Actual
CFM	2250	2269
SF RPM	2176	2662
Motor RPM	-	2948
SF System SetPt	-	36.6
RL Voltage	-	209/210/209
RL Amperage	-	5.8/5.7/5.87
Total ESP	-	NA
Fan Discharge SP	-	NA

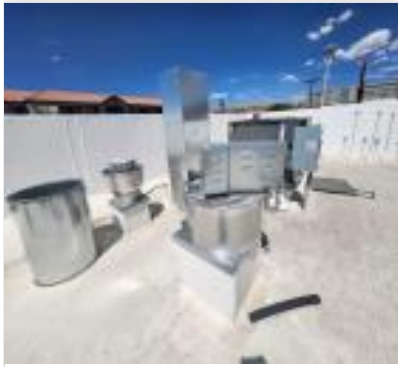
EF-1

KEF-1

Asset: KEF1

AREA:GRIDDLE

Unit Data		
	Design	Actual
MFG	COOK	CAPTIVEAIRE
Model Num	GC-146	CASRE18DD
Serial Num	-	5195411
Type	UTILITY	UTILITY
Configuration	Vertical	VERTICAL

Motor Data		
	Design	Actual
Motor MFG	-	TECO
Frame	-	145T
Horsepower	1.000	1
Motor Rpm	-	1150
Phase	3	3
Voltage (rated)	208	230/460
Amperage (rated)	-	3.44/1.72
Service Factor	-	1.15

Test Data		
	Design	Actual
CFM	1600	1596
Fan RPM	1105	961
Fan Rotation	-	CCW
Motor RPM	-	961
System SetPt	-	62.7HZ
RL Voltage	-	208/208/207
RL Amperage	-	3.06/3.07/3.06
Total ESP	1.400	0.79"
Fan Inlet SP	-	-0.79"
Fan Discharge SP	-	ATM

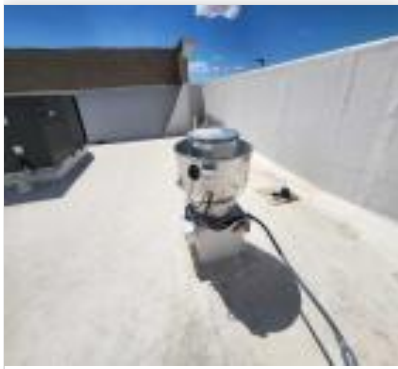
EF-2

KEF-2

Asset: KEF2

AREA:FRYER

Unit Data		
	Design	Actual
MFG	COOK	CAPTIVEAIRE
Model Num	GC-146	DU50HFA
Serial Num	-	5195411
Type	Upblast/Ceiling	UPBLAST
Configuration	Vertical	VERTICAL

Motor Data		
	Design	Actual
Motor MFG	-	TELCO GREEN
Frame	-	NA
Horsepower	0.500	0.5
Motor Rpm	-	2000
Phase	1	1
Voltage (rated)	115V	115
Amperage (rated)	-	6.3
Service Factor	-	1.15

Test Data		
	Design	Actual
CFM	775	802
Fan RPM	1532	1700
Fan Rotation	-	CCW
Motor RPM	-	1700
System SetPt	-	85%
RL Voltage	-	120
RL Amperage	-	6.3
Total ESP	1250	0.53"
Fan Inlet SP	-	-0.53"
Fan Discharge SP	-	ATM

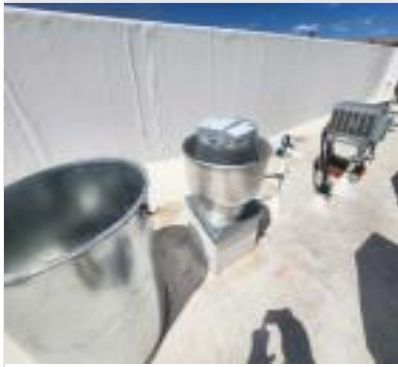
EF-3

KEF-3

Asset: KEF3

AREA: DISHWASHER

Unit Data		
	Design	Actual
MFG	CAPTIVEAIRE	CAPTIVEAIRE
Model Num	DU33HFA	DU33HFA
Serial Num	-	5195411
Type	UPBLAST/CEILING	UPBLAST
Configuration	VERTICAL	VERTICAL

Motor Data		
	Design	Actual
Motor MFG	-	TELCO GREEN
Frame	-	NL
Horsepower	0.33	0.33
Motor Rpm	-	2000
Phase	1	1
Voltage (rated)	115	115
Amperage (rated)	-	4.3
Service Factor	-	1.15

Test Data		
	Design	Actual
CFM	525	515
Fan RPM	1500	1540
Fan Rotation	-	CCW
Motor RPM	-	1540
System SetPt	-	77
RL Voltage	-	120
RL Amperage	-	2.38
Total ESP	0.800	0.49"
Fan Inlet SP	-	-0.49"
Fan Discharge SP	-	ATM

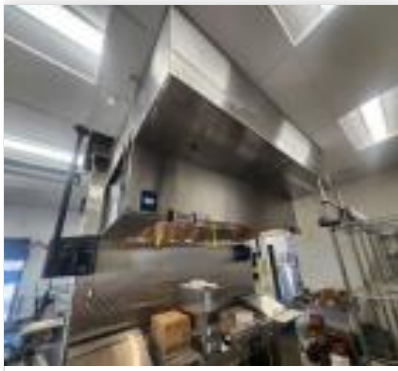
HOOD-1

20230724\_145620  
07/26/2023

Asset: HD1

AREA:GRIDDLE

Unit Data		
	Design	Actual
MFG	CAPTIVEAIRE	CAPTIVEAIRE
Model Num	5424 ND-2-ACPSP-F	5424 ND-2-ACPSP-F
Job / Serial Num	-	5195411
Type	TYPE I CANOPY	TYPE I CANOPY
Hood length	96"	96"
Hood Width	54"	54"
Supply Plenum Type	-	PERFORATED
Supply Plenum Width	12"	12"
Supply Plenum Length	108"	108"

Test Data Exhaust		
	Design	Actual
Filter Type	Captrate Solo	CAPTRATE SOLO
Filter Size 1	16x16	16X16
Filter Qty 1	5	5
Filter AK factor size 1	1.62	1.62
Filter Total AK Area	8.1	8.1
Filter1 FPM	-	194
Filter2 FPM	-	205
Filter3 FPM	-	195
Filter4 FPM	-	211
Filter5 FPM	-	184
Filter Ave FPM(corr)	-	197
CFM	1600	1596

Test Data Supply		
	Design	Actual
Total AK Area	10.5	10.5
Kv factor (Vel)	0.89	0.89
Num of Readings	-	8
Reading1 FPM	-	133
Reading2 FPM	-	147
Reading3 FPM	-	127
Reading4 FPM	-	137
Reading5 FPM	-	143
Reading6 FPM	-	110
Reading7 FPM	-	129
Reading8 FPM	-	118
Ave FPM(corr)	-	130
CFM	1600	1218

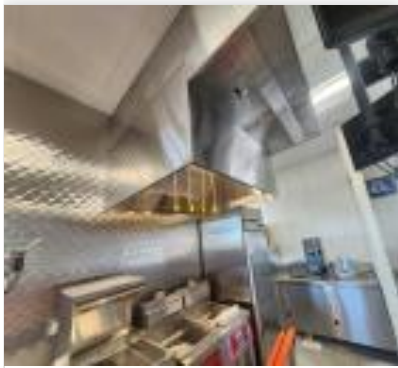
HOOD-2

20230724\_145626  
07/26/2023

Asset: HD2

AREA:FRYER

Unit Data		
	Design	Actual
MFG	CAPTIVEAIRE	CAPTIVEAIRE
Model Num	5424 ND-2-ACPSP-F	5424 ND-2-ACPSP-F
Job / Serial Num	-	5195411
Type	TYPE 1 CANOPY	TYPE I CANOPY
Hood length	60"	60"
Hood Width	54"	54"
Supply Plenum Type	-	PERFORATED
Supply Plenum Width	12"	12"
Supply Plenum Length	60"	60"

Test Data Supply		
	Design	Actual
Total AK Area	5	5
Kv factor (Vel)	0.87	0.87
Num of Readings	-	4
Reading1 FPM	-	233
Reading2 FPM	-	250
Reading3 FPM	-	264
Reading4 FPM	-	221
Ave FPM(corr)	-	241.6
CFM	620	1051

Test Data Exhaust		
	Design	Actual
Filter Type	Captrate Solo	CAPTRATE SOLO
Filter Size 1	16x16	16X16
Filter Qty 1	3	3
Filter AK factor size 1	1.62	1.62
Filter Total AK Area	4.86	4.86
Filter1 FPM	-	157
Filter2 FPM	-	177
Filter3 FPM	-	161
Filter Ave FPM(corr)	-	165
CFM	775	802

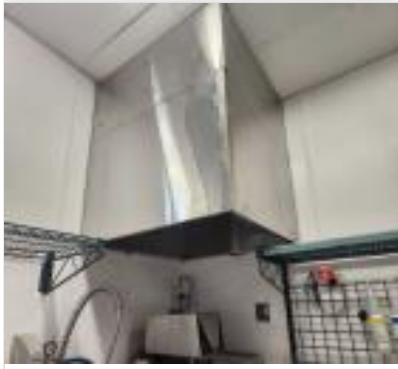
HOOD-3

**20230724\_145607**  
**07/26/2023**

Asset: HD(Type2)3

AREA:DISHWASHER

Unit Data		
	Design	Actual
MFG	CAPTIVEAIRE	CAPTIVEAIRE
Model Num	4224 VHB-G	4224 VHB-G
Serial Num	-	5195411
Type	-	TYPE II
Hood length	42	42"
Hood Width	42	42"
Num of Exhaust Risers	-	1

Test Data		
	Design	Actual
Exhaust VEL(corr)	-	945
Exhaust CFM	525	515
