Report: TAB REPORT
Function: Test, Adjust, & Balance
Date: 04/17/2024

PROJECT
04-08-24 CAVA MONTGOMERY, AL
(EASTCHASE)

Project: 04-08-24 CAVA MONTGOMERY, AL (EASTCHASE)

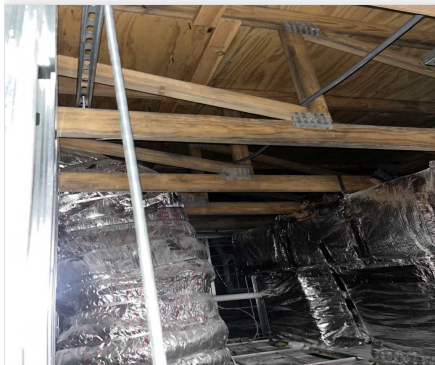
B5CBEA2E_9AB3_4854_B1..
04/16/2024

Issue Name : Hood / Grease Cleanout Door
Description : Hood grease duct is not accessible due to hard ceiling unable visually see grease cleanout door installed on the grease duct. Request that the mechanical provide a picture of the grease door location and door size.
Created By : National TAB **Assigned To :** National TAB - Brianna Biggs
Status : Open
Priority : High **Asset Tag :**
Originated Date : 04/16/2024 - Dale Wheeler - National TAB

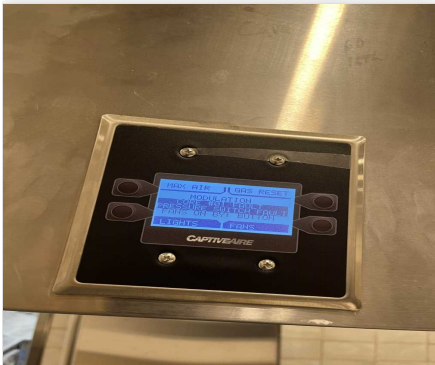
83BCFE20_64E7_4665_B3..
04/15/2024

Issue Name : Hood / HMI Screen Fault
Description : Hood HMI screen has a fault reading core #01 low pressure switch.
Created By : National TAB **Assigned To :** National TAB - Brianna Biggs
Status : Open
Priority : Urgent **Asset Tag :**
Originated Date : 04/15/2024 - Dale Wheeler - National TAB

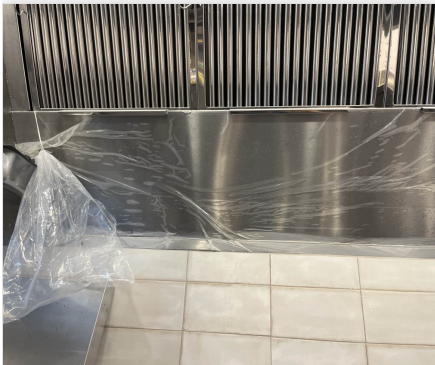
image
04/15/2024

Issue Name : Hood / Protective Plastic
Description : Hoods protective plastic needs to be removed from all parts of the hood.
Created By : National TAB **Assigned To :** National TAB - Brianna Biggs
Status : Open
Priority : Medium **Asset Tag :**
Originated Date : 04/15/2024 - Dale Wheeler - National TAB

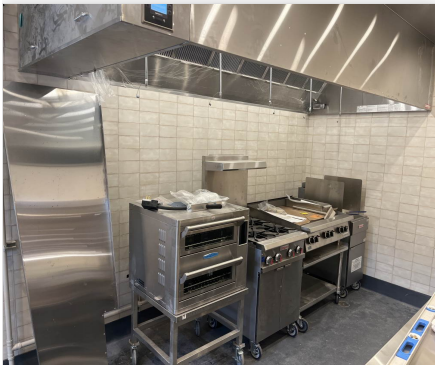
image
04/15/2024

Issue Name : Hood / Side Panel
Description : Hood side panel is not installed.
Created By : National TAB **Assigned To :** National TAB - Brianna Biggs
Status : Open
Priority : Medium **Asset Tag :**
Originated Date : 04/15/2024 - Dale Wheeler - National TAB

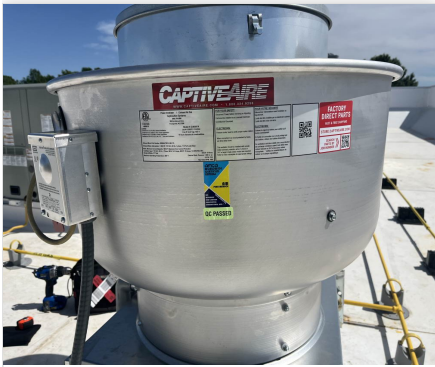
IMG_0242
04/15/2024

Issue Name : KEF1 / Identification Tag
Description : KEF1 is missing identification tag on fan disconnect.
Created By : National TAB **Assigned To :** National TAB - Brianna Biggs
Status : Open
Priority : Medium **Asset Tag :** KEF1
Originated Date : 04/15/2024 - RJ Cervantes - National TAB

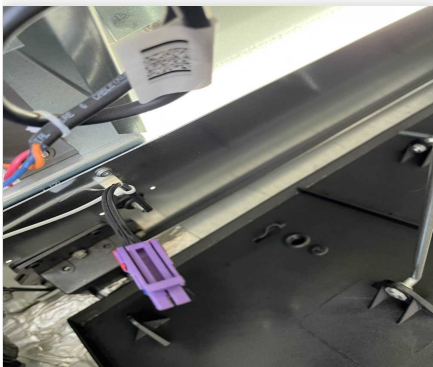
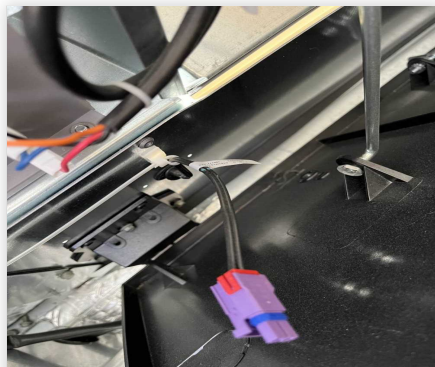
Issue Name : RTU1 & RTU3 / Enthalpy Sensor
Description : RTU1 & RTU3 enthalpy sensor is not operational. Recommend sensor be plugged in to the correct terminal.
Created By : National TAB **Assigned To :** National TAB - Brianna Biggs
Status : Open
Priority : High **Asset Tag :**
Originated Date : 04/15/2024 - Dale Wheeler - National TAB

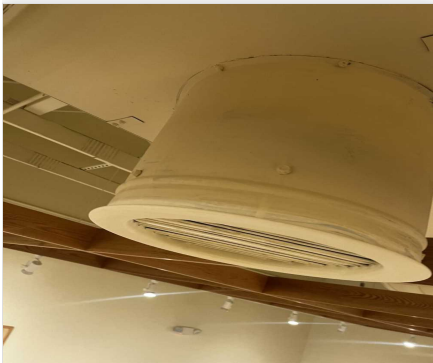
A396CEA6_F045_4132_8D..
04/15/2024

Issue Name : RTU1 / Missing Damper
Description : RTU1 SGRD7 damper is missing, unable to balance diffuser to within design CFM. Recommend having damper installed.
Created By : National TAB **Assigned To :** National TAB - David Annan
Status : Open
Priority : High **Asset Tag :**
Originated Date : 04/15/2024 - David Annan - National TAB

Asset									
Asset Name	Location	Type	Size	DESIGN CFM	AK	CFM(1)	CFM(2)	FINAL CFM	% to design
SGRD1	DINING	D	10"	350	0.73	362	266	266	76.0
SGRD2	DINING	D	10"	350	0.73	214	271	271	77.4
SGRD3	DINING	D	10"	350	0.73	331	352	352	100.6
SGRD4	DINING	D	12"	400	1.4	443	422	422	105.5
SGRD5	DINING	D	12"	400	1.4	471	427	427	106.8
SGRD6	DINING	D	12"	400	1.4	429	416	416	104.0
SGRD7	DINING	D	12"	450	1.4	603	692	692	153.8
Total				2700		2853	2846	2846	105.41%

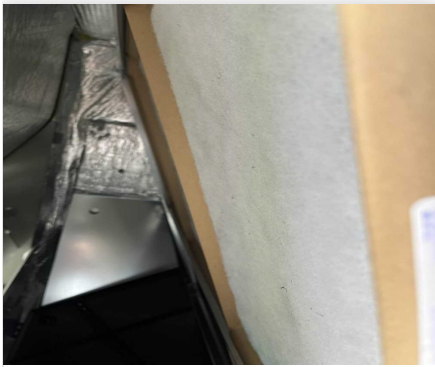
BB131DDC_EBEF_465D_88..
04/15/2024

Issue Name : RTU1, RTU2, RTU3 / Construction Filters
Description : RTU1, RTU2, RTU3 construction filters are installed. Merv 8 pleated filters should be installed on all units.
Created By : National TAB **Assigned To :** National TAB - Brianna Biggs
Status : Open
Priority : Medium **Asset Tag :**
Originated Date : 04/15/2024 - Dale Wheeler - National TAB

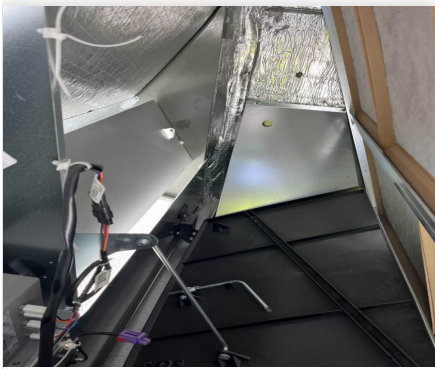
4A3B36BF_AE5E_44E3_88..
04/16/2024

Issue Name : RTU1, RTU2, RTU3 / Economizers
Description : RTU1, RTU2, RTU3 economizers do not close when thermostats are placed into unoccupied mode.
Created By : National TAB **Assigned To :** National TAB - Brianna Biggs
Status : Open
Priority : High **Asset Tag :**
Originated Date : 04/16/2024 - Dale Wheeler - National TAB

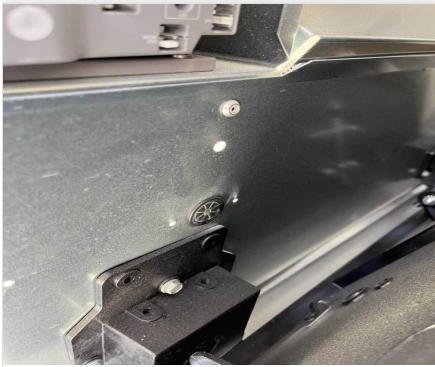
4593485D_5D90_4131_A6..
04/15/2024

Issue Name : RTU2 / Enthalpy Sensor
Description : RTU2 enthalpy sensor is not installed. Recommend sensor be installed.
Created By : National TAB **Assigned To :** National TAB - Brianna Biggs
Status : Open
Priority : Urgent **Asset Tag :**
Originated Date : 04/15/2024 - Dale Wheeler - National TAB

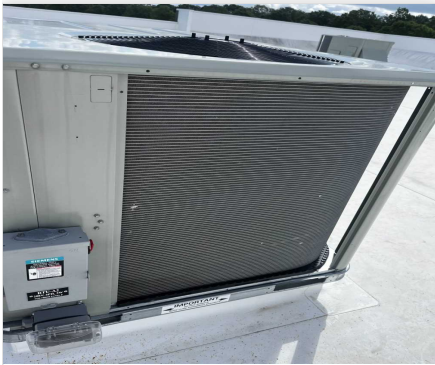
D2BE4874_565E_416D_B4..
04/15/2024

Issue Name : RTU2 / Hail Guards
Description : RTU2 hail guards are not installed. Recommend having hail guards installed.
Created By : National TAB **Assigned To :** National TAB - David Annan
Status : Open
Priority : Medium **Asset Tag :**
Originated Date : 04/15/2024 - David Annan - National TAB
