Report: TAB Report
Function: Test, Adjust, & Balance
Date: 12/02/2025
Completed By: National TAB

11-24-25 CHIPOTLE #5571 MIDDLEBURG, FL

1694 BLANDING BLVD

Project: 11-24-25 CHIPOTLE #5571 MIDDLEBURG, FL

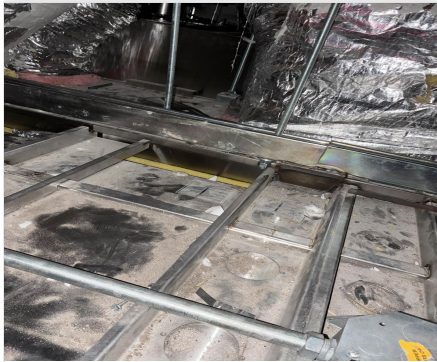
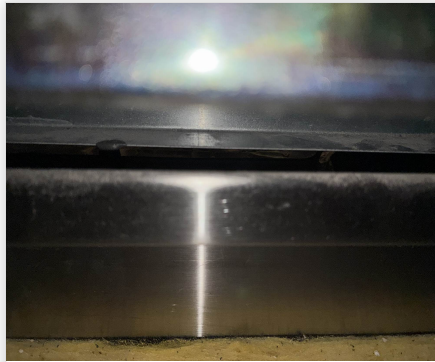
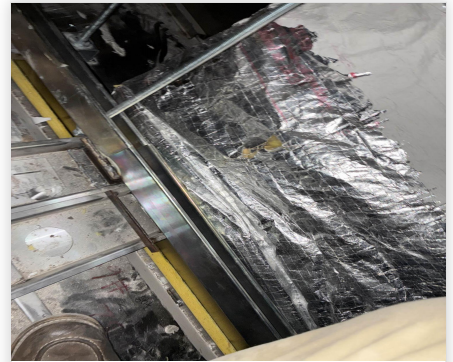
Issue Name : MAU leak above hood
Description : There is a moderate air leak where the middle PSP riser joins to the hood.
Created By : National TAB **Assigned To :** National TAB - Dan Hertenstein
Status : Open
Priority : Urgent **Asset Tag :**
Originated Date : 11/26/2025 - Jackson Gunnels - National TAB

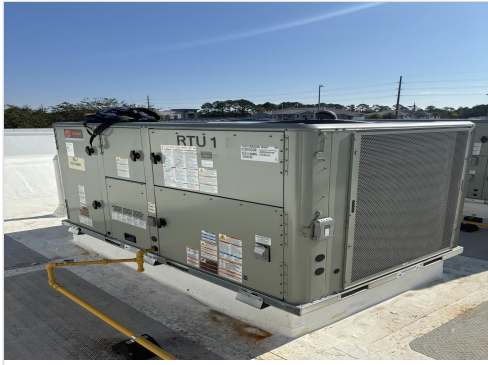
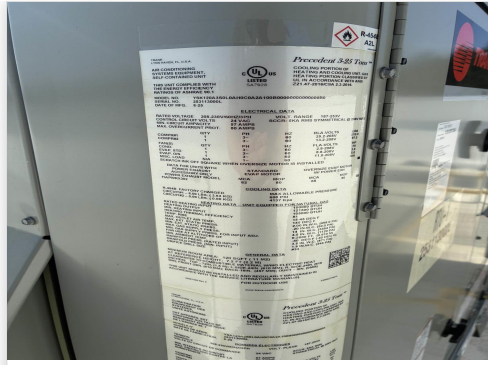
Unit Data - PHOTO LOG

Unit Data		
	Design	Actual
MFG	TRANE	TRANE
Serial Num	-	25133000L
Model Num	YSJ120	YSJ120A3SOL0AH0C0A2A1
Type	RTU	RTU
Configuration	VERTICAL	VERTICAL
Num OA Filters 1	-	1
OA Filter Size 1	-	36X14.25
Num Final Filter 1	-	3
Final Filter Size 1	-	16X20X2
Num Final Filter 2	-	2
Final Filter Size 2	-	18X20X2

Test Data		
	Design	Actual
SF CFM	3500	3501
SF RPM	-	1263
RA CFM	3000	2981
OA CFM	500	518
RL Voltage	-	204/207/206
RL Amperage	8.8	3.5/3.5/3.5
SF Rotation	-	CORRECT
SF System SetPt	-	68.3
RA Damper Position	-	90%
Min OA Damper Position	-	10%
Min OA Damper Type	-	ECONOMIZER
OA Enthalpy Setpt	-	28 BTU/LB

Performance Data		
	Design	Actual
MA Plenum SP	-	-0.52"
Fan Suction SP	-	-0.89"
Fan Discharge SP	-	0.78"
Total ESP	0.80"	1.3
Fan Total SP	-	1.67

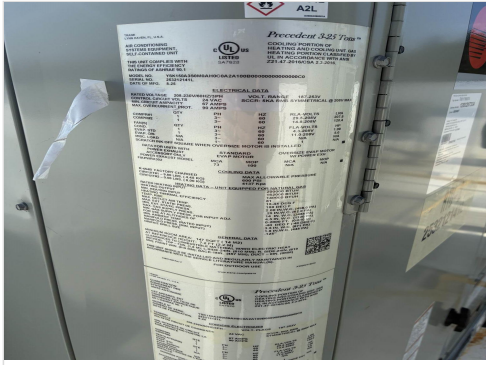
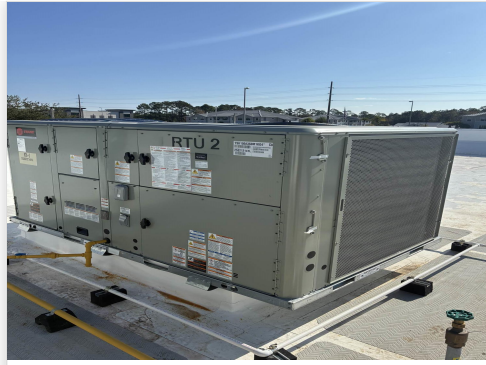
Unit Data - PHOTO LOG

Unit Data		
	Design	Actual
MFG	TRANE	TRANE
Serial Num	-	25312141L
Model Num	YSJ150	YSJ150A3S0M0AH0C0A2A100B
Type	RTU	RTU
Configuration	VERTICAL	VERTICAL
Num OA Filters 1	-	1
OA Filter Size 1	-	36X14.25
Num Final Filter 1	-	3
Final Filter Size 1	-	16X20X2
Num Final Filter 2	-	2
Final Filter Size 2	-	18X20X2

Test Data		
	Design	Actual
SF CFM	4400	4394
SF RPM	-	1322
RA CFM	3400	4268
OA CFM	1000	126
RL Voltage	-	205/206/206
RL Amperage	-	4.25/4.15/4.21
SF Rotation	-	CORRECT
SF System SetPt	-	68.1
RA Damper Position	-	100
Min OA Damper Position	-	0
Min OA Damper Type	-	ECONOMIZER
OA Enthalpy Setpt	-	28 BTU/LB

Performance Data		
	Design	Actual
MA Plenum SP	-	-0.54"
Fan Suction SP	-	-0.84
Fan Discharge SP	-	0.64"
Total ESP	0.80"	1.18"
Fan Total SP	-	1.48"

Notes:
Economizer non-functional

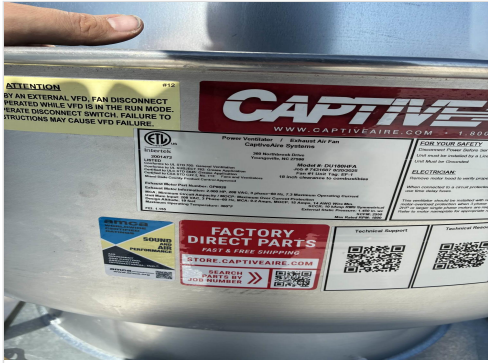
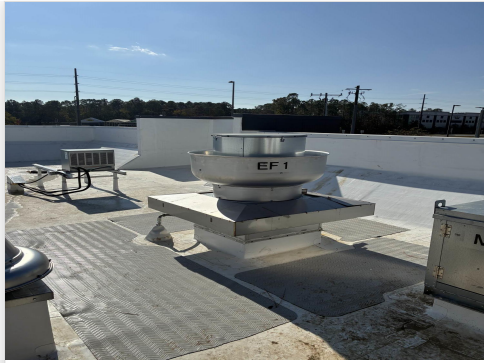
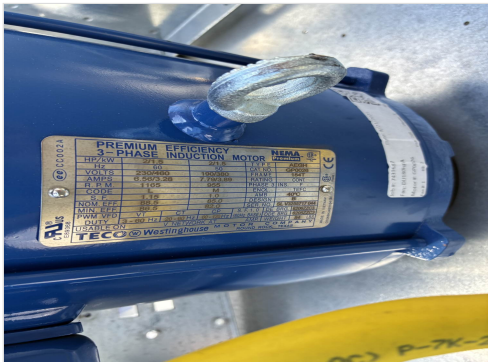
Unit Data		
	Design	Actual
MFG	CAPTIVE-AIRE	CAPTIVE-AIRE
Model Num	DU180HFA	DU180HFA
Serial Num	-	7431687
Type	UPBLAST	CENTRIFUGAL
Configuration	VERTICAL	UPBLAST

Motor Data		
	Design	Actual
Motor MFG	-	TECO- WESTINGHOUSE
Frame	-	184T
Horsepower	2.00	2.00
Motor Rpm	-	1165
Phase	3	3
Voltage (rated)	208	230
Amperage (rated)	-	6.56
Service Factor	-	1.15

Test Data		
	Design	Actual
CFM	2550	2479
Fan RPM	1220	1133
Fan Rotation	-	CCW
Motor RPM	-	DIRECT DRIVE
System SetPt	-	55.7
RL Voltage	-	121
RL Amperage	-	5.2
Total ESP	1.450"	0.91"
Fan Inlet SP	-	-0.91"
Fan Discharge SP	-	ATM"

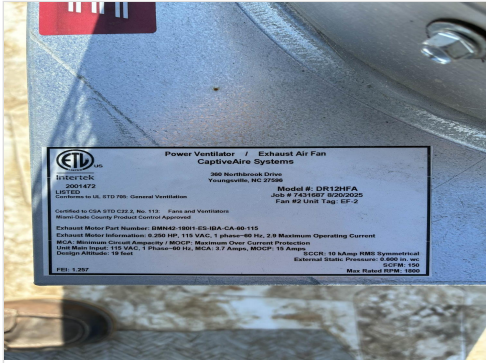
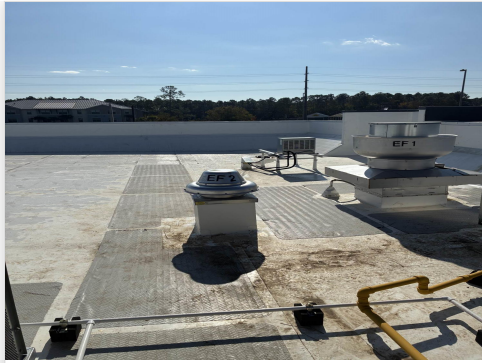
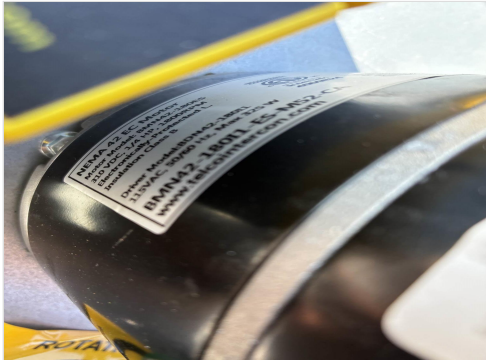
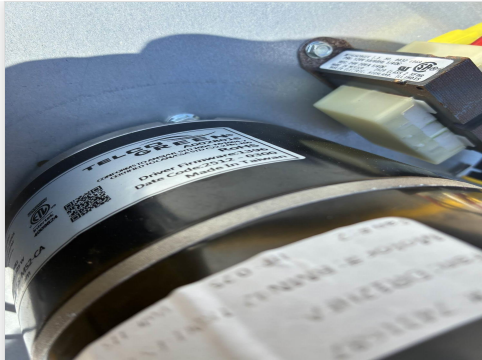
Unit Data		
	Design	Actual
MFG	CAPTIVE-AIRE	CAPTIVE-AIRE
Model Num	DR12HFA	DR12HFA
Serial Num	-	7431687
Type	DOWNBLAST	CENTRIFUGAL
Configuration	VERTICAL	DOWNBLAST

Motor Data		
	Design	Actual
Motor MFG	-	TELCO-GREEN
Horsepower	0.250	0.250
Motor Rpm	-	1800
Phase	1	1
Voltage (rated)	115	115
Amperage (rated)	-	2.9

Test Data		
	Design	Actual
CFM	150	153
Fan RPM	1282	738
Fan Rotation	-	CCW
Motor RPM	-	DIRECT DRIVE
System SetPt	-	40
RL Voltage	-	120
RL Amperage	-	0.3
Total ESP	0.600"	0.11"
Fan Inlet SP	-	-0.11"
Fan Discharge SP	-	ATM
