**Report: Preliminary Report**  
**Function: Test, Adjust, & Balance**  
**Date: 11/30/2025**  
**Completed By: National TAB**

## 11-24-25 CHIPOTLE #5571 MIDDLEBURG, FL

1694 BLANDING BLVD

MIDDLEBURG, FL 32068

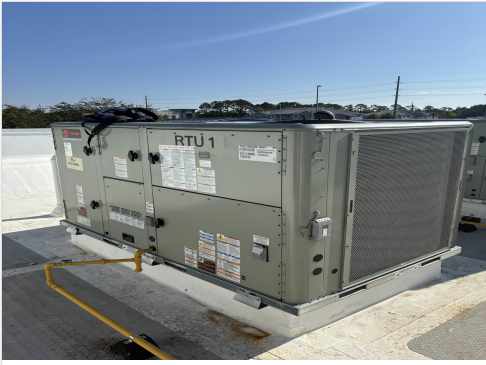
# Unit Data - PHOTO LOG

Unit Data		
	Design	Actual
MFG	TRANE	TRANE
Serial Num	-	25133000L
Model Num	YSJ120	YSJ120A3SOL0AH0C0A2A1
Type	RTU	RTU
Configuration	VERTICAL	VERTICAL
Num OA Filters 1	-	1
OA Filter Size 1	-	36X14.25
Num Final Filter 1	-	3
Final Filter Size 1	-	16X20X2
Num Final Filter 2	-	2
Final Filter Size 2	-	18X20X2

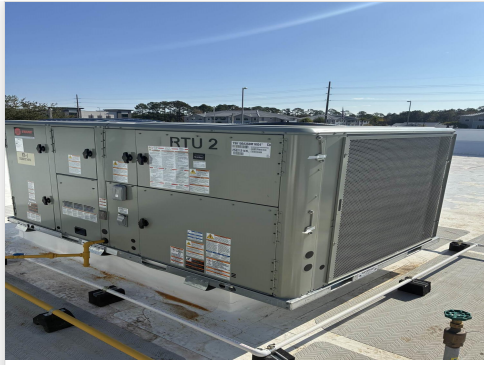
Test Data		
	Design	Actual
SF CFM	4400	4394
SF RPM	-	1322
RA CFM	3400	4268
OA CFM	1000	126
RL Voltage	-	205/206/206
RL Amperage	-	4.25/4.15/4.21
SF Rotation	-	CORRECT
SF System SetPt	-	68.1
RA Damper Position	-	100
Min OA Damper Position	-	0
Min OA Damper Type	-	ECONOMIZER
OA Enthalpy Setpt	-	28 BTU/LB

Notes:  
Economizer non-functional
