**Report: FINAL TAB REPORT
Function: Test, Adjust, & Balance
Date: 10/05/2022**

**PROJECT
10-03 HAWAIIAN BROS - O'FALLON, IL**

Project: 10-03 HAWAIIAN BROS - O'FALLON, IL

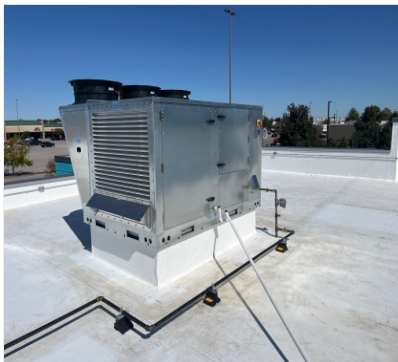
RTU-1

Unit Data		
	Design	Actual
MFG	CAPTIVE-AIRE	CAPTIVE-AIRE
Serial Num	-	5448882
Model Num	CASRTU30I.250-20-20T-DOAS	CASRTU3-I.250-20-20T-DOAS
Type	DOAS	DOAS
Configuration	VERTICAL	VERTICAL
Num OA Filters 1	-	4
OA Filter Size 1	-	23x14
Num Final Filter 1	-	8
Final Filter Size 1	-	20x25x2

Motor Data		
	Design	Actual
Motor MFG	-	TECO
Frame	-	213T
Horsepower	3	3
Motor Rpm	-	1175
Phase	3	3
Rated Voltage	208	230/460
Rated Amperage	-	9.2/4.6

Test Data		
	Design	Actual
SF CFM	3200	3190
SF RPM	-	1234 @ 63.0 HZ
RA CFM	1350	1332
OA CFM	1850	1858
RL Voltage	-	214/214/214
RL Amperage	-	7.8 AVE
SF Rotation	-	CCW, CORRECT
RA Damper Position	-	54%
Min OA Damper Position	-	46%
Min OA Damper Type	-	ECONOMIZER

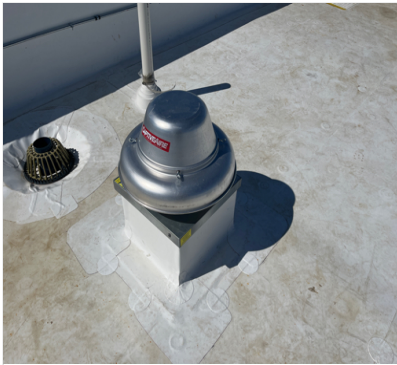
EF-3

Unit Data		
	Design	Actual
MFG	CAPTIVE-AIRE	CAPTIVE-AIRE
Model Num	DR12HFA	DR12HFA
Serial Num	-	5448882
Type	DOWNBLAST	DOWNBLAST
Configuration	HORIZONTAL	VERTICAL

Test Data		
	Design	Actual
CFM	200	189
Fan RPM	1070	1230
Fan Rotation	-	CCW, CORRECT
Motor RPM	-	1230
System SetPt	-	65%
RL Voltage	-	119
RL Amperage	-	0.74
Total ESP	0.38"	0.39"
Fan Inlet SP	-	-0.39"
Fan Discharge SP	-	ATM

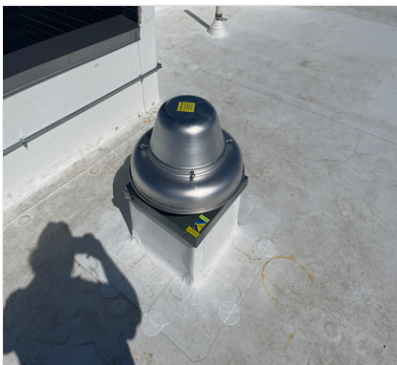
EF-4

Unit Data		
	Design	Actual
MFG	CAPTIVE-AIRE	CAPTIVE-AIRE
Model Num	DR12HFA	DR12HFA
Serial Num	-	5448882
Type	DOWNBLAST	DOWNBLAST
Configuration	VERTICAL	VERTICAL

Test Data		
	Design	Actual
CFM	150	147
Fan RPM	1190	1037
Fan Rotation	-	CCW, CORRECT
Motor RPM	-	1037
System SetPt	-	56%
RL Voltage	-	120
RL Amperage	-	0.44
Total ESP	0.50"	0.23"
Fan Inlet SP	-	-0.23"
Fan Discharge SP	-	ATM

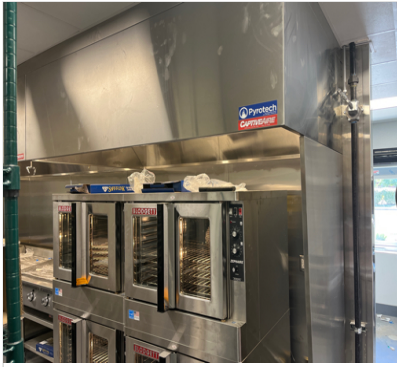
HOOD-1

Unit Data		
	Design	Actual
MFG	CAPTIVEAIRE	CAPTIVEAIRE
Model Num	5424 ND-2	5424 ND-2
Job / Serial Num	-	5448882
Type	TYPE I LOW PROXIMITY	TYPE I
Hood length	89"	89"
Hood Width	54"	54"

Test Data Exhaust		
	Design	Actual
Filter Type	CAPTRATE SOLO	CAPTRATE SOLO
Filter Size 1	16X16	16X16
Filter Qty 1	5	5
Filter AK factor size 1	1.62	1.62
Filter Total AK Area	8.1	8.1
Filter1 FPM	-	129
Filter2 FPM	-	110
Filter3 FPM	-	121
Filter4 FPM	-	143
Filter5 FPM	-	132
Filter Ave FPM(corr)	-	127
CFM	1115	1029
