Report: FINAL TAB REPORT
Function: Test, Adjust, & Balance
Date: 10/05/2022

10-03 HAWAIIAN BROS - O'FALLON, IL

Project: 10-03 HAWAIIAN BROS - O'FALLON, IL

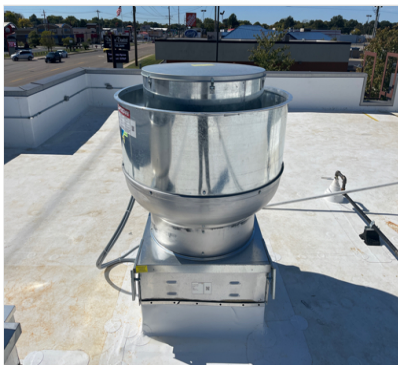
EF-1

Test Data		
	Design	Actual
CFM	4025	3916
Fan RPM	894	1162
Fan Rotation	-	CW, CORRECT
Motor RPM	-	1162
System SetPt	-	59.6 HZ
RL Voltage	-	215/215/215
RL Amperage	-	9.5 AVE
Total ESP	1.50"	1.65"
Fan Inlet SP	-	-1.65"
Fan Discharge SP	-	ATM

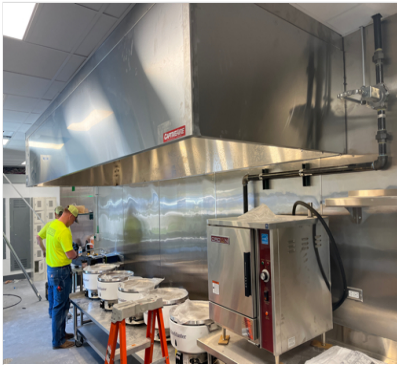
HOOD-3

Test Data		
	Design	Actual
Exhaust CFM	2025	2020
