**Report: FINAL TAB REPORT
Function: Test, Adjust, & Balance
Date: 10/05/2022**

10-03 HAWAIIAN BROS - O'FALLON, IL

Project: 10-03 HAWAIIAN BROS - O'FALLON, IL

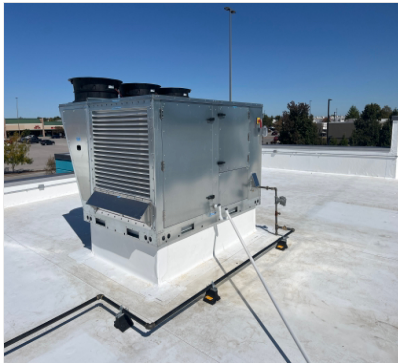
RTU-1

Test Data		
	Design	Actual
SF CFM	3200	3190
SF RPM	-	1234 @ 63.0 HZ
RA CFM	1350	1332
OA CFM	1850	1858
RL Voltage	-	214/214/214
RL Amperage	-	7.8 AVE
SF Rotation	-	CCW, CORRECT
RA Damper Position	-	54%
Min OA Damper Position	-	46%
Min OA Damper Type	-	ECONOMIZER

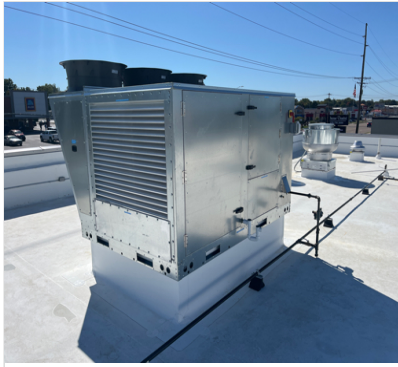
RTU-2

Test Data		
	Design	Actual
SF CFM	3200	3197
SF RPM	-	1097 @ 56.0 HZ
RA CFM	0	0
OA CFM	3200	3197
RL Voltage	-	215/214/214
RL Amperage	-	6.4 AVE
SF Rotation	-	CCW, CORRECT
RA Damper Position	-	0%
Min OA Damper Position	-	100%
Min OA Damper Type	-	ECONOMIZER

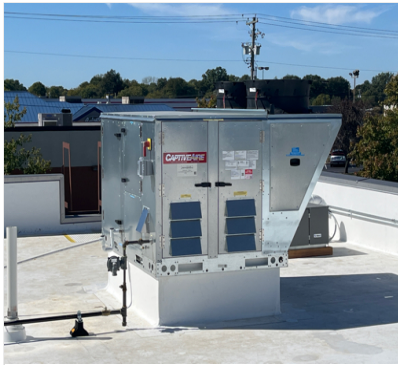
RTU-3

Test Data		
	Design	Actual
SF CFM	2800	2891
SF RPM	-	1808 @ 62.0 HZ
RA CFM	1475	1552
OA CFM	1325	1339
RL Voltage	-	215/215/214
RL Amperage	-	11.9 AVE
SF Rotation	-	CCW, CORRECT
RA Damper Position	-	60%
Min OA Damper Position	-	40%
Min OA Damper Type	-	ECONOMIZER

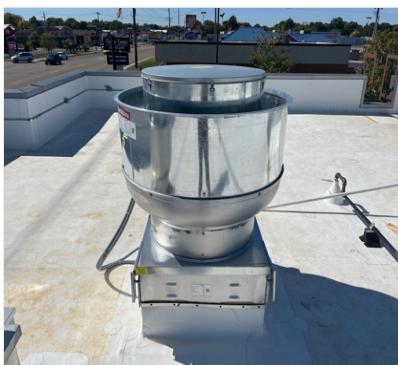
EF-1

Test Data		
	Design	Actual
CFM	4025	3916
Fan RPM	894	1162
Fan Rotation	-	CW, CORRECT
Motor RPM	-	1162
System SetPt	-	59.6 HZ
RL Voltage	-	215/215/215
RL Amperage	-	9.5 AVE
Total ESP	1.50"	1.65"
Fan Inlet SP	-	-1.65"
Fan Discharge SP	-	ATM

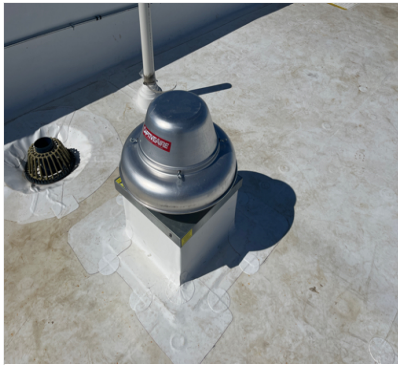
EF-3

Test Data		
	Design	Actual
CFM	200	189
Fan RPM	1070	1230
Fan Rotation	-	CCW, CORRECT
Motor RPM	-	1230
System SetPt	-	65%
RL Voltage	-	119
RL Amperage	-	0.74
Total ESP	0.38"	0.39"
Fan Inlet SP	-	-0.39"
Fan Discharge SP	-	ATM

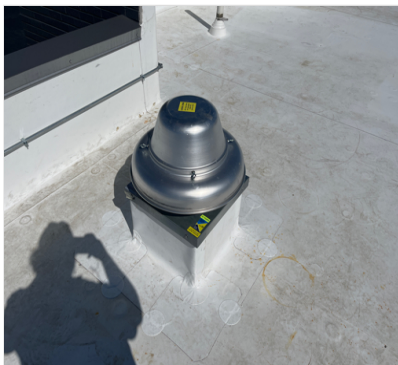
EF-4

Test Data		
	Design	Actual
CFM	150	147
Fan RPM	1190	1037
Fan Rotation	-	CCW, CORRECT
Motor RPM	-	1037
System SetPt	-	56%
RL Voltage	-	120
RL Amperage	-	0.44
Total ESP	0.50"	0.23"
Fan Inlet SP	-	-0.23"
Fan Discharge SP	-	ATM

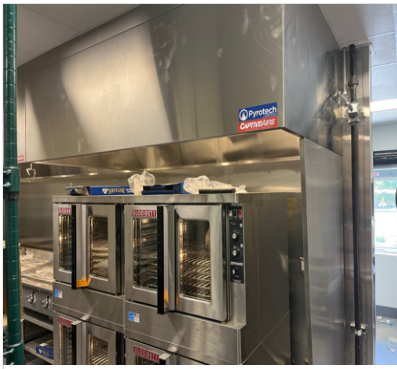
HOOD-1

Test Data Exhaust		
	Design	Actual
Filter Type	CAPTRATE SOLO	CAPTRATE SOLO
Filter Size 1	16X16	16X16
Filter Qty 1	5	5
Filter AK factor size 1	1.62	1.62
Filter Total AK Area	8.1	8.1
Filter1 FPM	-	129
Filter2 FPM	-	110
Filter3 FPM	-	121
Filter4 FPM	-	143
Filter5 FPM	-	132
Filter Ave FPM(corr)	-	127
CFM	1115	1029

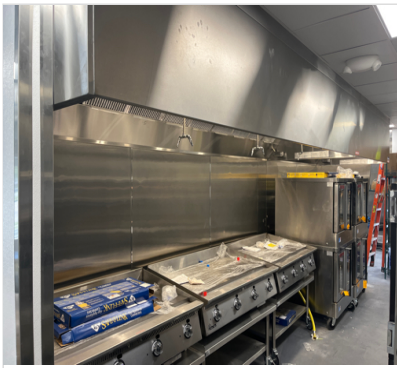
HOOD-2

Test Data Exhaust		
	Design	Actual
Filter Type	CAPTRATE SOLO	CAPTRATE SOLO
Filter Size 1	16X16	16X16
Filter Qty 1	9	9
Filter AK factor size 1	1.62	1.62
Filter Total AK Area	14.58	14.58
Filter1 FPM	-	203
Filter2 FPM	-	191
Filter3 FPM	-	196
Filter4 FPM	-	200
Filter5 FPM	-	200
Filter6 FPM	-	192
Filter7 FPM	-	192
Filter8 FPM	-	188
Filter9 FPM	-	222
Filter Ave FPM(corr)	-	198
CFM	2910	2887

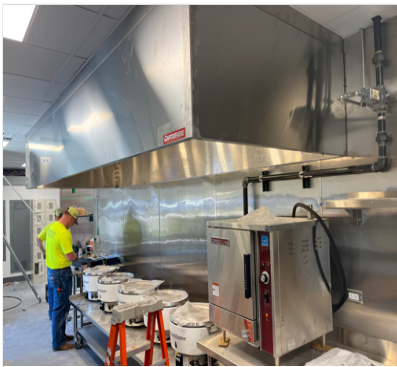
HOOD-3

Test Data		
	Design	Actual
Exhaust CFM	2025	2020
