**Report: FINAL TAB REPORT
Function: Test, Adjust, & Balance
Date: 10/05/2022**

**PROJECT
10-03 HAWAIIAN BROS - O'FALLON, IL**

Project: 10-03 HAWAIIAN BROS - O'FALLON, IL

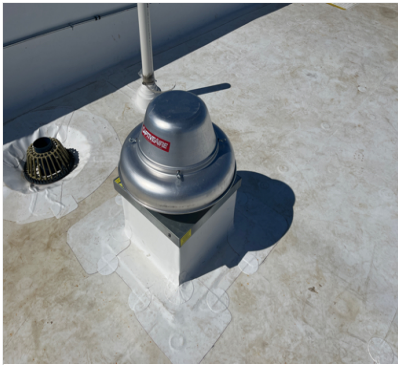
EF-3

Test Data		
	Design	Actual
CFM	200	189
Fan RPM	1070	1230
Fan Rotation	-	CCW, CORRECT
Motor RPM	-	1230
System SetPt	-	65%
RL Voltage	-	119
RL Amperage	-	0.74
Total ESP	0.38"	0.39"
Fan Inlet SP	-	-0.39"
Fan Discharge SP	-	ATM

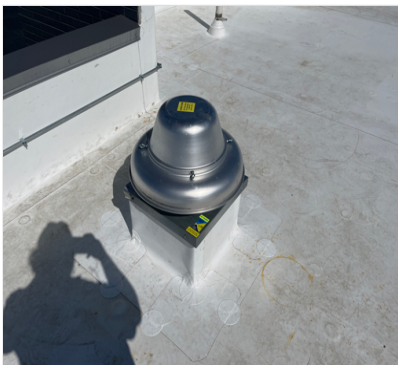
EF-4

Test Data		
	Design	Actual
CFM	150	147
Fan RPM	1190	1037
Fan Rotation	-	CCW, CORRECT
Motor RPM	-	1037
System SetPt	-	56%
RL Voltage	-	120
RL Amperage	-	0.44
Total ESP	0.50"	0.23"
Fan Inlet SP	-	-0.23"
Fan Discharge SP	-	ATM

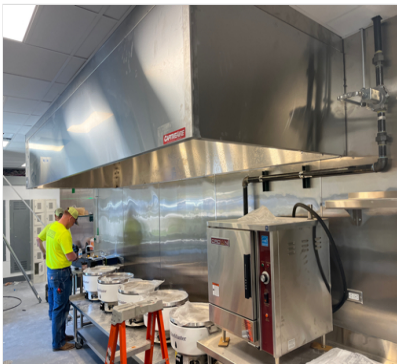
HOOD-3

Test Data		
	Design	Actual
Exhaust CFM	2025	2020
