**Report: TAB REPORT
Function: Test, Adjust, & Balance
Date: 12/13/2022**

**PROJECT
12-05 CULVERS - LAKE CITY, FL**

Project: 12-05 CULVERS - LAKE CITY, FL

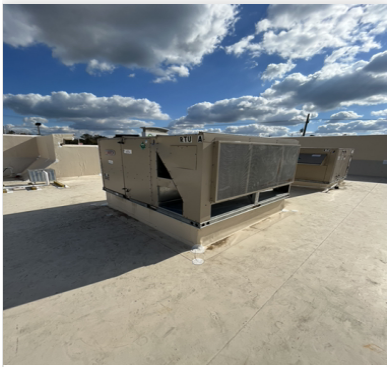
RTU.jpeg

Issue Name : RTU3 CFM is above design.

Description : Currently operating at 4062 CFM out of a designed 3250 CFM. Motor sheave turned to minimum setting, however airflow is still too high and motor is overramping. Recommended replacing fan sheave to a BK90 with 1.1875" bore. New fan sheave will require a BX57 or BX58 belt. Airflows set proportionally high so that once changed, airflow be within design.

RTU3-OA NEW SHEAVE HAS BEEN ORDERED TO BRING INTO DESIGN.

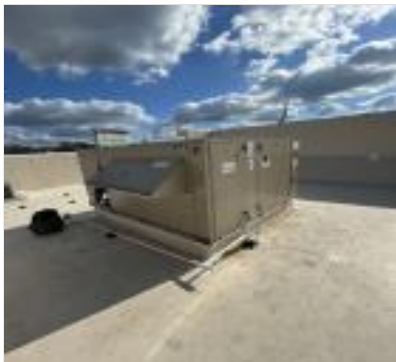
RTU-1

Test Data		
	Design	Actual
SF CFM	5200	5206
SF RPM	-	577
RA CFM	4300	4290
OA CFM	900	916
RL Voltage	-	206/207/206
RL Amperage	-	4.3/4.3/4.1
SF Rotation	-	CCW
RA Damper Position	-	55%
Min OA Damper Position	-	45%
Min OA Damper Type	-	ECONOMIZER
OA Enthalpy Setpt	-	5

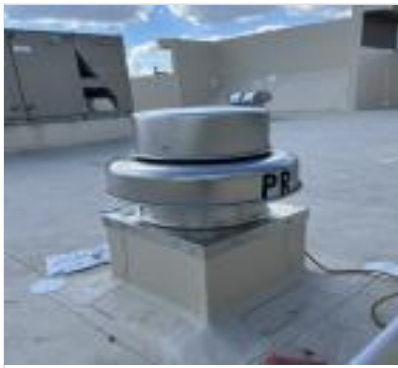
PRV-4

Test Data		
	Design	Actual
CFM	350	362
Fan RPM	1532	DD
Fan Rotation	-	CCW
Motor RPM	-	1050
System SetPt	-	LOWEST SETTING
RL Voltage	-	115
RL Amperage	-	1.2
Total ESP	0.6"	0.26"
Fan Inlet SP	-	-0.26"
Fan Discharge SP	-	ATM

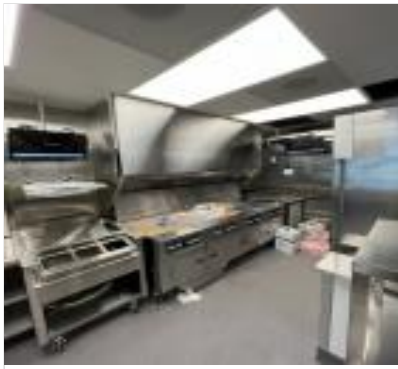
HOOD 1

Test Data Exhaust		
	Design	Actual
Filter Type	X-TRACTOR	X-TRACTOR
Filter Size 1	16X16	16X16
Filter Qty 1	5	5
Filter AK factor size 1	1.53	1.53
Filter Total AK Area	7.65	7.65
Filter1 FPM	-	-206.9
Filter2 FPM	-	-191.3
Filter3 FPM	-	-226.1
Filter4 FPM	-	-209.4
Filter5 FPM	-	-252.7
Filter Ave FPM(corr)	-	197
CFM	1500	1507

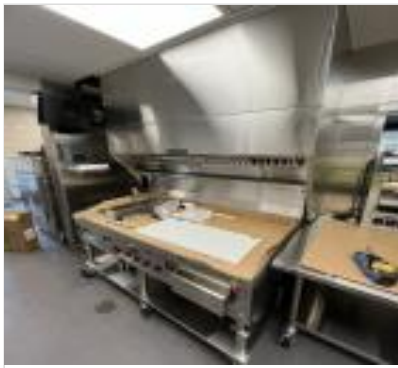
HOOD 2

Test Data Exhaust		
	Design	Actual
Filter Type	GREASE GRABBER	GREASE GRABBER
Filter Size 1	16X16	16X16
Filter Qty 1	4	4
Filter AK factor size 1	1.53	1.53
Filter Total AK Area	6.12	6.12
Filter1 FPM	-	-273.1
Filter2 FPM	-	-275.3
Filter3 FPM	-	-251.7
Filter4 FPM	-	-263.1
Filter Ave FPM(corr)	-	242
CFM	1500	1480

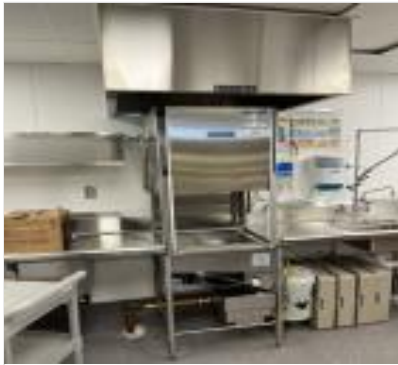
HOOD 3

Test Data		
	Design	Actual
Exhaust VEL(corr)	-	1065
Exhaust CFM	350	362
