**Report: TAB REPORT  
Function: Test, Adjust, & Balance  
Date: 12/13/2022**

**PROJECT  
12-05 CULVERS - LAKE CITY, FL**

Project: 12-05 CULVERS - LAKE CITY, FL

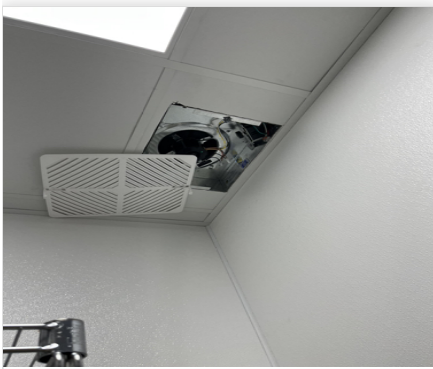
EF2.jpeg

**Issue Name :** EF#2 is not getting power

**Description :** Potentiometer and switch are on for fan to run, however, fan is not turning on.

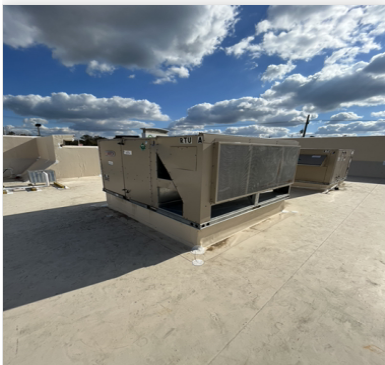
RTU.jpeg

**Issue Name :** RTU30A CFM is above design.

**Description :** Currently running at 4062 cfm out of a designed 3250. Motor sheave turned to minimum setting, however cfm is still too high and motor is overramping. Recommended to replace fan sheave to a BK90 with 1.1875" bore. New fan sheave will require a BX57 or BX58 belt.

RTU3-OA NEW SHEAVE HAS BEEN ORDERED TO BRING INTO DESIGN.

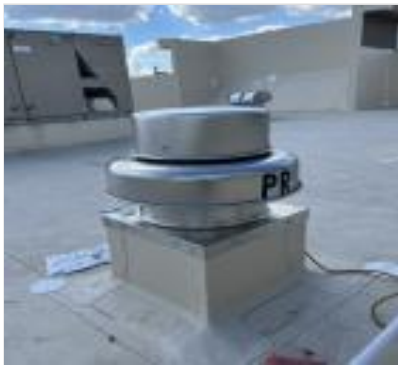
**PRV4.jpeg**

**Issue Name :** PRV4 is not wired in yet.

**Description :** Conduit needs to be run to through raceway in fan and wired in to get power.
