Report: TAB Report
Function: Test, Adjust, & Balance
Date: 05/28/2025
Completed By: National TAB

05-26-25 WAWA #5449 WILDWOOD, FL

Wawa
260 West Baltimore Pike
Wawa, PA 19063

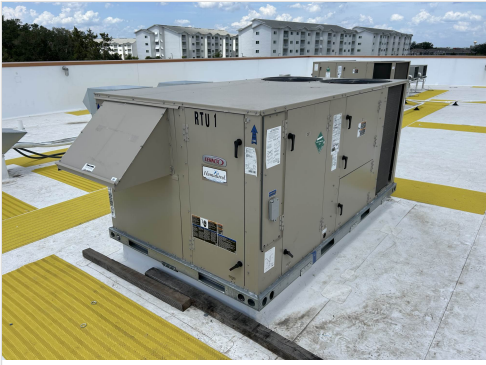
Unit Data - PHOTO LOG

Asset: RTU1

AREA: CORE

Unit Data		
	Design	Actual
MFG	LENNOX ENLIGHT	LENNOX ENLIGHT
Serial Num	-	5624L02316
Model Num	LCT102H4E	LCT102H4EG2Y
Type	RTU	RTU
Configuration	VERTICAL	VERTICAL
Num OA Filters 1	-	1
OA Filter Size 1	-	23x14
Num Final Filter 1	-	4
Final Filter Size 1	-	20x25x2

Test Data		
	Design	Actual
SF CFM	3400	3474
SF RPM	-	1139
MOTOR RPM	-	1139
RA CFM	2900	2957
OA CFM	500	517
RL Voltage	-	209/211/210
RL Amperage	-	2.8/2.7/2.8
SF System SetPt	-	64%
OA Damper Position	-	41%
OA Damper Type	-	SINGLE BLADE

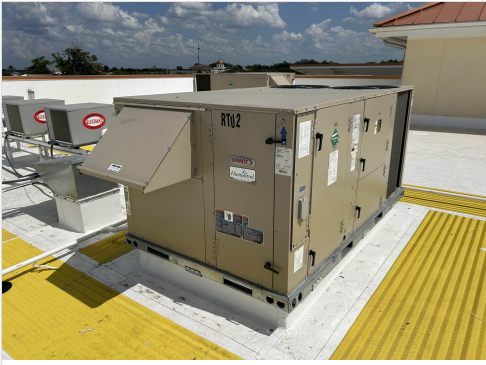
Unit Data - PHOTO LOG

Asset: RTU2

AREA:DELI

Unit Data		
	Design	Actual
MFG	LENNOX ENLIGHT	LENNOX ENLIGHT
Serial Num	-	5624L02673
Model Num	LCT150H4E	LCT150H4EN2Y
Type	RTU	RTU
Configuration	VERTICAL	VERTICAL
Num OA Filters 1	-	1
OA Filter Size 1	-	23x14
Num Final Filter 1	-	4
Final Filter Size 1	-	20x25x2

Test Data		
	Design	Actual
SF CFM	5000	5009
SF RPM	-	1549
MOTOR RPM	-	1549
RA CFM	4250	4253
OA CFM	750	756
RL Voltage	-	210/211/212
RL Amperage	-	5.8/5.6/5.8
SF System SetPt	-	87%
OA Damper Position	-	46%
OA Damper Type	-	SINGLE BLADE

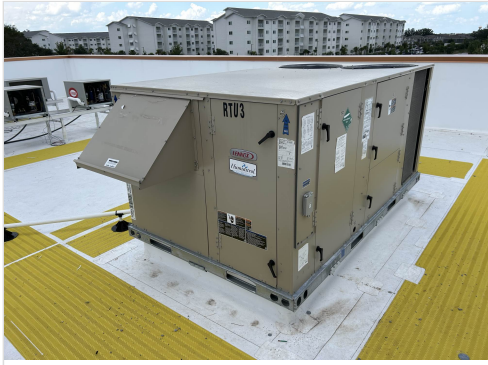
Unit Data - PHOTO LOG

Asset: RTU3

AREA:RETAIL

Unit Data		
	Design	Actual
MFG	LENNOX ENLIGHT	LENNOX ENLIGHT
Serial Num	-	5624L02667
Model Num	LCT092H4E	LCT092H4EG2Y
Type	RTU	RTU
Configuration	VERTICAL	VERTICAL
Num OA Filters 1	-	1
OA Filter Size 1	-	23x14
Num Final Filter 1	-	4
Final Filter Size 1	-	20x25x2

Test Data		
	Design	Actual
SF CFM	3000	3035
SF RPM	-	1068
MOTOR RPM	-	1068
RA CFM	2550	2572
OA CFM	450	463
RL Voltage	-	210/211/211
RL Amperage	-	2.3/2.2/2.3
SF System SetPt	-	60%
OA Damper Position	-	39%
OA Damper Type	-	SINGLE BLADE

RTU 3 return grilles - excessive vibration noise

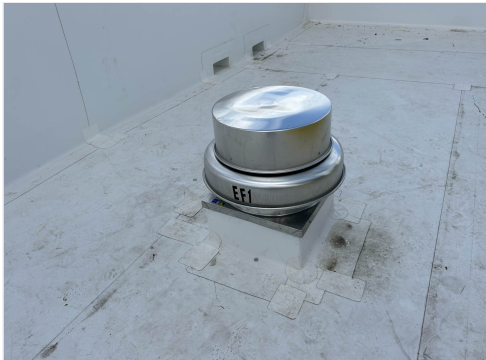
Unit Data - PHOTO LOG

Asset: EF1

AREA:BACK OF HOUSE

Unit Data		
	Design	Actual
MFG	GREENHECK	GREENHECK
Model Num	G-140	G-140-B-4-1-22-X
Serial Num	-	27049717
Type	DOWNBLAST	DOWNBLAST
Configuration	VERTICAL	VERTICAL

Test Data		
	Design	Actual
CFM	1200	1201
Fan RPM	818	DD
Fan Rotation	-	CW
Motor RPM	-	DD
System SetPt	-	SPEED CONTROLLER (MARKED)
RL Voltage	-	121
RL Amperage	-	1.8
Total ESP	.375"	0.18"
Fan Inlet SP	-	-0.18"
Fan Discharge SP	-	ATM

Total exhaust remains at +126%, cannot be reduced without causing motor to overamp. Grilles are balanced proportional to the current total.
