Report: TAB Report
Function: Test, Adjust, & Balance
Date: 12/12/2025
Completed By: National TAB

PROJECT
02-02-26 QT #1176 CAYCE, SC

Project: 02-02-26 QT #1176 CAYCE, SC

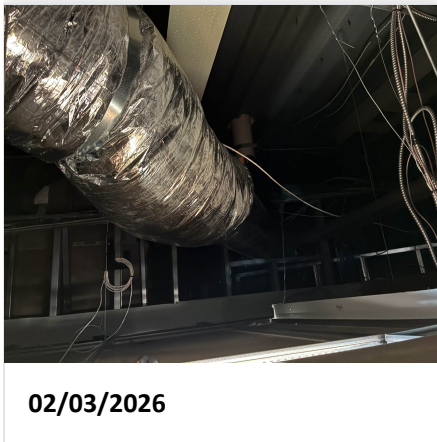
Issue Name : RTU-3: Damper 3-1 Not Present
Description : The damper for 3-1 is not present. Could not reduce airflow. Diffuser is above design but not anticipated to cause any issue.
Created By : National TAB **Assigned To :** National TAB - Dan Hertenstein
Status : Open
Priority : InfoOnly **Asset Tag :** SGRD1
Originated Date : 02/03/2026 - Alex Bauer - National TAB

Asset	Notes	Date	Written By
SGRD1	DAMPER NOT INSTALLED	02/05/2026	Michael McDonnell

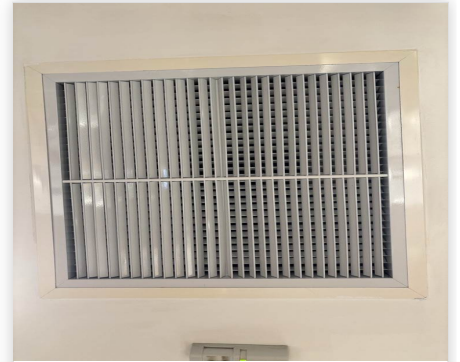
Issue Name : RTU-3: Incorrect Kitchen Diffusers
Description : The kitchen diffusers 3-2 through 3-5 are the incorrect type. They need to be the TITUS 300FS diffuser with the installed deflection blades.
Created By : National TAB **Assigned To :** National TAB - Dan Hertenstein
Status : Open
Priority : High **Asset Tag :** RT-3
Originated Date : 02/03/2026 - Alex Bauer - National TAB
