**Report: TAB Report**  
**Function: Test, Adjust, & Balance**  
**Date: 12/12/2025**  
**Completed By: National TAB**

**PROJECT**  
**02-02-26 QT #1176 CAYCE, SC**

Project: 02-02-26 QT #1176 CAYCE, SC

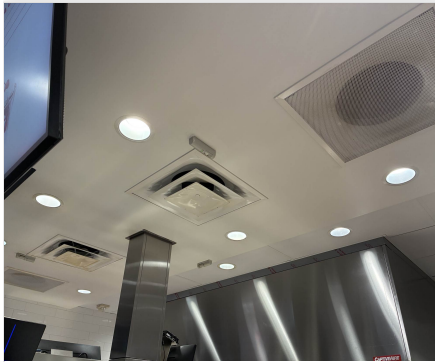
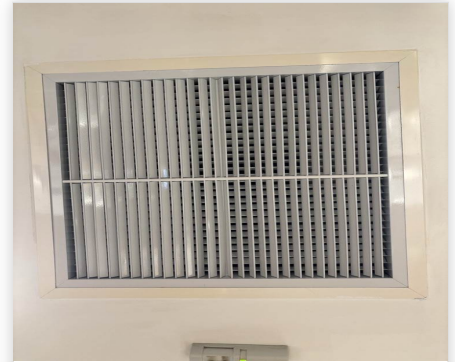
**Issue Name :** Incorrect Kitchen Diffusers  
**Description :** The kitchen diffusers 3-2 through 3-5 are the incorrect type. They need to be the TITUS 300FS diffuser with the installed deflection blades.  
**Created By :** National TAB      **Assigned To :** National TAB - Dan Hertenstein  
**Status :** Open  
**Priority :** High      **Asset Tag :** RT-3  
**Originated Date :** 02/03/2026 - Alex Bauer - National TAB

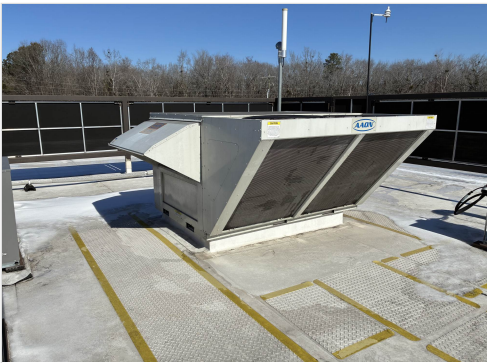
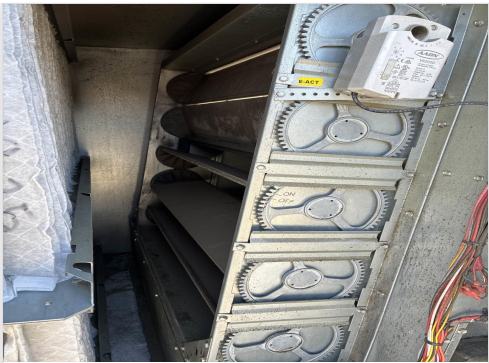
Notes:  
See issues list.
