# National TAB

Project: 02-02-26 QT #1176 CAYCE, SC

## Issue List

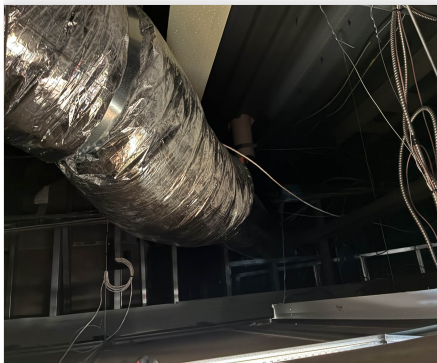
**Issue Name :** RTU-3: Damper 3-1 Not Present  
**Description :** The damper for 3-1 is not present. Could not reduce airflow. Diffuser is above design but not anticipated to cause any issue.  
**Created By :** National TAB                      **Assigned To :** National TAB - Dan Hertenstein  
**Status :** Open  
**Priority :** InfoOnly                              **Asset Tag :** SGRD1  
**Originated Date :** 02/03/2026 - Alex Bauer - National TAB

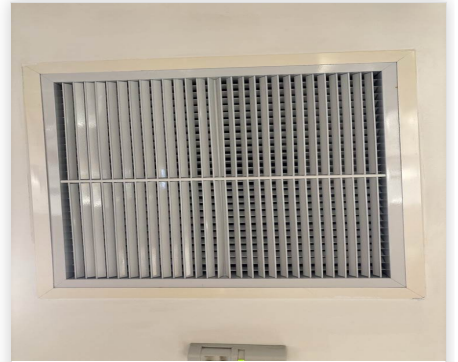
**Issue Name :** RTU-3: Incorrect Kitchen Diffusers  
**Description :** The kitchen diffusers 3-2 through 3-5 are the incorrect type. They need to be the TITUS 300FS diffuser with the installed deflection blades.  
**Created By :** National TAB                      **Assigned To :** National TAB - Dan Hertenstein  
**Status :** Open  
**Priority :** High                                      **Asset Tag :** RT-3  
**Originated Date :** 02/03/2026 - Alex Bauer - National TAB

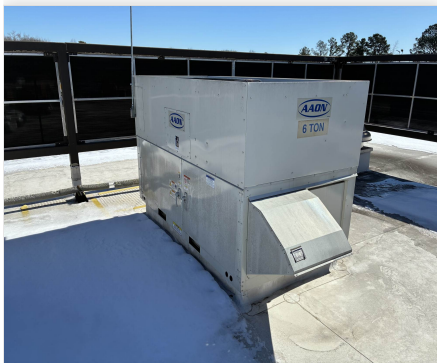
**Issue Name :** RTU-4 Below Design Airflow  
**Description :** The Yaskawa J1000 VFD is set to its maximum speed option and the RTU is below scheduled airflow. Unit is operating at 371 cfm per ton, which is typically acceptable rate. not anticipated to cause any issue. INFO ONLY.  
**Created By :** National TAB                      **Assigned To :** National TAB - Dan Hertenstein  
**Status :** Open  
**Priority :** InfoOnly                                      **Asset Tag :** RT-4  
**Originated Date :** 02/03/2026 - Alex Bauer - National TAB
