Report: TAB Report
Function: Test, Adjust, & Balance
Date: 12/12/2025
Completed By: National TAB

PROJECT
02-02-26 QT #1176 CAYCE, SC

Project: 02-02-26 QT #1176 CAYCE, SC

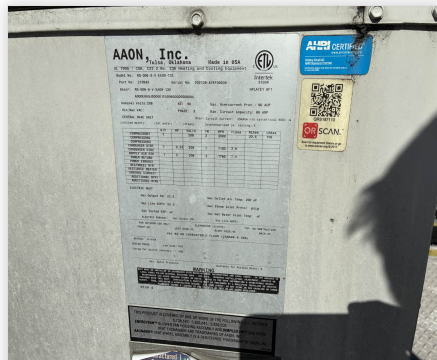
Issue Name : RTU-4 Low Flow
Description : The Yaskawa J1000 VFD is set to its maximum speed option and the RTU is not producing enough airflow as it should (79%/100%). It is recommended to ensure the dampers are fully open and existent as well to check for resistance in the system. 66 CFM/ton is within the acceptable range for a unit of this size.
Created By : National TAB **Assigned To :** National TAB - Dan Hertenstein
Status : Open
Priority : High **Asset Tag :** RT-4
Originated Date : 02/03/2026 - Alex Bauer - National TAB

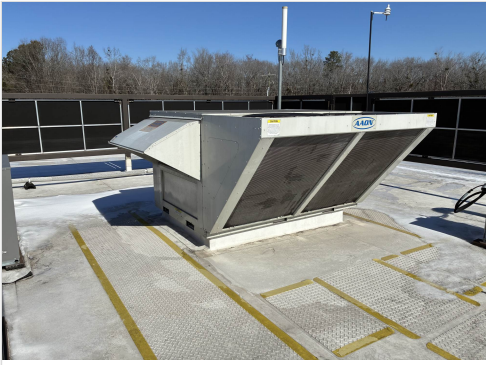
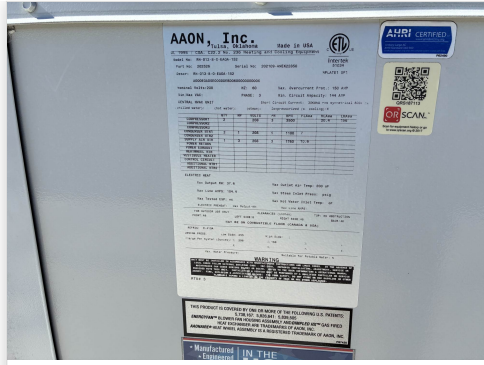
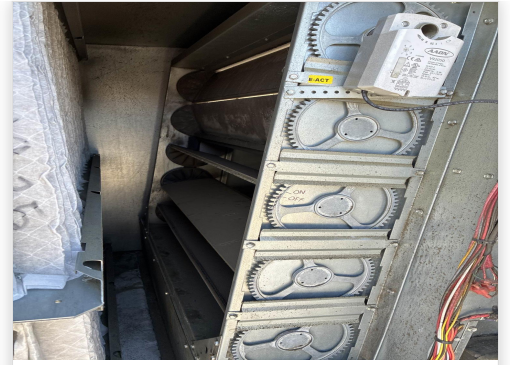
Asset: RT-3

Notes:
See issues list.
