National TAB

Project: 02-02-26 QT #1176 CAYCE, SC

Issue List

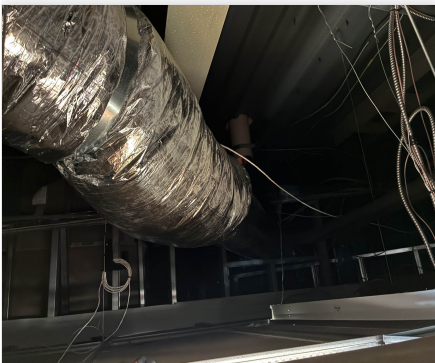
Issue Name : Damper 3-1 Not Present
Description : The damper for 3-1 is not present.
Created By : National TAB **Assigned To :** National TAB - Dan Hertenstein
Status : Open
Priority : Urgent **Asset Tag :** SGRD1
Originated Date : 02/03/2026 - Alex Bauer - National TAB

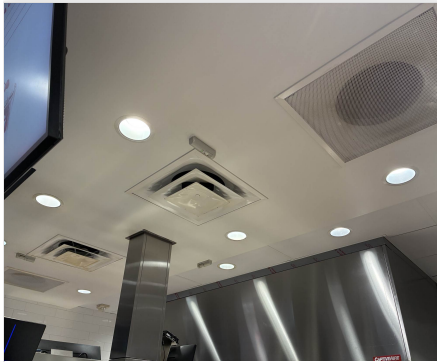
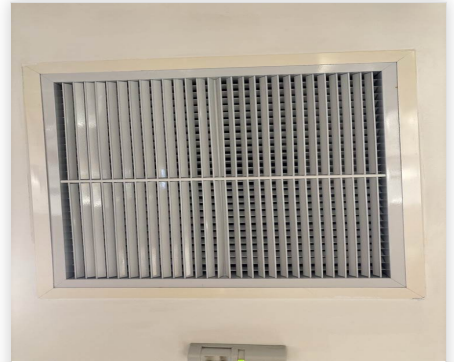
Issue Name : Incorrect Kitchen Diffusers
Description : The kitchen diffusers 3-2 through 3-5 are the incorrect type. They need to be the TITUS 300FS diffuser with the installed deflection blades.
Created By : National TAB **Assigned To :** National TAB - Dan Hertenstein
Status : Open
Priority : High **Asset Tag :** RT-3
Originated Date : 02/03/2026 - Alex Bauer - National TAB

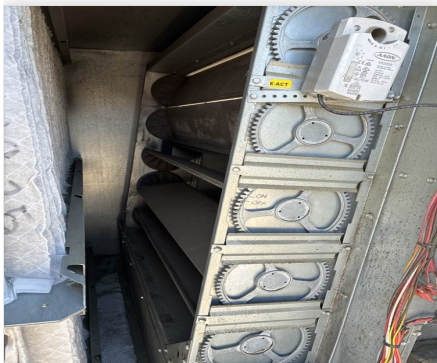
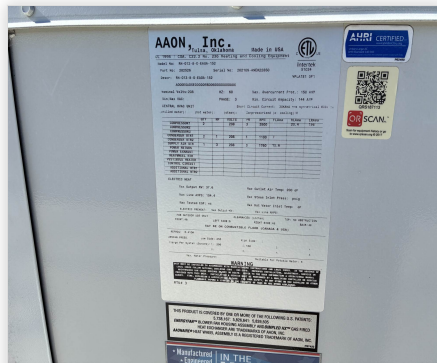
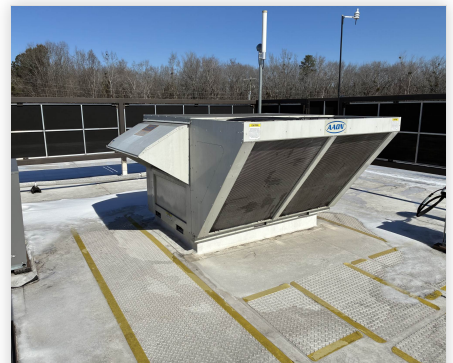
Issue Name : RTU-3 Economizer Actuator Malfunction
Description : The actuator for the economizer stopped responding to commands from the store computer when setting the outside air when the hood is off. The outside air was set manually.
Created By : National TAB **Assigned To :** National TAB - Dan Hertenstein
Status : Open
Priority : Urgent **Asset Tag :**
Originated Date : 02/03/2026 - Alex Bauer - National TAB

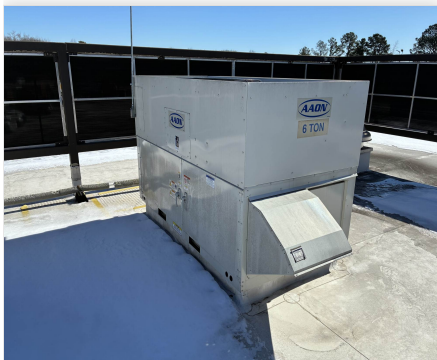
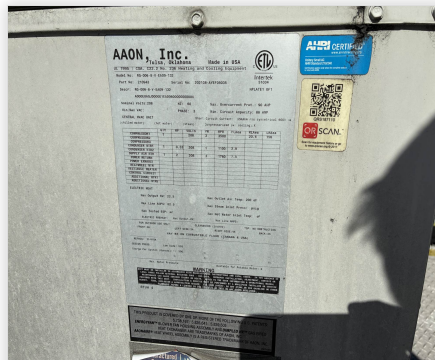
Issue Name : RTU-4 Low Flow
Description : The Yaskawa J1000 VFD is set to its maximum speed option and the RTU is not producing enough airflow as it should (79%/100%). It is recommended to ensure the dampers are fully open and existent as well to check for resistance in the system. 66 CFM/ton is within the acceptable range for a unit of this size.
Created By : National TAB **Assigned To :** National TAB - Dan Hertenstein
Status : Open
Priority : High **Asset Tag :** RT-4
Originated Date : 02/03/2026 - Alex Bauer - National TAB
