Report: TAB Report
Function: Test, Adjust, & Balance
Date: 12/12/2025
Completed By: National TAB

PROJECT
02-02-26 QT #1176 CAYCE, SC

1600 DIXIANNA RD

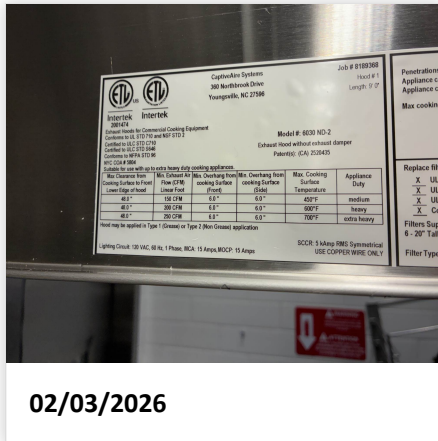
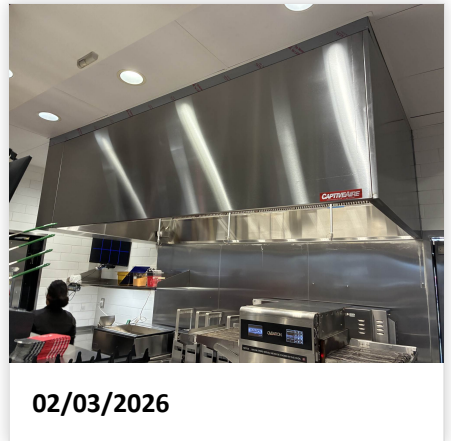
Issue Name : No Hood End Panels Installed
Description : There are no hood end panels installed as per the Hood Schedule.
Created By : National TAB **Assigned To :** National TAB - Dan Hertenstein
Status : Open
Priority : Low **Asset Tag :** HD1
Originated Date : 02/03/2026 - Alex Bauer - National TAB

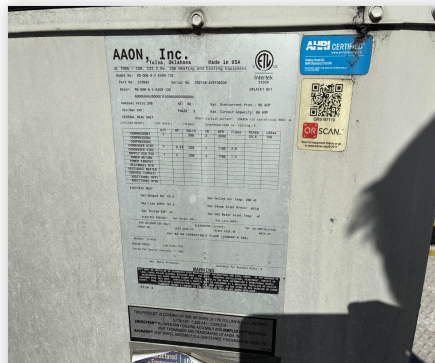
Issue Name : RTU-4 Below Design Airflow
Description : The Yaskawa J1000 VFD is set to its maximum speed option and the RTU is below scheduled airflow. Unit is operating at 371 cfm per ton, which is typically acceptable rate. not anticipated to cause any issue. INFO ONLY.
Created By : National TAB **Assigned To :** National TAB - Dan Hertenstein
Status : Open
Priority : InfoOnly **Asset Tag :** RT-4
Originated Date : 02/03/2026 - Alex Bauer - National TAB

[1] BELOW SCHEDULED AIRFLOW. UNIT IS 6 TONS AND OPERATING AT 371 CFM PER TON. NOT ANTICIPATED TO CAUSE ANY ISSUE.
