Report: TAB Report
Function: Test, Adjust, & Balance
Date: 12/12/2025
Completed By: National TAB

PROJECT
02-02-26 QT #1176 CAYCE, SC

Project: 02-02-26 QT #1176 CAYCE, SC

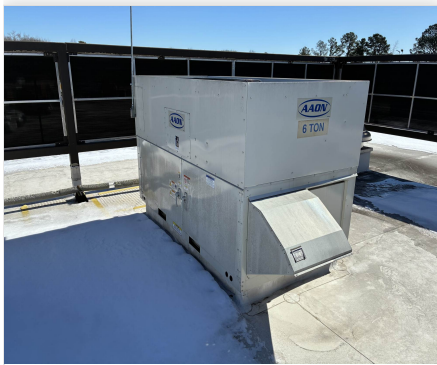
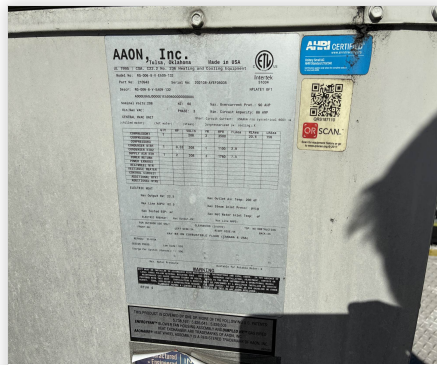
Issue Name : RTU-4 Below Design Airflow
Description : The Yaskawa J1000 VFD is set to its maximum speed option and the RTU is below design airflow.
Created By : National TAB **Assigned To :** National TAB - Dan Hertenstein
Status : Open
Priority : Medium **Asset Tag :** RT-4
Originated Date : 02/03/2026 - Alex Bauer - National TAB

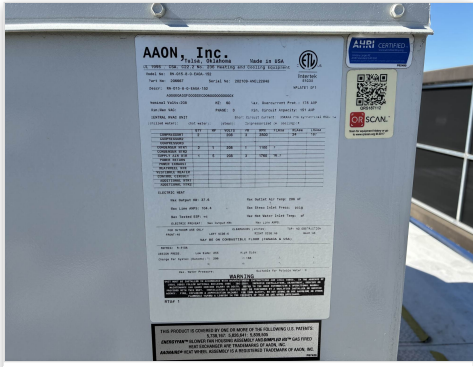
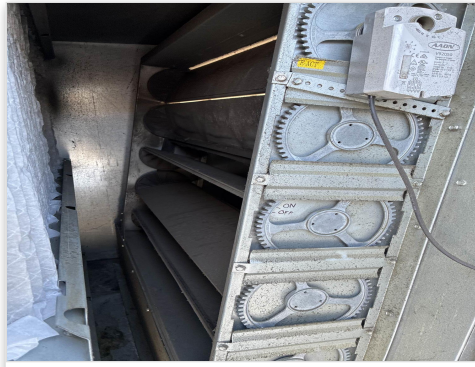
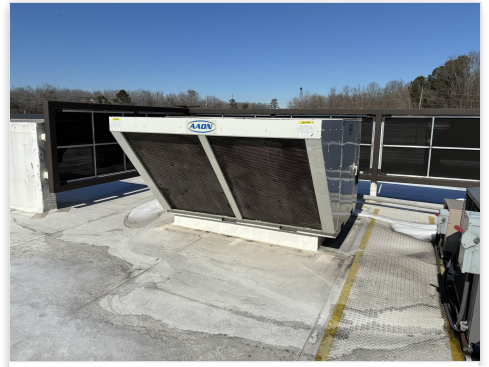
Asset: RT-1

Unit Data	
	Actual
MFG	AAON
Serial Num	202109-ANEL22848
Model Num	RN-015-8-0-EA0A-152
Num OA Filters 1	1
OA Filter Size 1	22.5X44.5
Num Final Filter 1	2
Final Filter Size 1	19.5X46.5X2

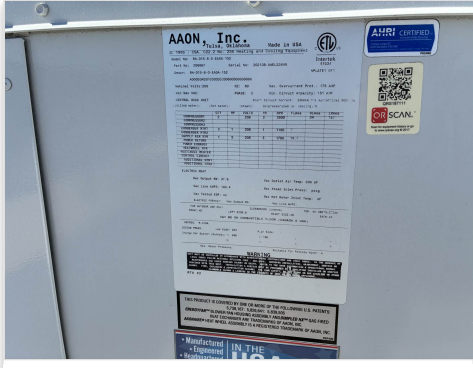
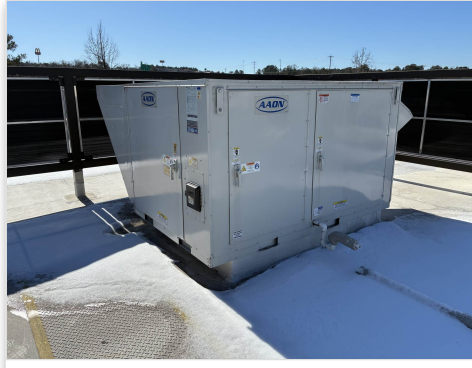
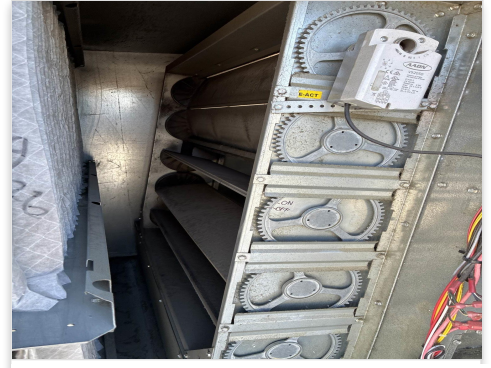
Asset: RT-2

Unit Data	
	Actual
MFG	AAON
Serial Num	202109-ANEL22849
Model Num	RN-015-8-0-EA0A-152
Num OA Filters 1	1
OA Filter Size 1	22.5X44.5
Num Final Filter 1	2
Final Filter Size 1	19.5X46.5X2

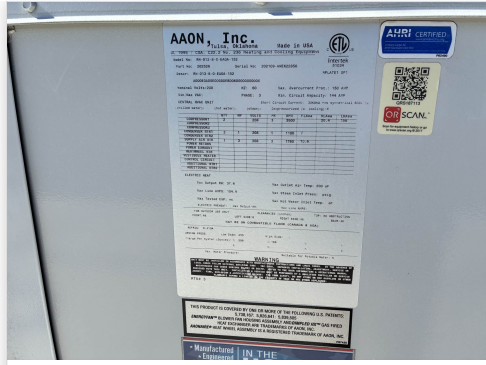
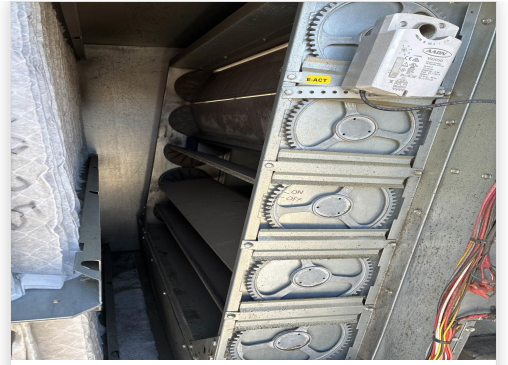
Asset: RT-3

Unit Data	
	Actual
MFG	AAON
Serial Num	202109-ANEK22850
Model Num	RN-013-8-0-EA0A-152
Num OA Filters 1	1
OA Filter Size 1	22.5X44.5
Num Final Filter 1	2
Final Filter Size 1	19.5X46.5X2

Notes:
See issues list.

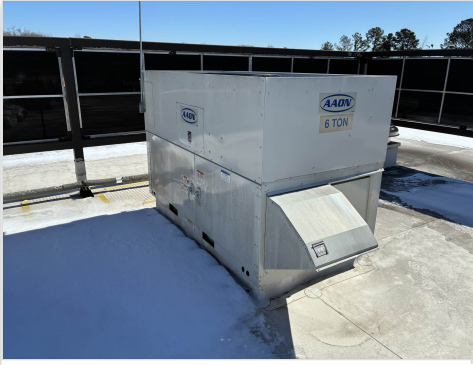
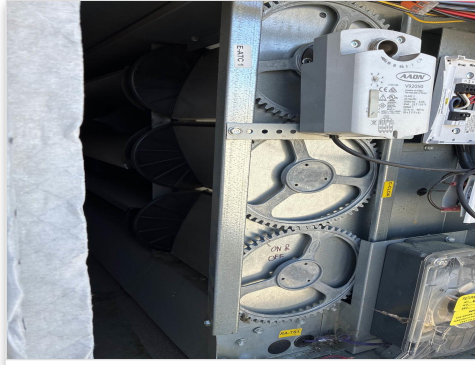
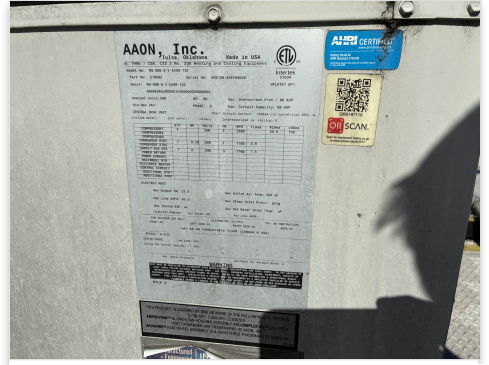
Asset: RT-4

Unit Data	
	Actual
MFG	AAON
Serial Num	202108-AYEF05035
Model Num	RQ-006-8-V-EA09-132
Num OA Filters 1	1
OA Filter Size 1	12X17
Num Final Filter 1	1
Final Filter Size 1	20X34X2

Test Data		
	Design	Actual
SF CFM	2800	2229
SF RPM	-	1760
OA CFM (Hoods On)	270	264
OA CFM (Hoods Off)	270	264
RL Voltage	-	214 VFD
RL Amperage	-	5.43 VFD
VFD Max SetPt	-	60 Hz
OA Damper Position (Hoods On)	-	46%
OA Damper Position (Hoods Off)	-	46%

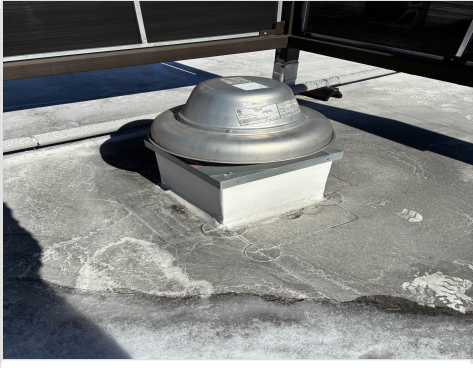
Asset: EF2

Unit Data		
	Design	Actual
MFG	NA	CAPTIVE AIRE
Model Num	NA	DR12HFA
Serial Num	-	5019669
Type	-	DOWNBLAST
Configuration	-	VERTICAL

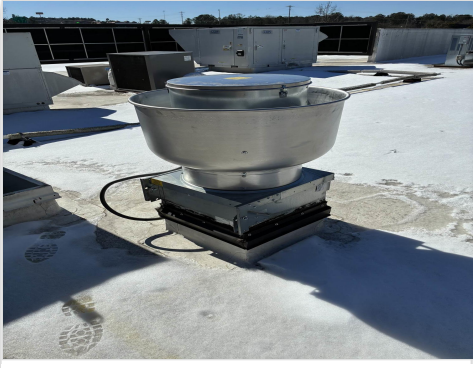
Asset: EF3

Unit Data		
	Design	Actual
MFG	NA	CAPTIVEAIRE
Model Num	NA	DU50HFA
Serial Num	-	8189368
Type	UPBLAST	UPBLAST
Configuration	VERTICAL	VERTICAL

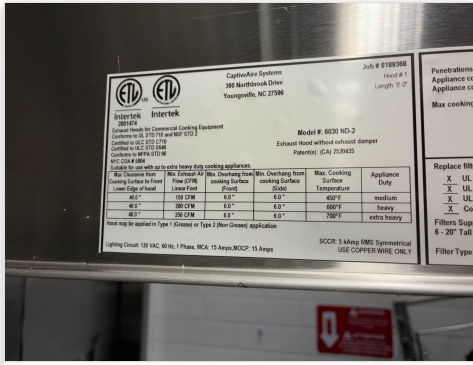
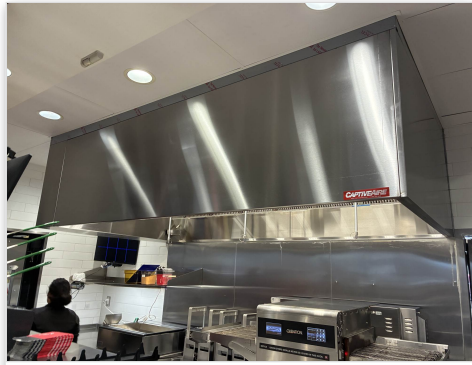
Asset: HD1

Design	Actual
MFG	CAPTIVEAIRE	CAPTIVEAIRE
Model Num	6030ND-2-F	6030ND-2
Job / Serial Num	-	8189368
Type	-	TYPE I CANOPY
Hood length	-	108"
Hood Width	-	60"
