**Report: TAB Report**  
**Function: Test, Adjust, & Balance**  
**Date: 12/12/2025**  
**Completed By: National TAB**

**PROJECT**  
**02-02-26 QT #1176 CAYCE, SC**

QUIKTRIP  
4705 SOUTH 129TH EAST AVENUE  
TULSA, OK 74134

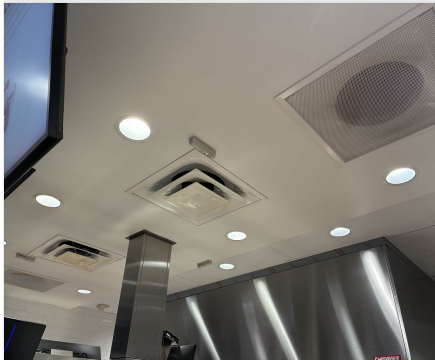
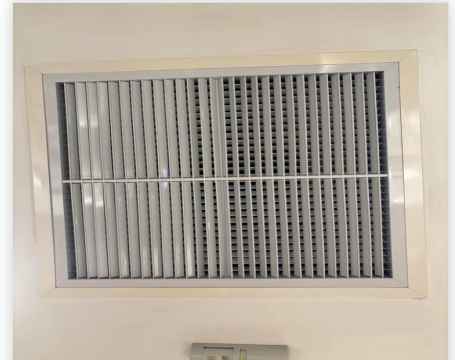
**Issue Name :** Incorrect Kitchen Diffusers  
**Description :** The kitchen diffusers 3-2 through 3-5 are the incorrect type. They need to be the TITUS 300FS diffuser with the installed deflection blades.  
**Created By :** National TAB      **Assigned To :** National TAB - Dan Hertenstein  
**Status :** Open  
**Priority :** High      **Asset Tag :** RT-3  
**Originated Date :** 02/03/2026 - Alex Bauer - National TAB

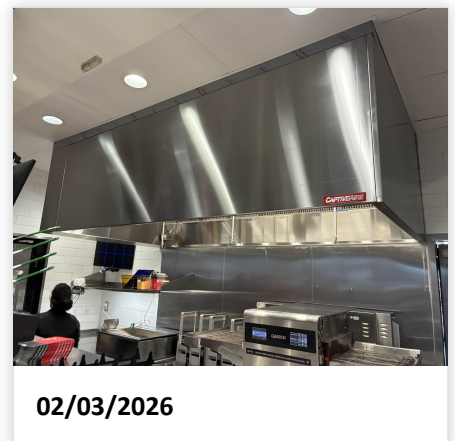
| <b>Issue Name :</b> | No Hood End Panels Installed | | |
| <b>Description :</b> | There are no hood end panels installed as per the Hood Schedule. | | |
| <b>Priority :</b> | High | <b>Asset Tag :</b> | HD1 |

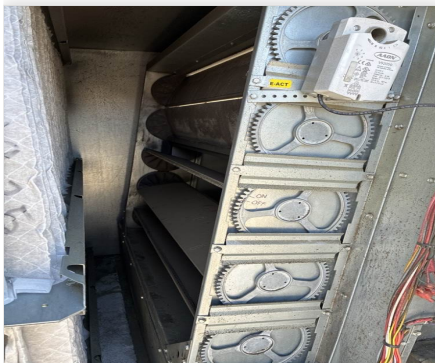
**Issue Name :** RTU-3 Economizer Actuator Malfunction  
**Description :** The actuator for the economizer stopped responding to commands from the store computer when setting the outside air when the hood is off. The outside air was set manually.  
**Created By :** National TAB **Assigned To :** National TAB - Dan Hertenstein  
**Status :** Open  
**Priority :** Urgent **Asset Tag :**  
**Originated Date :** 02/03/2026 - Alex Bauer - National TAB

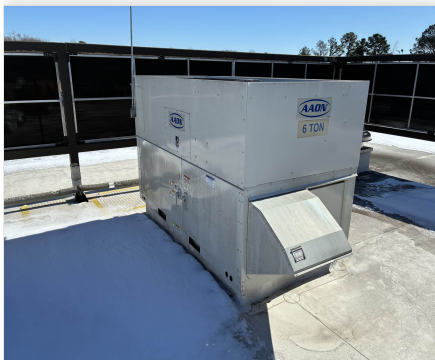
**Issue Name :** RTU-4 Low Flow  
**Description :** The Yaskawa J1000 VFD is set to its maximum speed option and the RTU is not producing enough airflow as it should (79%/100%). It is recommended to ensure the dampers are fully open and existent as well to check for resistance in the system. 66 CFM/ton is within the acceptable range for a unit of this size.  
**Created By :** National TAB **Assigned To :** National TAB - Dan Hertenstein  
**Status :** Open  
**Priority :** High **Asset Tag :** RT-4  
**Originated Date :** 02/03/2026 - Alex Bauer - National TAB
