Report: TAB Report
Function: Test, Adjust, & Balance
Date: 11/13/2024
Completed By: National TAB

PROJECT
11-11-24 WAWA #5438 ALACHUA, FL

Project: 11-11-24 WAWA #5438 ALACHUA, FL

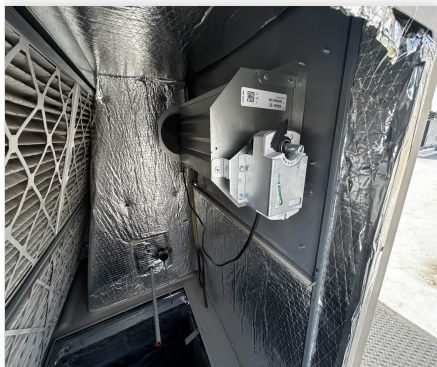
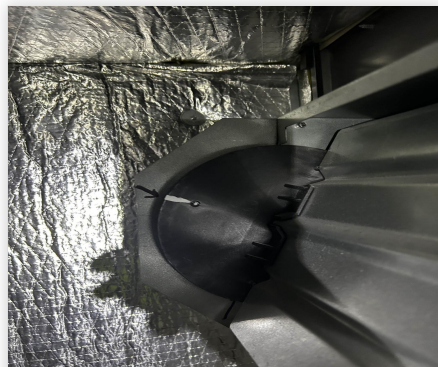
Issue Name : RTU-3 Outside Air Damper
Description : RTU-3 Outside Air damper is non-functional. Damper was manually set and marked. 11/25/2024 - Damper motor not repaired. Discussed with MC and they will be setting the damper to the marked position once repaired. Damper currently locked at design airflow.
Created By : National TAB **Assigned To :** National TAB - Kristopher Passley
Status : Open
Priority : Medium **Asset Tag :**
Originated Date : 11/12/2024 - Kristopher Passley - National TAB

RTU-3 OA MOTOR IS LOCKED AT DESIGN SETPOINT. RECOMMEND INSTALLING NEW MOTOR SO THAT DAMPER CLOSES WHEN UNIT IS TURNED OFF. // RTU-1 AND RTU-2 OA DAMPERS ARE FULLY OPERATIONAL.

Damper position set manually and marked on the damper shaft. Discussed with MC and they will be correctly setting the Damper % through the Lennox Core app once the damper motor is repaired/replaced.
